SERVICE NEWS

Vol. 8, No. 3, July -September 1981
CONTENTS

Aft Cargo Door Uplock Binding

by William B. Maddox, *Senior Aircraft Design Engineer*

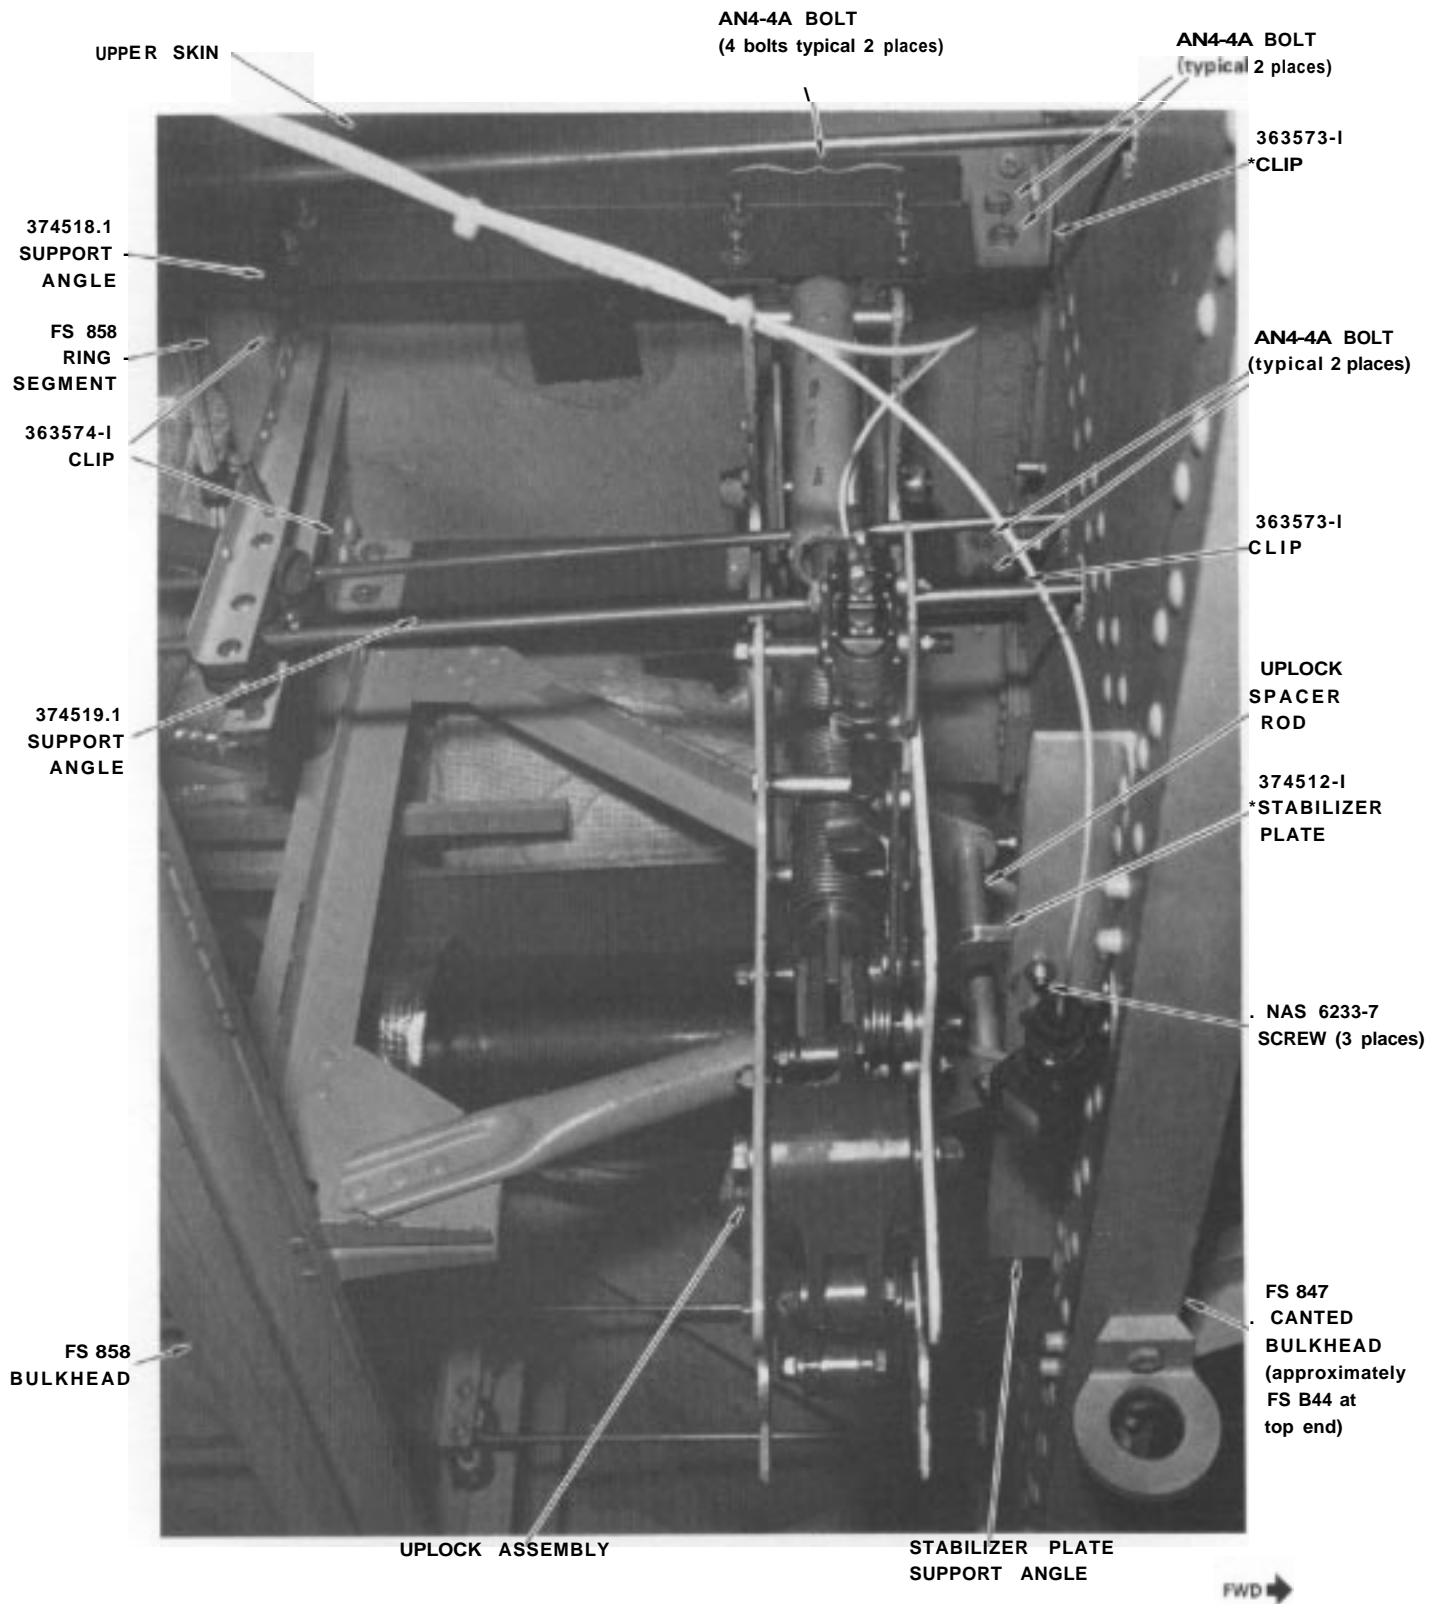
AFT CARGO DOOR UPLOCK ASSEMBLY

Binding aft cargo uplocks can be frustrating to deal with and difficult to troubleshoot. If you are having problems with a binding uplock, the trouble may be traceable to an unsuspected cause: misaligned aft cargo door uplock support angles (Figure 1).

The uplock support angles, part numbers 374518-1 (RH) and 374519-1 (LH), are components of the uplock support assembly, part number 374513-1. The uplock support assembly is located between the fuselage station 847 canted bulkhead (844 at top end) and the fuselage station 858 bulkhead, just to the right of the aircraft centerline. As its name implies, its purpose is to support the aft cargo door uplock mechanism.

Figure 1. Aft cargo door uplock assembly and supporting structure, seen from below.

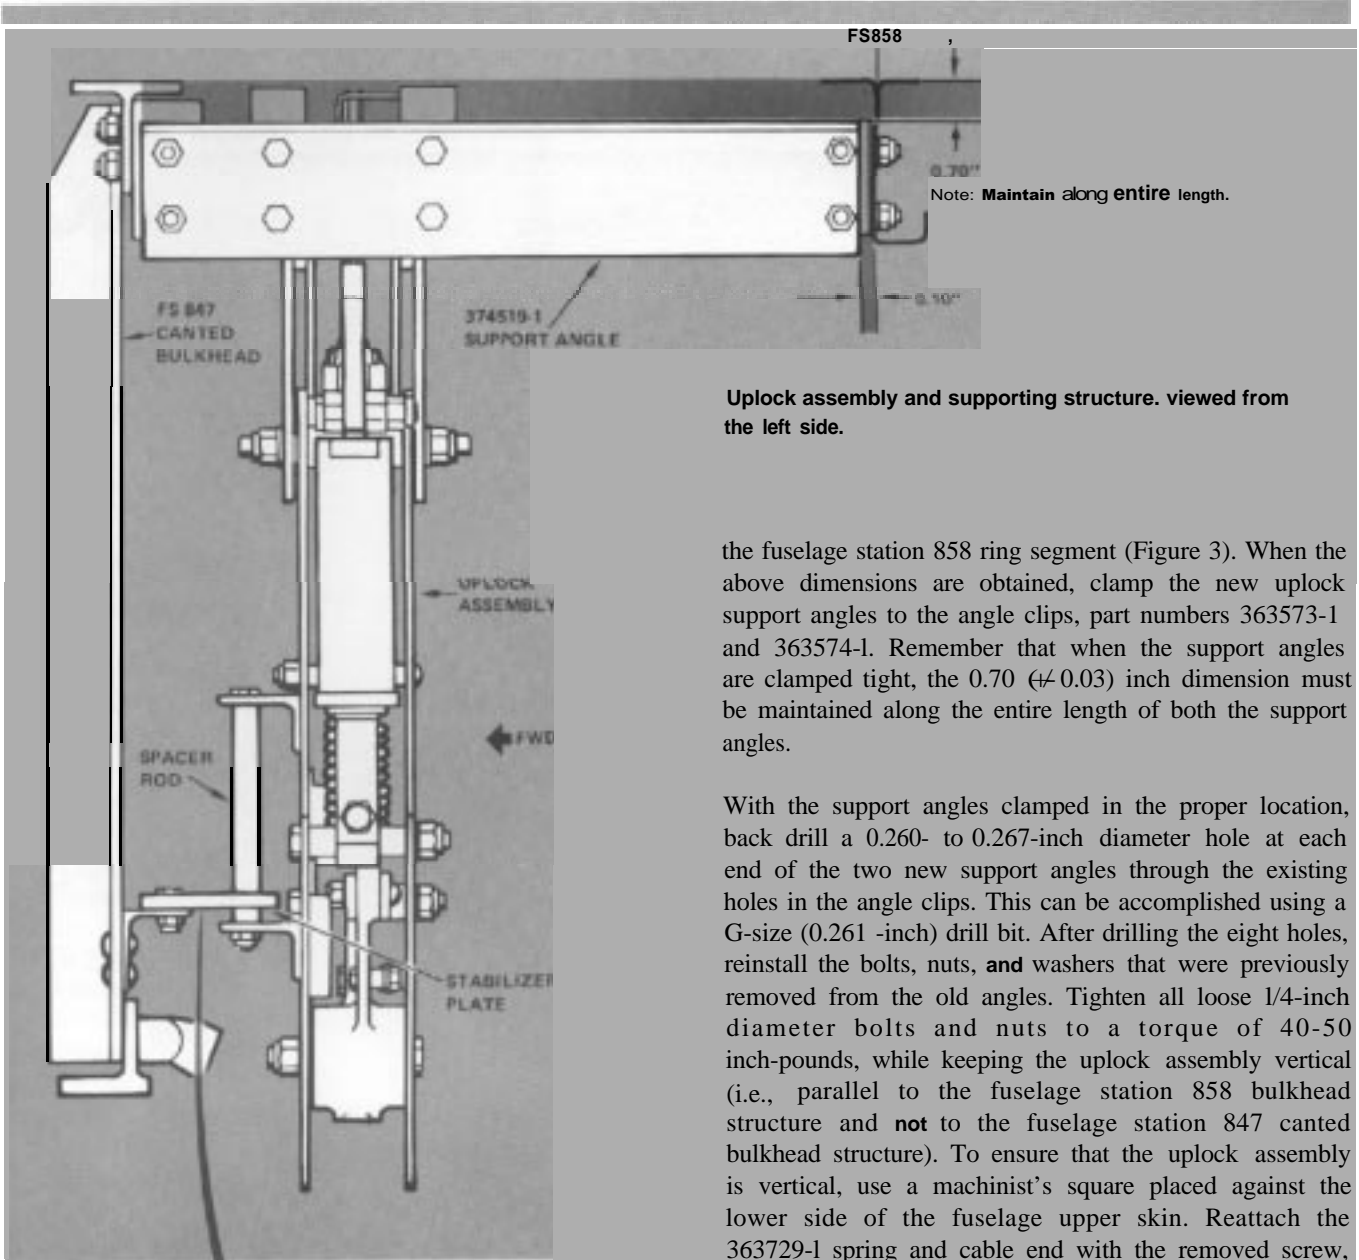
Examine the two uplock support angles to see if the upper surface of both the angles is 0.70 (\pm 0.03) of an inch below the inside surface of the fuselage upper skin along their entire lengths (Figure 3). If you find that the uplock support angles are not in tolerance in accordance with the above dimension, the two uplock support angles should be removed and replaced.

Uplock assembly and supporting structure, viewed from the left side.

Now position the uplock and uplock support assembly with the new support angles attached so that the upper surfaces of the new support angles are 0.70 (\pm 0.03) of an inch from the inside surface of the fuselage upper skin, and the aft end of each angle is 0.10 (\pm 0.03) inch from

the fuselage station 858 ring segment (Figure 3). When the above dimensions are obtained, clamp the new uplock support angles to the angle clips, part numbers 363573-1 and 363574-1. Remember that when the support angles are clamped tight, the 0.70 (± 0.03) inch dimension must be maintained along the entire length of both the support angles.

With the support angles clamped in the proper location, back drill a 0.260- to 0.267-inch diameter hole at each end of the two new support angles through the existing holes in the angle clips. This can be accomplished using a G-size (0.261 -inch) drill bit. After drilling the eight holes, reinstall the bolts, nuts, and washers that were previously removed from the old angles. Tighten all loose 1/4-inch diameter bolts and nuts to a torque of 40-50 inch-pounds, while keeping the uplock assembly vertical (i.e., parallel to the fuselage station 858 bulkhead structure and **not** to the fuselage station 847 canted bulkhead structure). To ensure that the uplock assembly is vertical, use a machinist's square placed against the lower side of the fuselage upper skin. Reattach the 363729-1 spring and cable end with the removed screw, nut and washer. Now rigger the aft cargo door uplock assembly and emergency release cable in accordance with the applicable maintenance instructions. During the rigging, check the position of the serrated plates to ensure the uplock remains vertical and recheck the 0.03inch clearance between the uplock spacer rod and the slot in the 374512-1 stabilizer plate. Readjust if necessary.

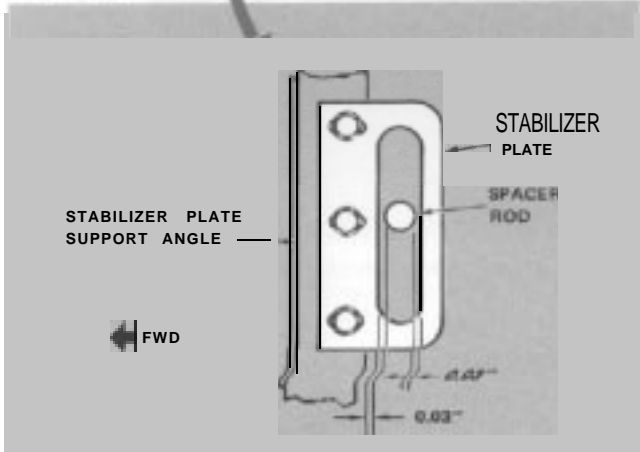
Figure 2, ▼ ▲ Figure 3.

To determine whether or not the uplock support angles need to be changed, check the relationship between the spacer rod, located on the forward side of the uplock assembly, and the stabilizer plate (P/N 374512-1) which is attached to the fuselage station 847 canted bulkhead. With no outside load applied, the clearance between the spacer rod and the stabilizer plate must be at least 0.03 of an inch on both the forward and aft sides of the rod (Figure 2).

Stabilizer plate viewed from above. Ensure that there is 0.03" clearance forward and left of the spacer rod.

If you find that there is insufficient clearance, or that the spacer rod and stabilizer plate are actually touching, attempt to correct the problem by adjusting the 374512-1 stabilizer plate. This is done by loosening the three NAS623-3-7 screws which attach the stabilizer plate to the fuselage station 847 canted bulkhead. Slide the

stabilizer plate forward or aft, as necessary, to obtain the appropriate clearance. Then tighten the screws. If the correct clearance cannot be obtained, or if the spacer rod strikes the adjacent structure (the stabilizer plate support angle), the two uplock support angles are probably misaligned. Make the following check to determine whether they are in fact misaligned:

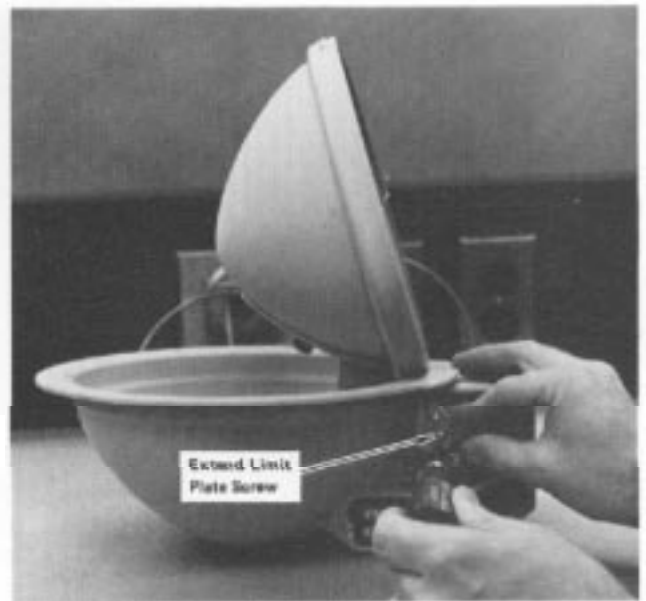
Figure 8. Adjusting the extend limit plate.

With the switch of the tester still in the extend position, hold the extend limit plate and then loosen the extend limit plate screw (Figure 8). Slowly rotate the extend limit plate counterclockwise. This allows the extend limit switch contacts to close, which completes the circuit and allows the inner canopy to extend farther. Measure the angle with a protractor and straightedge, as shown in Figure 6. When the extend angle has increased to 88 (+/-1) degrees, tighten the extend limit screw. Be sure not to allow the extend angle to exceed 90 degrees or damage to the unit may result.

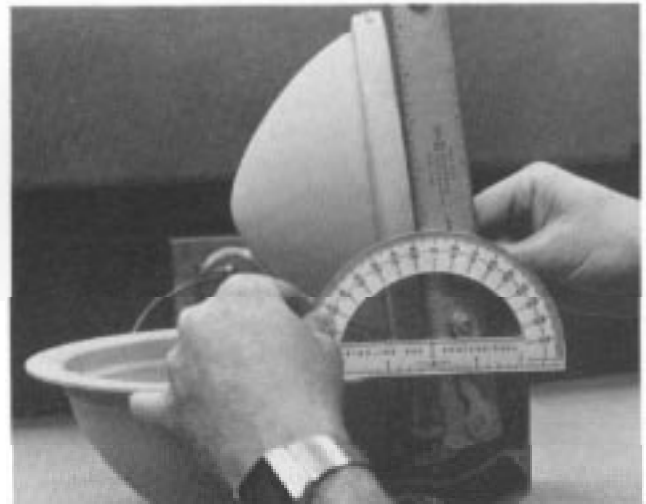
Figure 9. Insufficient extension, requiring extend limit switch adjustment.

If the extend limit plate does not rotate far enough to allow the correct extend angle to be obtained (Figure 9), the extend limit switch itself will have to be adjusted. Before adjusting the extend limit switch, first rotate the extend limit plate clockwise to the approximate position that it had for the 74 degree extend angle. This is done more easily if the inner canopy is retracted before you try to rotate the extend limit plate (Figure 10).

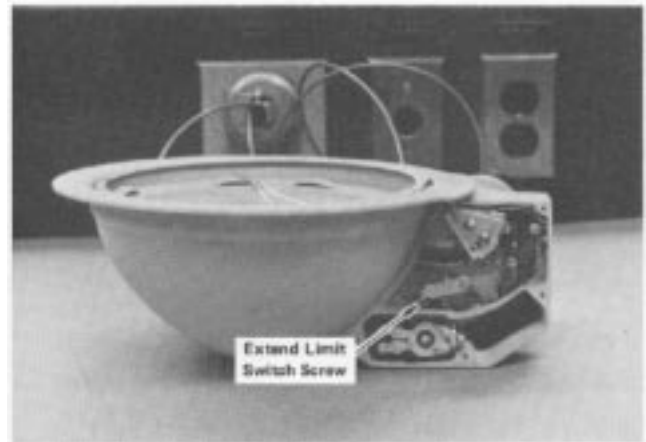
Figure 11. Extend limit switch repositioned to increase extend angle.

After the extend limit plate has been repositioned to the 74 degree position, loosen the extend limit switch screw and slide the extend limit switch to the left (Figure 11). Now retighten the extend limit switch screw and extend the canopy (Figure 12). Again attempt to adjust the extend angle to 88 (+/-1) degrees by rotating the extend limit plate counterclockwise, as previously described. If an extend angle of 88 (+/-1) degrees still cannot be obtained, the extend limit switch will have to be moved farther to the left.
