# *SERVICE NEWS*

**MAIN LANDING GEAR RUB**

**Vol. 13, No. 1, January - March 1986**

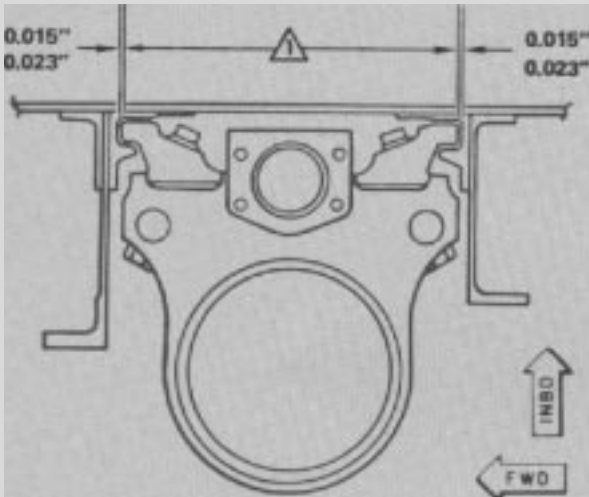
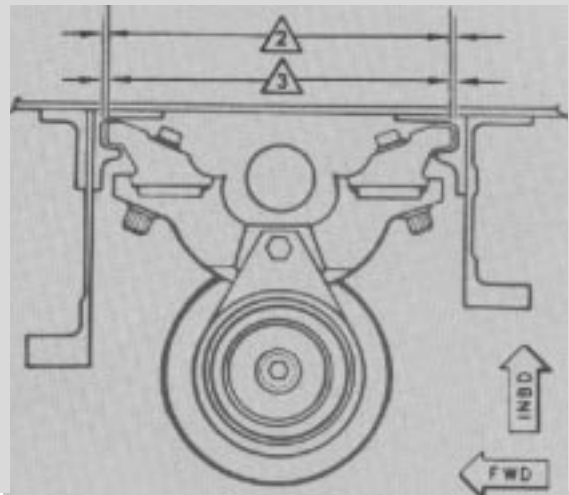
*Figure 1. Track shoes — fore and aft clearances.*

Operators of Hercules aircraft may on some occasions find evidence that there has been contact between the main landing gear torque strut and the vertical beams, or between the main gear piston and shelf bracket. This contact could be the result of any or a combination of the following causes:

- Shoe misadjustment
- Shoe or track wear
- Tire unbalance

The nature of the indications of landing gear rub are helpful in determining the extent of corrective action necessary to deal with the problem. For example, an airplane with suspected gear rub where only scratched or chipped paint is observed is considered flyable until adjustments can be made to provide more clearance. Do not, however, continue to operate the airplane for more than 100 flight hours without taking action to relieve the rub. An airplane that shows evidence of rubbing in

which metal-to-metal contact is taking place, causing gouging or scratching of the surfaces, is not considered flyable. Immediate corrective action is mandatory.

1. Check the lower shoe gap between the inboard face of the shoe and the face of the track. The gap should be 0.002 to 0.007 inch, measured with the airplane on jacks.
2. Check the lower shoe fore and aft clearances to ensure that they are not excessive. Adjust if required (see Figure 1).
3. Check the adjustment of the upper shoes for proper clearance and make sure that the tops of both shoes are within 0.06 inch of being an equal distance above the swivel bracket.
4. Check the upper shoe outboard facings (see Figure

**INITIAL GAPSETTING: 0.015" to 0.023"**

**TOTAL MINIMUM GAPSETTING: 0.010" to 0.020"**  
**TOTAL INITIAL GAP SETTING: 0.030" to 0.040"**

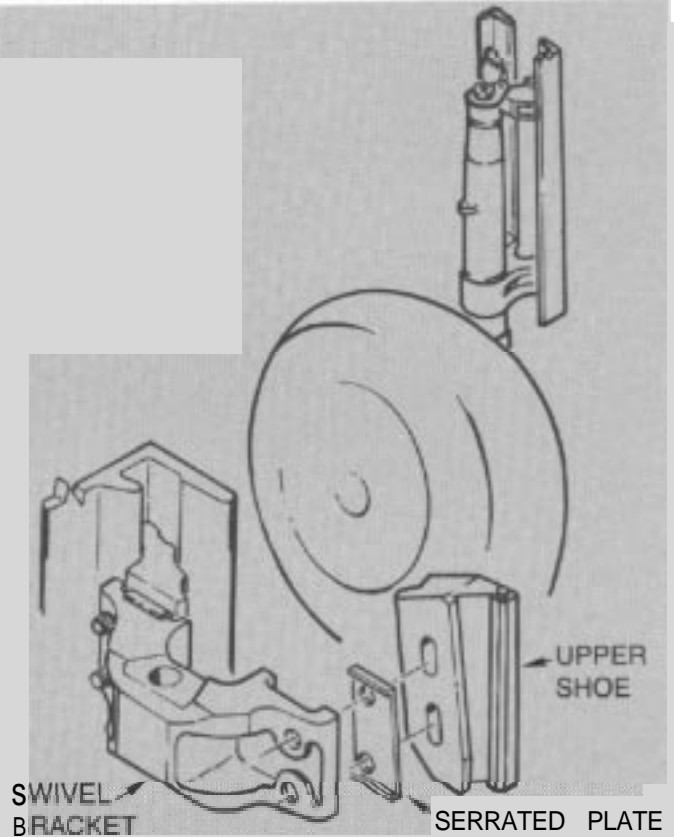
Figure 3. Upper track shoe installation.

If a main landing gear strut has a rubbing condition that cannot be corrected by the above measures, check to see whether the aircraft has the thick (0.130 inch) serrated plates (P/N 372602-11, and -1R) installed between the upper shoes and the swivel bracket (see Figure 3).

If the thick serrated plates are present on the aircraft in question, the rubbing condition can be relieved by substituting the thin (0.065 to 0.070 inch) serrated plates (P/N 372602-3 and -4). The use of the thinner serrated plates shifts the position of the main landing gear piston/axle slightly outboard, thereby increasing the clearance in the contact area.

The thinner plates are interchangeable with the thick plates and may be substituted if increased clearance is desired.

Note that plates should be replaced in pairs, and that a combination of thick and thin plates on one swivel bracket is not acceptable. If the P/N 372602-3 and -4

thin serrated plates are not readily available, the -IL and -IR thick plates can be modified to the thinner -3 and -4 configuration by machining the inside of the channel section web to 0.065 to 0.070 inch in thickness. Then replat the reworked area with cadmium.

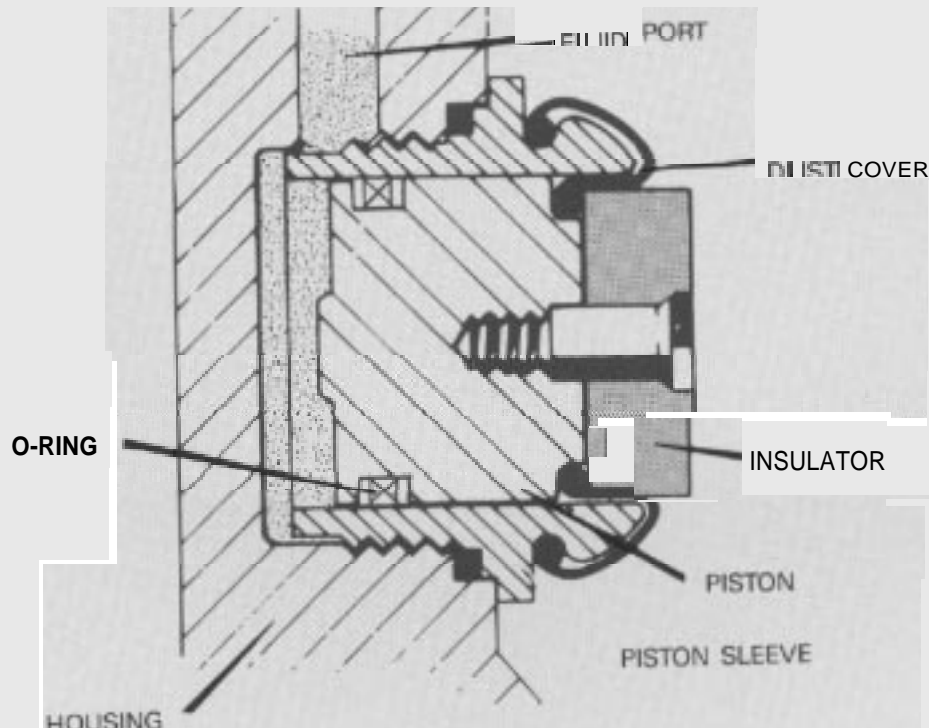
**MULTI-DISC ASSEMBLY**

There have been a number of reports of Goodyear multi-disc brakes being removed because of crushed or broken insulators. Here is a little background information on the problem, and some guidelines for inspection and acceptance or rejection of brake piston insulators.

Originally there was no specific requirement for compression strength or load testing of brake piston insulators. After the problem of broken and crushed insulators was reported, the parts were tested by Raymark and Abex, the two vendors concerned. The tests revealed that the Raymark parts crushed at 9,000-13,000 pounds, while the Abex parts failed at 20,000-25,000 pounds.

For inspection of used insulators, parts that are of inadequate strength usually delaminate and are therefore easy to identify. Any insulator that is starting to delaminate should be replaced. Also check visually for blisters, nicks, and cracks. Surface cracks are acceptable; but cracks that extend into the screw hole are cause for rejection. The height of the insulator is also important in determining if a part may be reinstalled for another run. Brake piston insulators less than 0.669 inches high should not be continued in service.

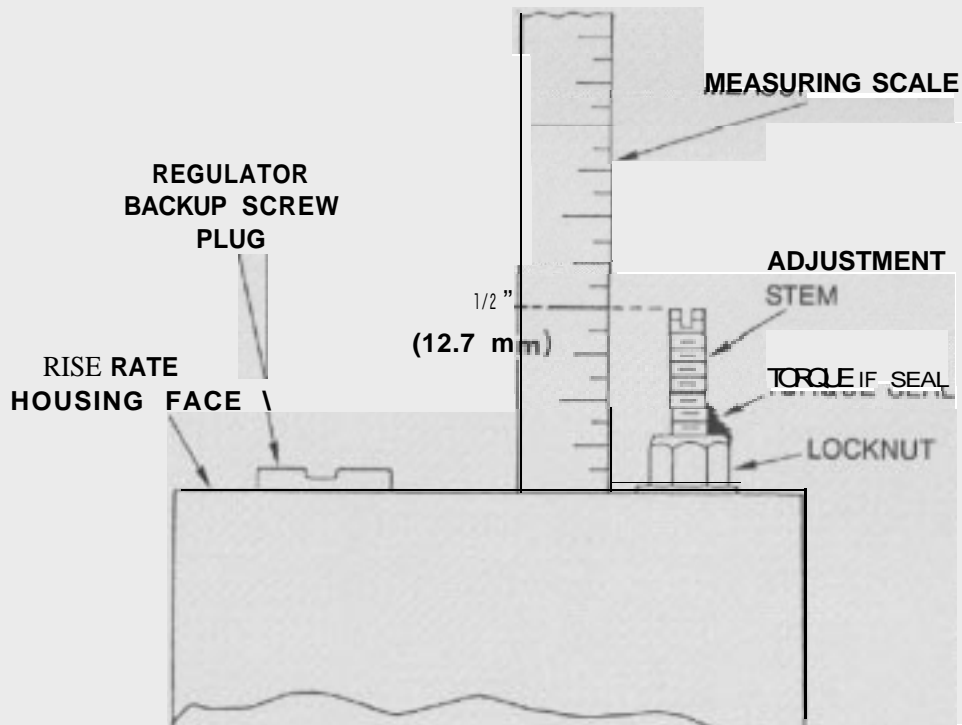
Figure 1. Adjustment stem measurement.

Some starter control valves have been previously adjusted at the factory and do not have the "A" stamped after the serial number on the nameplate. If this is the case, the adjustment stem will already be extended 1/2 inch from the face of the rise rate control housing and will not require further adjustment (see Figure 1). For this reason, be sure to check this dimension before any adjustment is made to the unit.

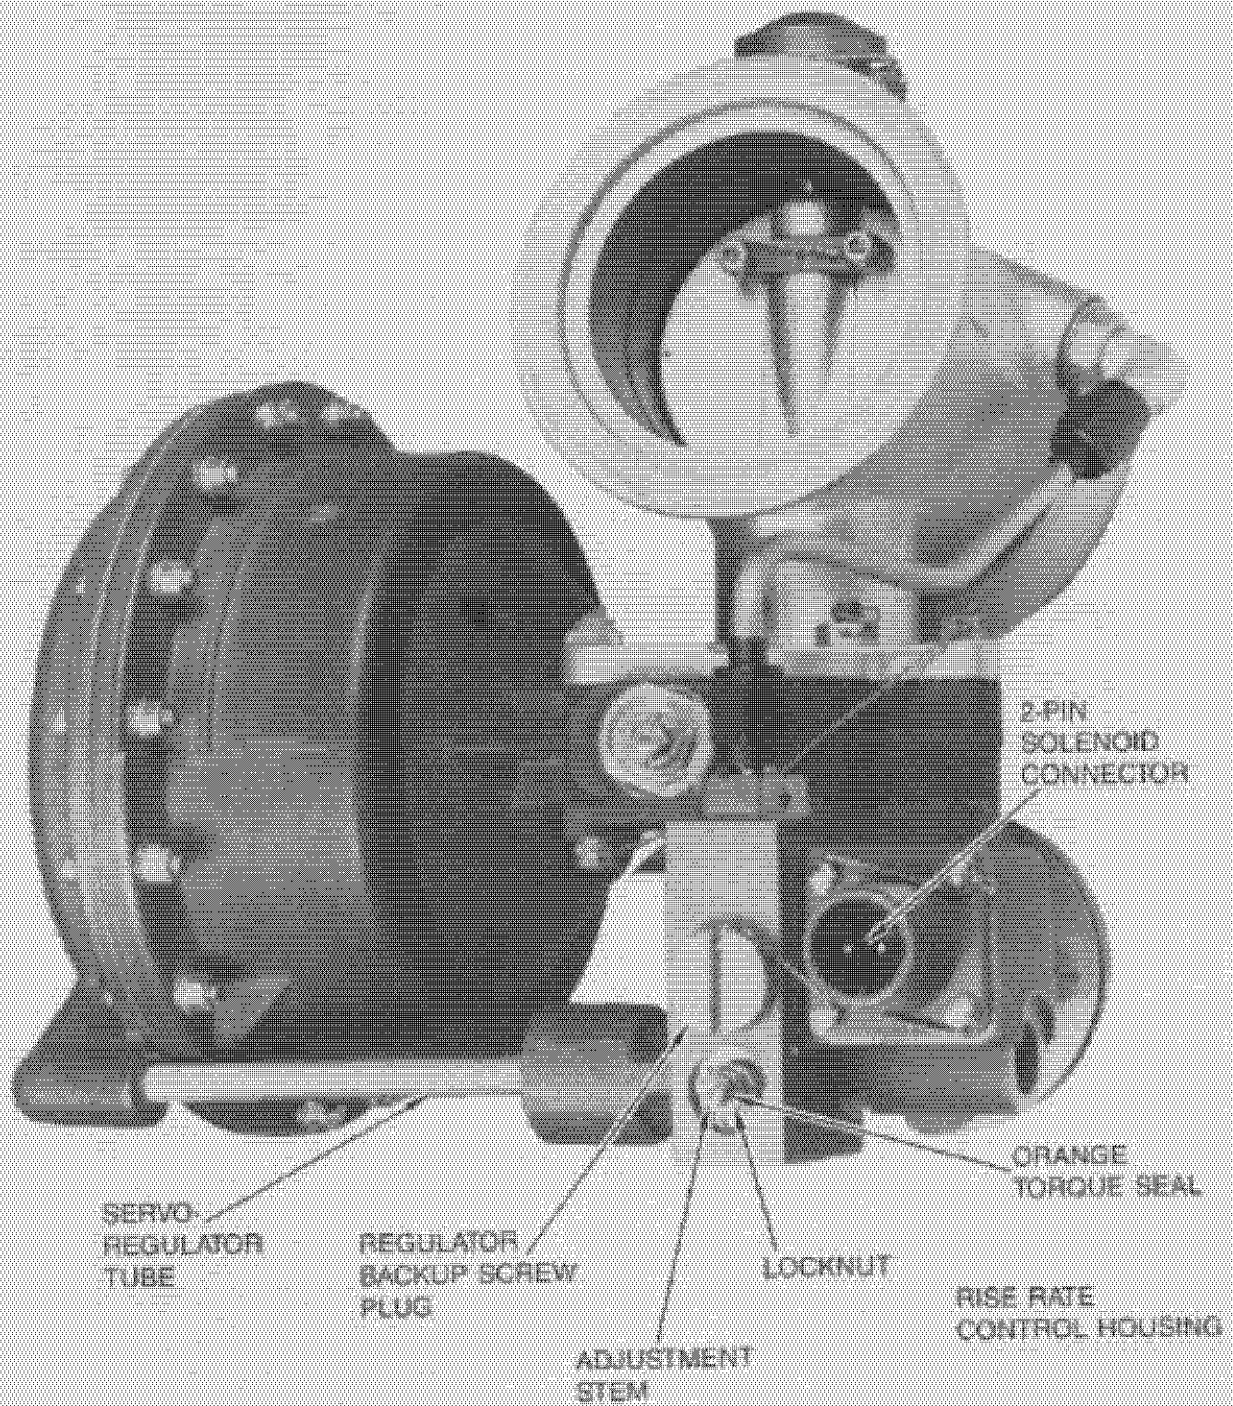
Figure 2. Rise rate control adjustment.

Later model Bendix starters (P/N 36E84-18QD or -18QF, for example) are equipped with a stronger clutch return spring. The stronger spring may, under certain circumstances, allow the starter to spool up to a higher RPM before the starter engages. This higher engagement RPM may cause a significant increase in the wear rate on the clutch and coupling teeth, thereby reducing the service life of these components. Bendix Service Bulletin No. 124A has been issued to establish the procedure to elevate the rise rate of the 38E73 starter control valves in order to make them compatible with the stronger return springs. Starter control valves which have been adjusted in compliance with the service bulletin may be identified by the letter "A" following the serial number on their name plate.

1. First, locate the rise rate control valve housing on the starter valve. It is located between the 2-pin solenoid connector and the servo-to-regulator tube (see **Figure 2**). The rise rate control adjusting stem (No. 10-32 thread) is situated above the large regulator backup screw plug. Both the adjusting stem and its locknut are covered with orange torque seal.

2. Scrape off the majority of the torque seal on the adjustment stem and lock nut, while exercising caution not to damage the adjustment screw threads.

3. Use a stiff non-metallic brush and the acetone solvent (or equivalent) to remove the torque seal remaining in the adjustment stem threads. It is important that the adjustment screw threads be properly cleaned without damaging them in the process. Binding may occur between the locknut and adjusting screw if the threads are not properly cleaned or are damaged.

4. Place a suitable blade-type screwdriver into the adjustment screw stem slot to hold it stationary while using a 1/4-inch wrench to unscrew (counterclockwise direction) the locknut only as required to loosen the assembly (about 1/2 turn).

5. Remove the wrench from the locknut and use the screwdriver to unscrew the adjustment stem four (4) complete turns (counterclockwise direction). Be very careful NOT to unscrew the adjustment stem more than four (4) turns since doing so may cause the stem to fall out. With this accomplished, hold the stem stationary with the screwdriver and carefully tighten the locknut (clockwise direction) as required to hold the stem in place.

6. Apply new torque seal to the threads of the stem.
7. Add the letter "A" after the serial number on the name plate on starter control valves which have been adjusted in this manner.
