2018 RESTORATION MAINTENANCE SUMMARY REPORT

Bloody Brook
Onondaga County, New York

Prepared for:
Lockheed Martin Corporation
Syracuse, New York

February 2019

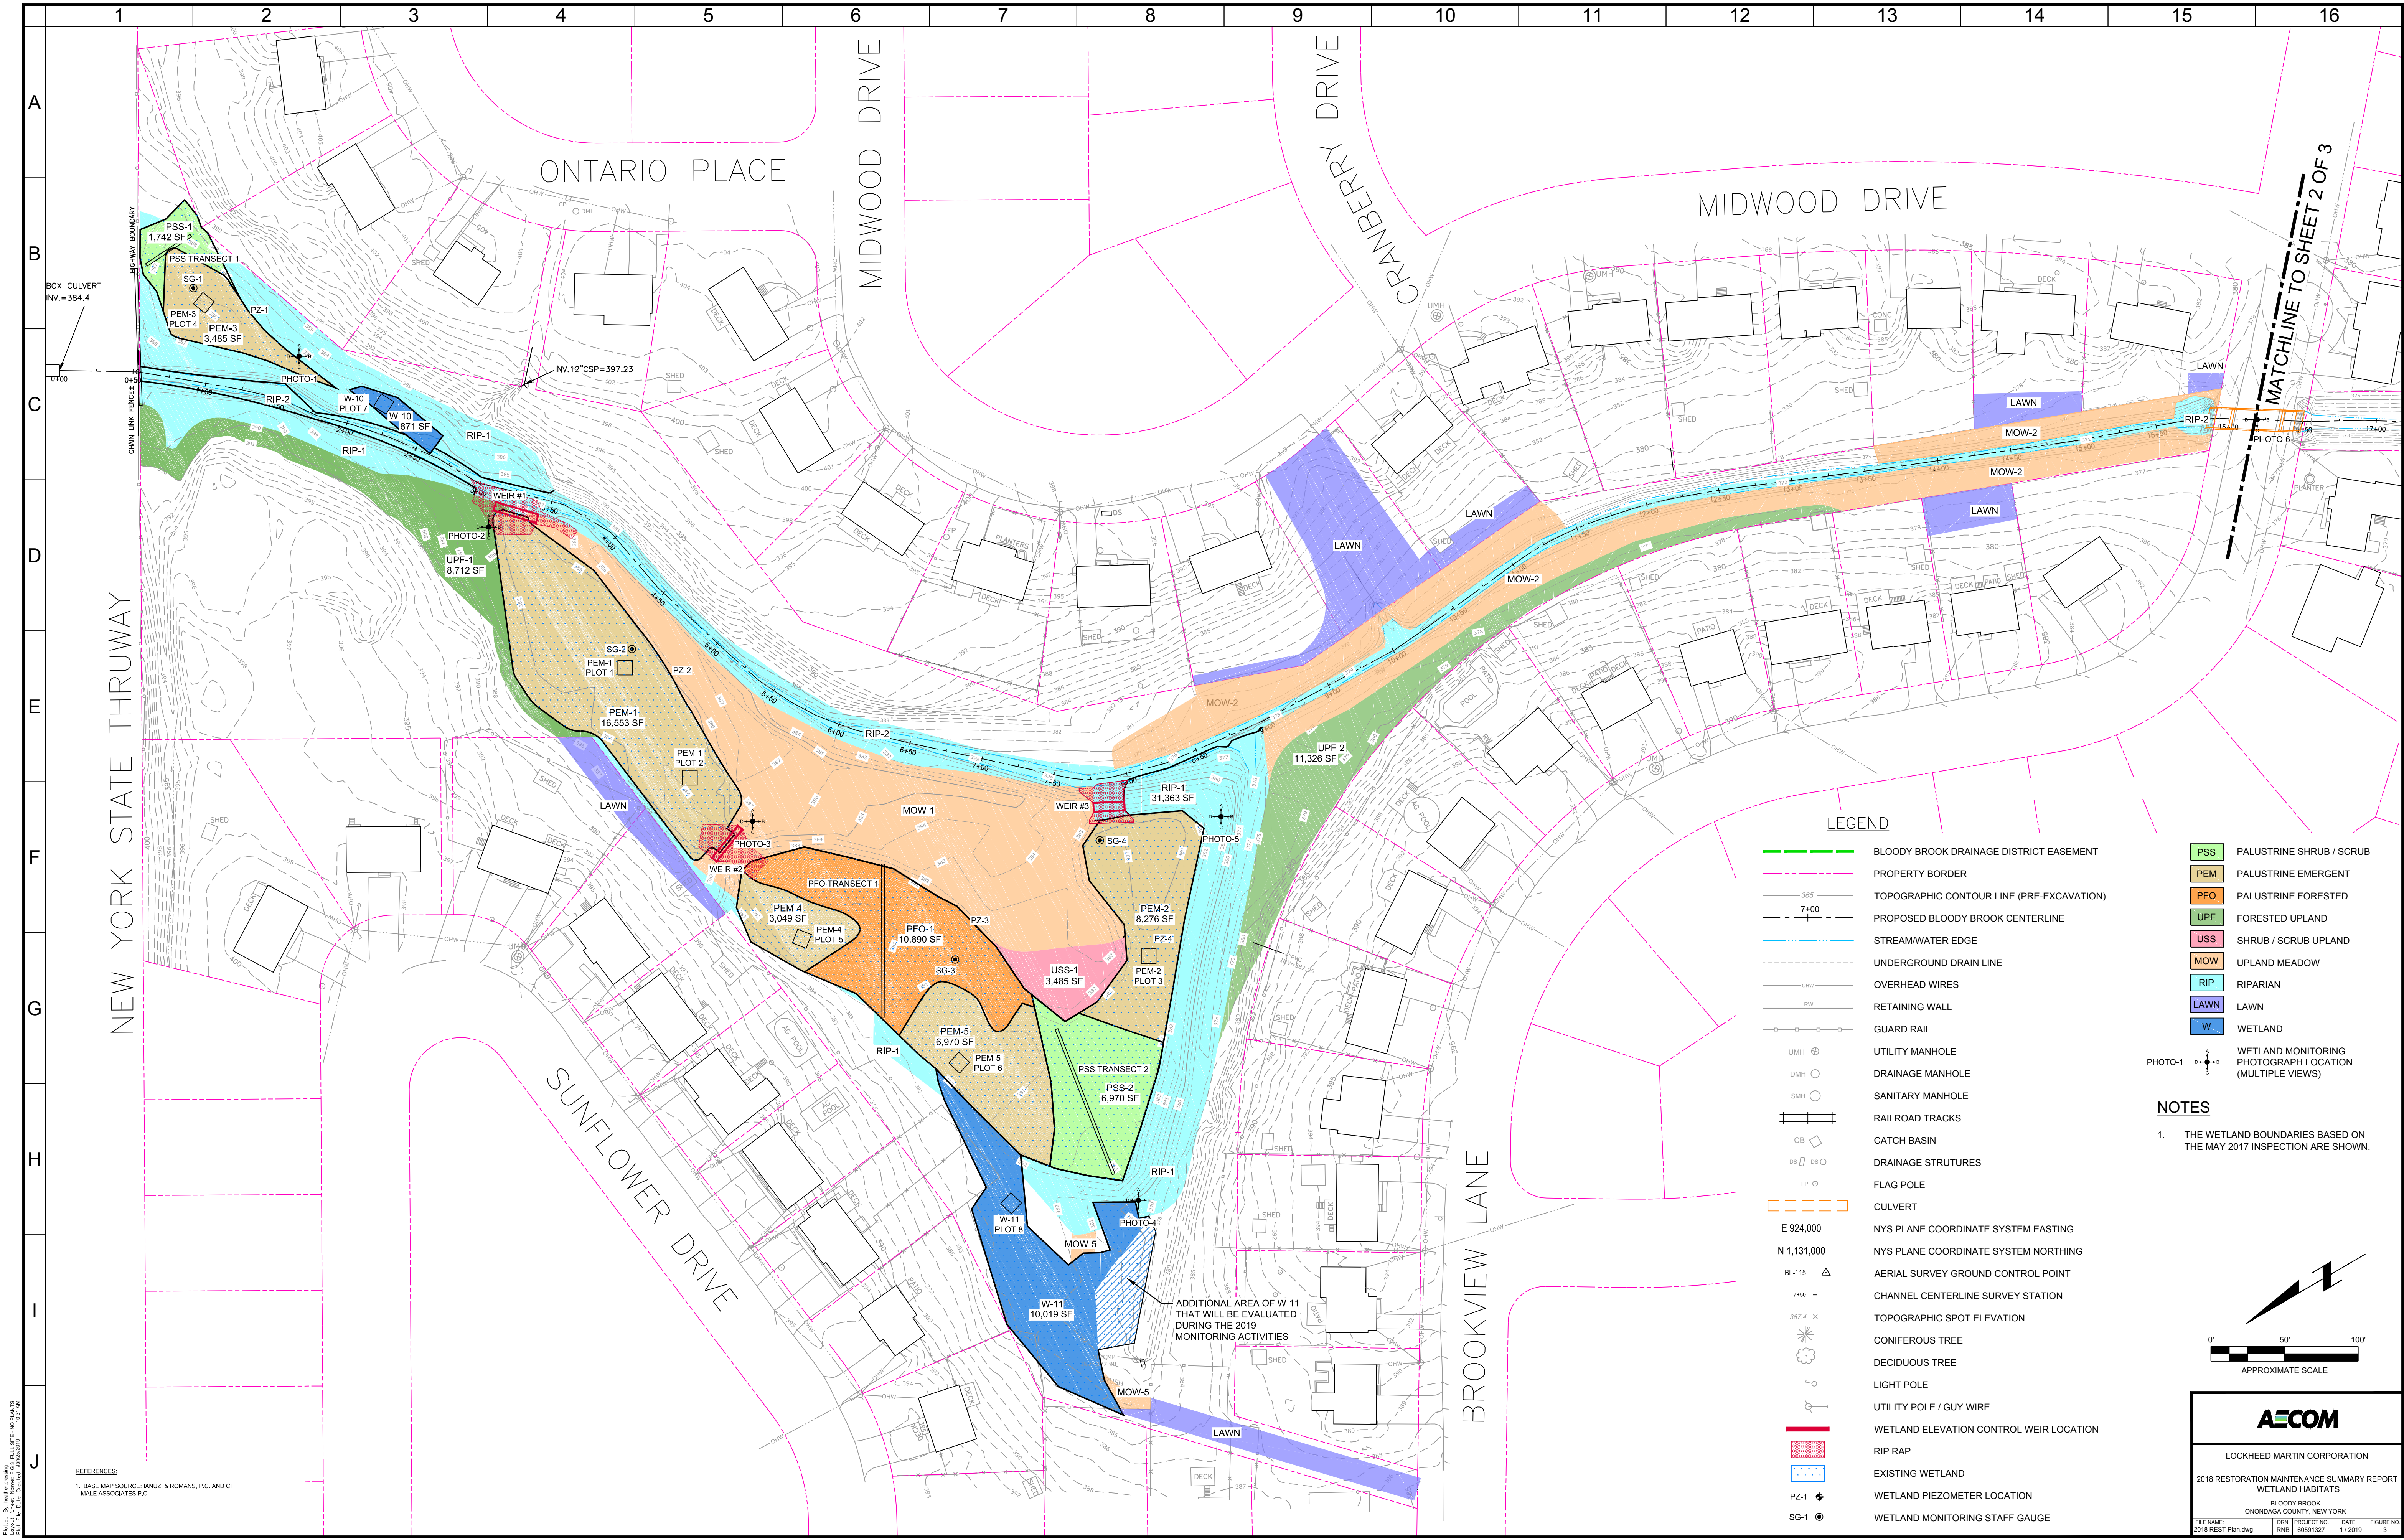
LOCKHEED MARTIN CORPORATION
2018 RESTORATION MAINTENANCE SUMMARY REPORT
WETLAND HABITATS
BLOODY BROOK
ONONDAGA COUNTY, NEW YORK
FILE NAME: 2018 REST Plan.dwg DRI PROJECT NO: 60591327 DATE: 1/2019 FIGURE NO: 3

- Habitat area W-11, shown on Figure 3, has developed a strong population of emergent vegetation. However, there is still a large area where the wetland seed mix did not germinate. Cattails from adjacent areas on the site will be transplanted in these bare spots. If the 2019 monitoring results indicate the transplants failed to develop, other options will be evaluated.

- W-11, shown on Figure 3, has developed a strong population of emergent vegetation. However, there is still a large area where the wetland seed mix did not germinate. After consultation with NYSDEC F&W during the October 18, 2018 site visit, approximately 40 cattails from adjacent areas on the site were transplanted in these bare spots instead of overseeding the area. If the 2019 monitoring results indicate the transplants failed to develop, other options will be evaluated, including overseeding with PA New England Province FACW Mix (ERNMX-251).

- For the majority of the planted upland meadow habitats (MOW-1 and MOW-2) (Figure 3), the seed mixture placed during restoration activities was successful. During the 2018 monitoring activities, large bare spots were identified in MOW-1 where the temporary construction staging area was located. During the November 2018 maintenance activities, those bare spots were covered with vegetation consistent with the upland meadow seed mix, therefore no reseeding was required.

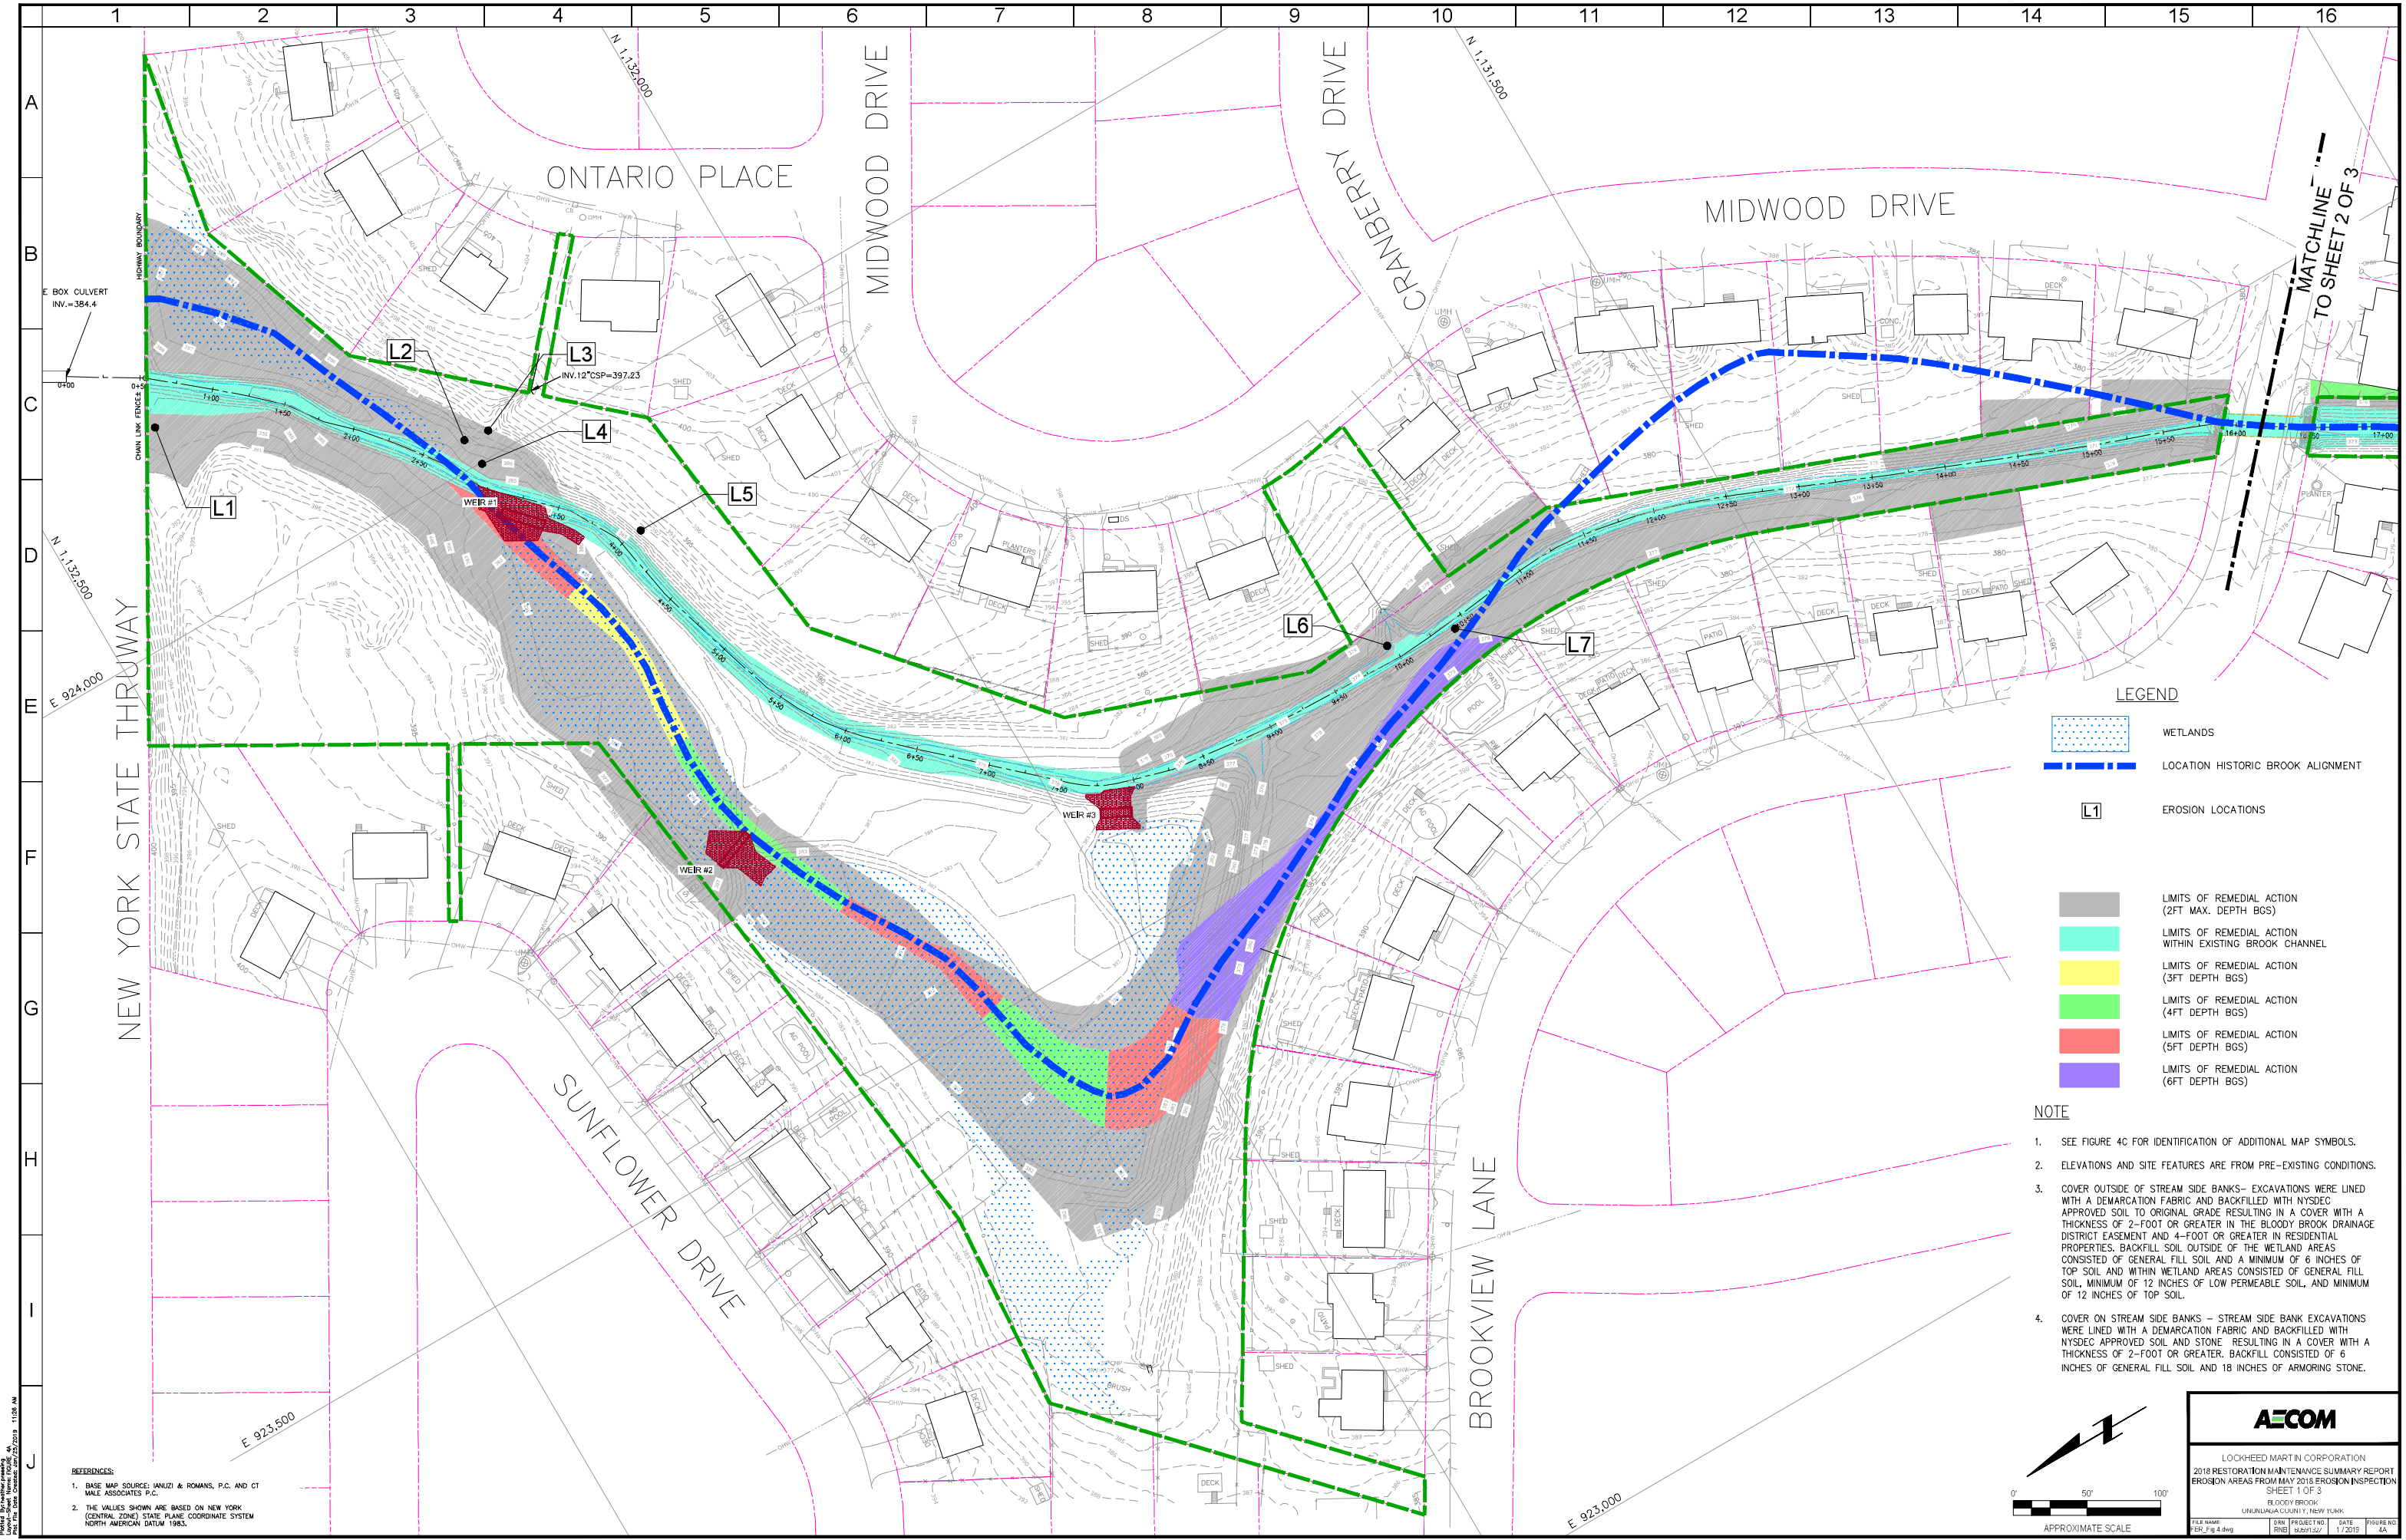
LOCKHEED MARTIN CORPORATION
2018 RESTORATION MAINTENANCE SUMMARY REPORT
EROSION AREAS FROM MAY 2018 EROSION INSPECTION
SHEET 1 OF 3
BLOODY BROOK
UNIONDALE COUNTY, NEW YORK

Location 1 is located in the upland forested area adjacent to the Thruway property (Figure 4A). At the time of the May 2018 inspection, minor vegetation loss within the area disturbed by remedial activities was noted for this location. During the November 2018 maintenance activities, vegetation loss and wet soil conditions were observed. Live stakes were planted within this area to stabilize the ground and to act as a barrier between the wetland and the invasive species present along the thruway. In coordination with NYSDEC F&W, large trees and additional live stakes will be planted in this area during spring 2019 to further stabilize this area and to create a stand of trees as a barrier between the Thruway and the wetlands.

Locations 2 and 3 are located in the riparian area just upstream of Weir 1 (Figure 4A). Minor vegetation loss and erosion within the areas disturbed by remedial activities was noted for these locations during the 2018 inspection. In early November 2018, live stakes were planted at Location 2 to improve bank stability. At Location 3, live stakes were planted and rip rap was placed to stabilize the ground to allow the live stakes to take root. These locations will be overseeded with PA New England Province Riparian Mix (ERNMX-253) or equivalent depending on availability, as needed during early spring 2019, prior to the 2019 monitoring event.

Location 4 is located in the riparian area adjacent to Weir 1 (Figure 4A). Minor vegetation loss within the area disturbed by remedial activities was noted for this location during the 2018 inspection. Live stakes were planted in this area in early November 2018 to improve bank stability. This location will be overseeded with PA New England Province Riparian Mix (ERNMX-253) or equivalent depending on availability, as needed during early spring 2019, prior to the 2019 monitoring event.

Location 5 is located in the riparian area downstream from Weir 1 (Figure 4A). During the 2018 inspection, portions of the side bank were noted as having sparse vegetation growth and minor rip- rap erosion. Live stakes were planted in this area in early November 2018 to improve bank stability. The rip rap was also adjusted in this area to prevent future erosion. This location will be overseeded with PA New England Province Riparian Mix (ERNMX-253) or equivalent depending on availability, as needed during early spring 2019, prior to the 2019 monitoring event.

Location 6 is located along the side bank adjacent to the empty lot on Midwood Drive, and Location 7 is located on the opposite bank just downstream from Location 6 (Figure 4A), both in residential areas. During the 2018 inspection, portions of the side bank showed signs of minor rip rap erosion at both of these locations. Rip rap was adjusted in both areas to help prevent future erosion. In both areas, a mixture of bagged topsoil and bagged compost were added prior to seeding. Both areas were then seeded with a cool season lawn mix to improve stability. These locations will be overseeded with Northeastern U.S. Road Native Mix (ERNMX-105) or equivalent depending on availability, as needed during the spring of 2019, prior to the 2019 monitoring event.

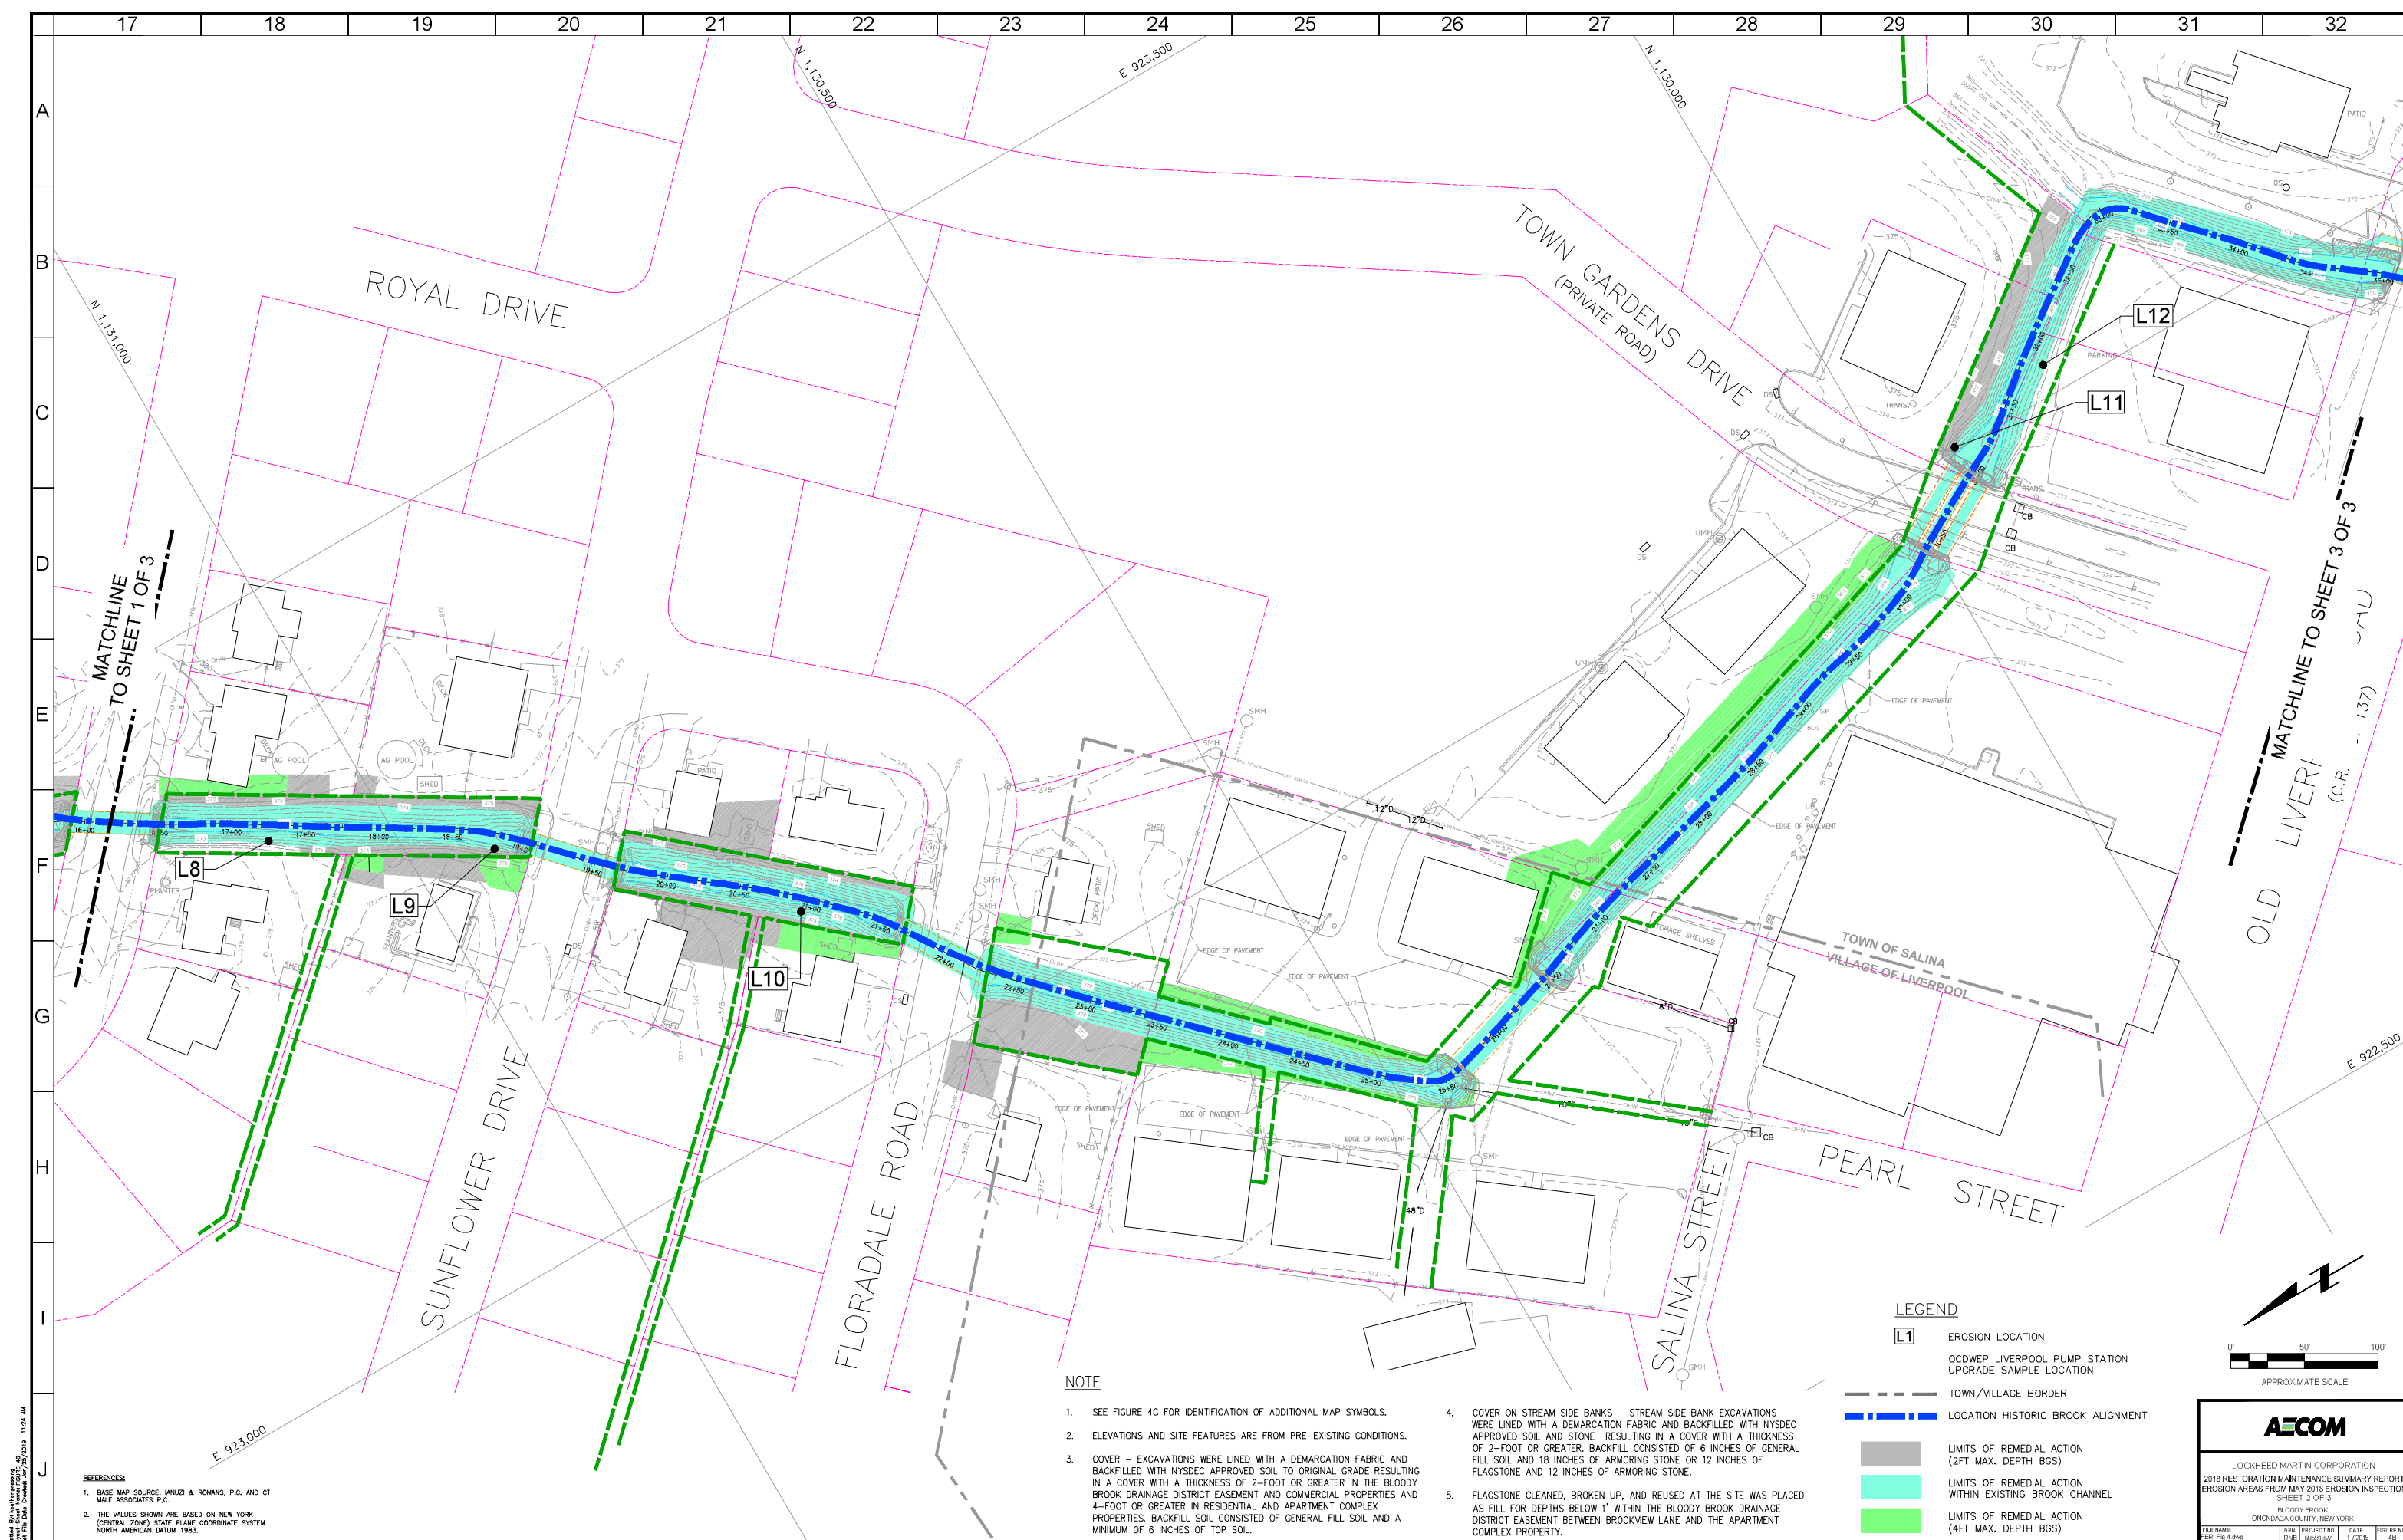
LOCKHEED MARTIN CORPORATION
2018 RESTORATION MAINTENANCE SUMMARY REPORT
EROSION AREAS FROM MAY 2018 EROSION INSPECTION
SHEET 2 OF 3
BLOODY BROOK
ONONDAGA COUNTY, NEW YORK
FILE NAME: 251_Fig 4.dwg
SHEET NO: 4B
DATE: 1/2019
FIGURE NO: 4B

Locations 8 and 9 are located in a residential area along the side bank between Brookview Lane and Sunflower Drive (Figure 4B). During the 2018 inspection, portions of the side bank showed signs of minor rip rap erosion. Rip rap was adjusted at both areas to help prevent future

erosion. The placement of additional topsoil was needed prior to overseeding. To promote the growth of vegetation, these areas were addressed by adding a mixture of bagged topsoil and bagged compost prior to seeding. Both areas were then seeded with a cool season lawn mix to improve stability. These locations will be overseeded with Northeastern U.S. Road Native Mix (ERNMX-105) or equivalent depending on availability, as needed during the spring of 2019, prior to the 2019 monitoring event.

Location 10 is located in the residential area between Sunflower Drive and Floradale Road (Figure 4B). During the 2018 inspection, portions of the side bank showed signs of minor rip rap erosion. This bank area was addressed by adjusting the rip rap to help prevent future erosion.

Location 11 is located along the side bank within the apartment complex area (Figure 4B). During the 2018 inspection, portions of this side bank showed signs of soil erosion. This bank area was addressed by adding a mixture of bagged topsoil and bagged compost prior to seeding. Both areas were then seeded with a cool season lawn mix to improve stability. These locations will be overseeded with Northeastern U.S. Road Native Mix (ERNMX-105) or equivalent depending on availability, as needed during the spring of 2019, prior to the 2019 monitoring event.

Location 12 is located along the side bank within a commercial property across from the apartment complex area (Figure 4B). During the 2018 inspection, portions of this side bank showed signs of minor rip rap erosion. This bank area was addressed by adjusting the rip rap to help prevent future erosion.

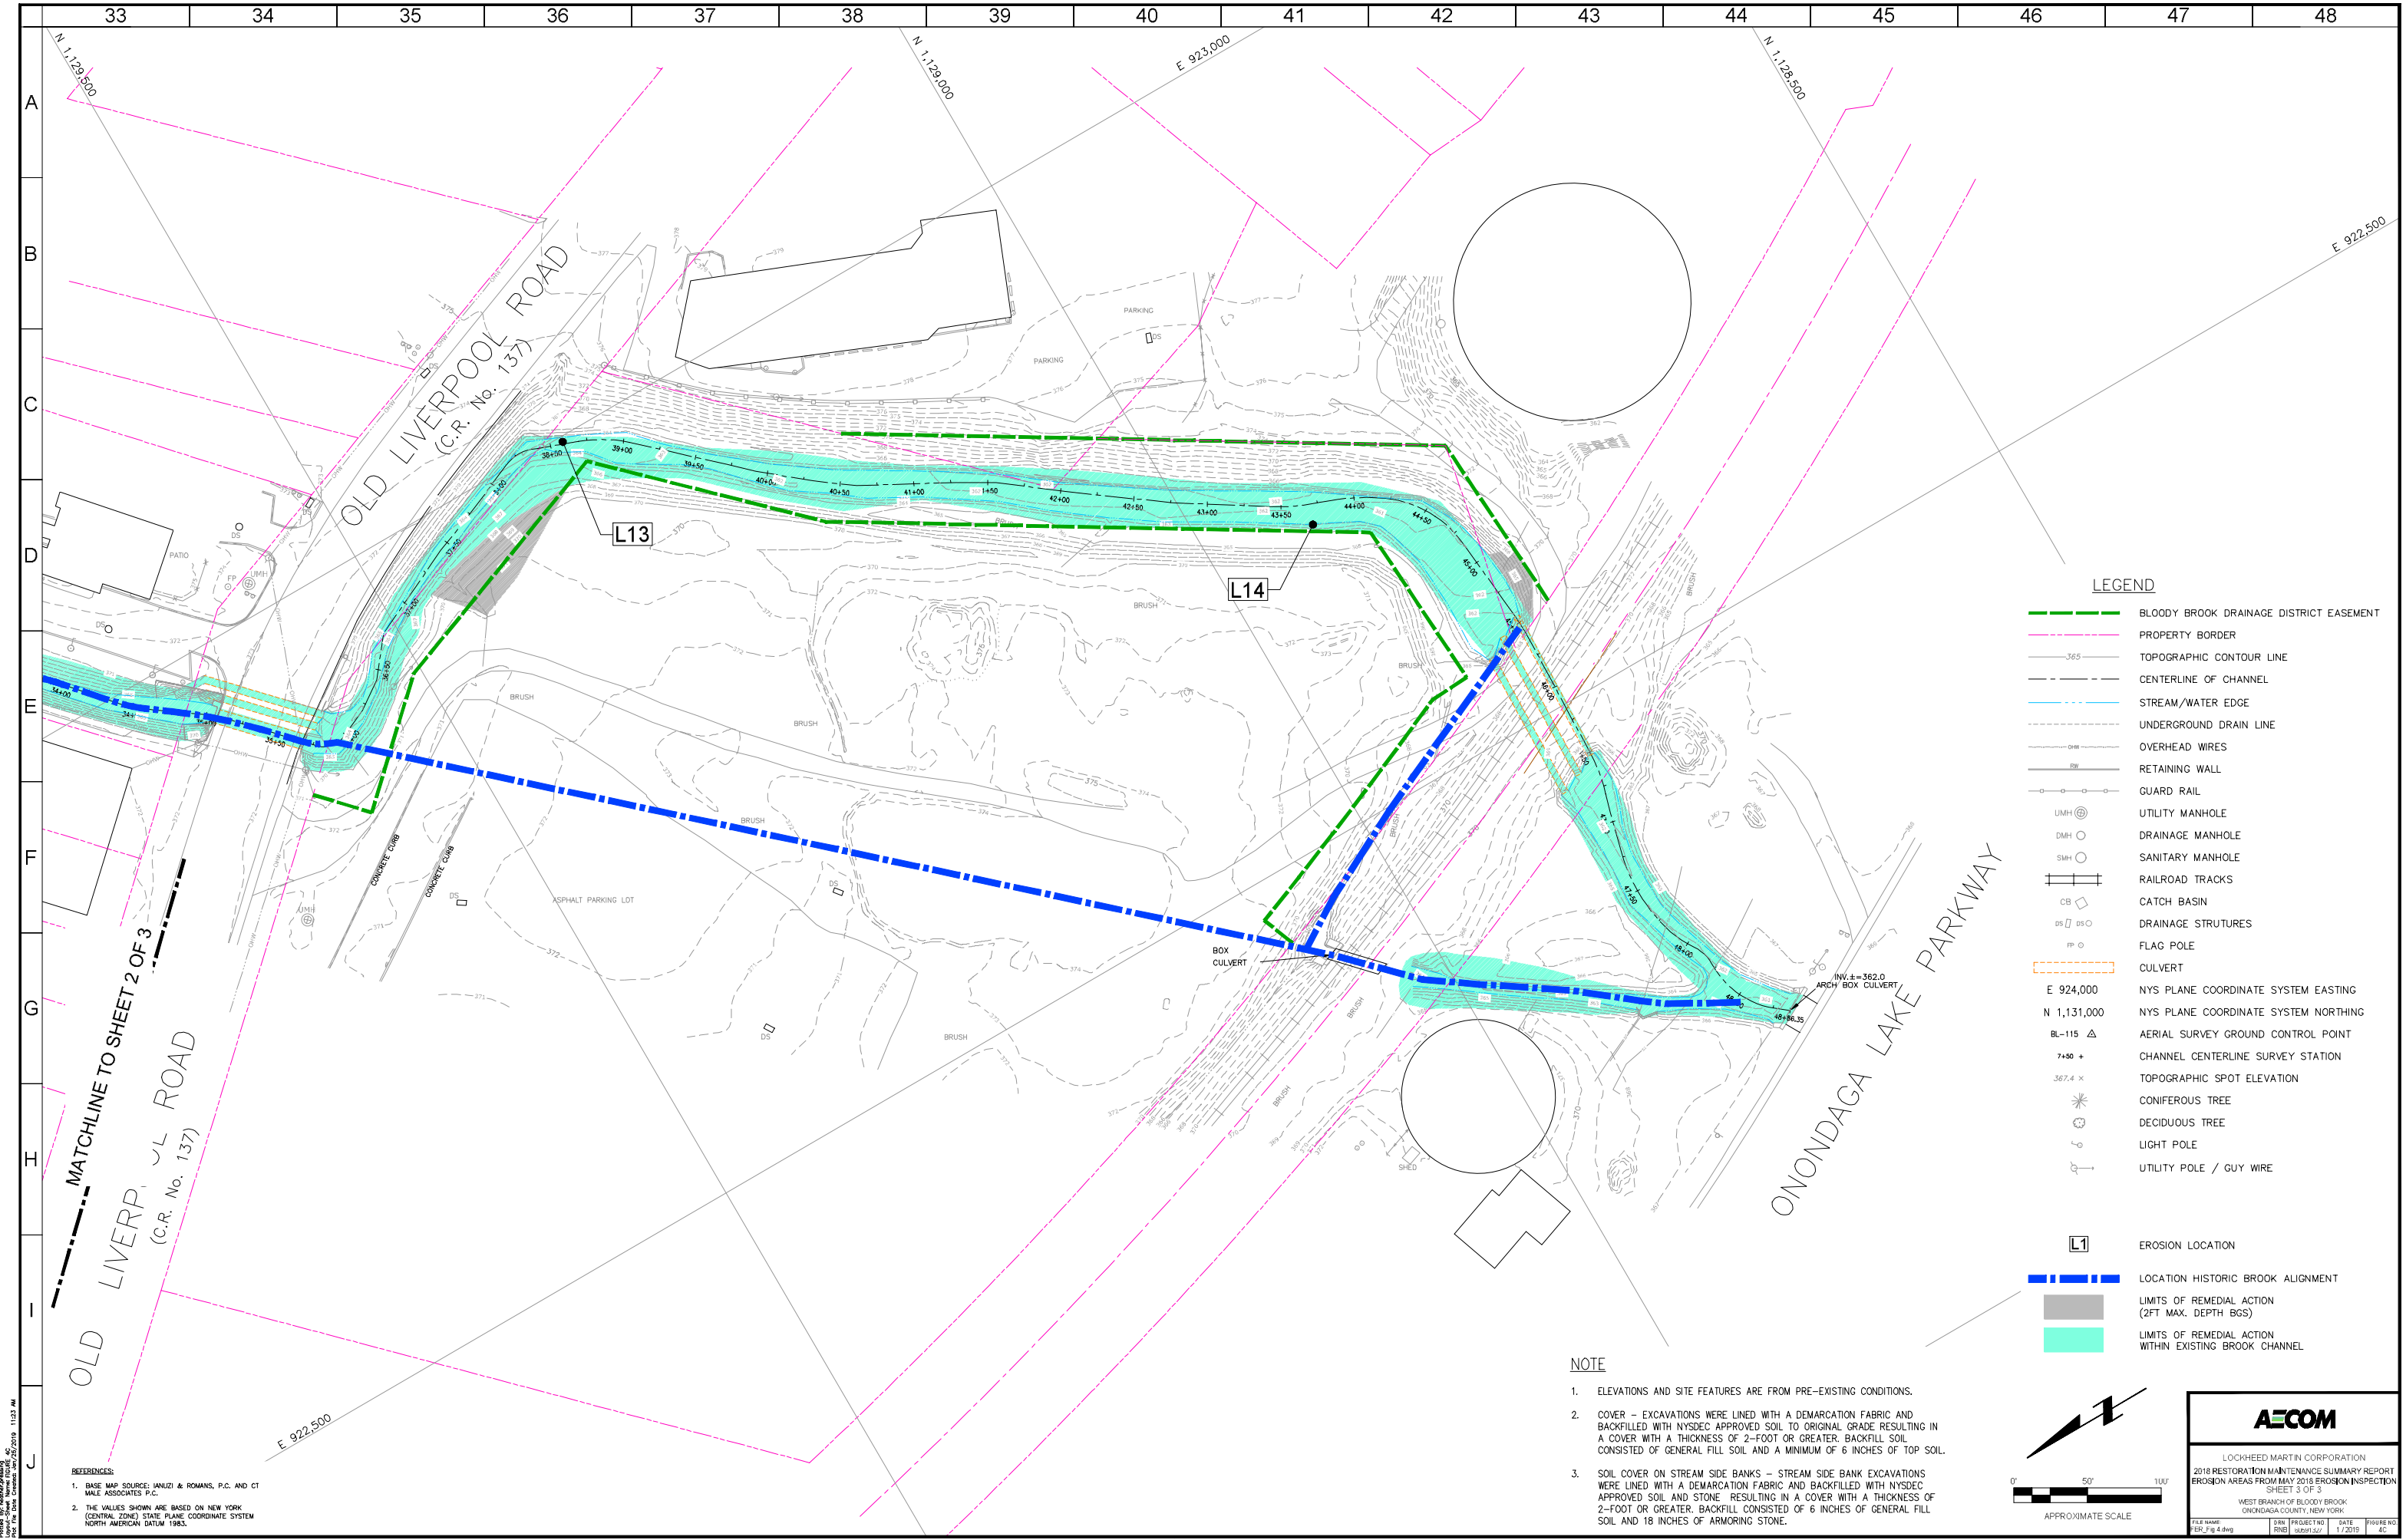
LOCKHEED MARTIN CORPORATION
2018 RESTORATION MAINTENANCE SUMMARY REPORT
EROSION AREAS FROM MAY 2018 EROSION INSPECTION
SHEET 3 OF 3
WEST BRANCH OF BLOODY BROOK
ONONDAGA COUNTY, NEW YORK

Location 13 is located in the commercial-light industrial area along the side bank below Old Liverpool Road (Figure 4C). As discussed in the RMSR and the RMWP, Onondaga County Department of Water Environment Protection (OCDWEP) notified AECOM in July 2018 that armor material had washed away from a portion of the channel bank below Old Liverpool Road following a heavy rain event. In May 2018, this location had been identified as Location 13 during the inspection and was noted as being an area with some rip rap erosion requiring installation of additional armor material.

Location 14 is located in the commercial-light industrial area upstream from the railroad (Figure 4C). During the 2018 inspection, vegetation loss was noted for a portion of the side bank. During the maintenance activities in November 2018, this area had filled in with vegetation, therefore no seed was placed. If needed, this location will be overseeded with Northeastern U.S. Road Native Mix [ERNMX-105] during spring 2019 to help improve bank stability.

In November/December 2017, repairs were made to the bank armor material just upstream from Location 13 in accordance with the NYSDEC approved October 2017 *Restoration Maintenance Work Plan*. These repairs were successful at stabilizing the armor material and were therefore extended to address the new erosion area. The repairs at Location 13 consisted of installing additional rip rap to continue the bank armoring from the stable upstream side

bank to the stable downstream side bank using similar rip rap used upstream during the repair activities in 2017 and was completed as follows:

- Similar to the installation of rip rap located upstream and downstream of Location 13, soil was removed to a depth of one foot from the top of the stream side bank to match the angle and anchoring of rip rap. The removed soil was reused onsite for filling in the transitional areas between the rip rap and the existing ground cover as well as to repair/reseed the access areas used to complete the repairs.

- Demarcation fabric (Mirafi FW700 or equivalent) similar to the original restoration and restoration completed for the remainder of the site was placed over the soil.

- Over the demarcation layer, 24- to 36-inch rip rap was laid at the bottom of the stream side bank and 6- to 12-inch stones around the larger stones and at the top of the bank. The rip rap was placed with two larger stones staggered on top of one another with the smaller stones filling in the gaps, and additional smaller stones were placed at the top of the stream side bank. Any remaining small stones were placed immediately downstream to further stabilize the banks where needed.

The work was completed during the week of November 12, 2018 using an excavator to remove soil and place the rip rap. The channel was accessed from the adjacent commercial property, and crane mats were used to stabilize the work area and minimize damage caused by equipment. The maintenance activities were to replace eroded rip rap and did not change the stream dimensions. Intrusive work (including soil removal) was completed outside of the brook. Additionally, to minimize turbidity concerns, removal of rip rap currently in place along the bottom of the side bank was completed by hand.

Following armor repairs, the area was restored by overseeding with Northeastern U.S. Road Native Mix (ERNMX-105). Straw was placed over the seeded areas to promote germination. Additional seed will be placed as needed in spring 2019, prior to the spring 2019 monitoring event. Additionally in early spring 2019 prior to the 2019 monitoring activities, armor material at Location 13 will be adjusted within the transition areas to fill any gaps following material settling over the winter.
