## 2019 RESTORATION MAINTENANCE SUMMARY REPORT

## Bloody Brook Onondaga County, New York

Lockheed Martin Corporation Syracuse, New York

December 2019

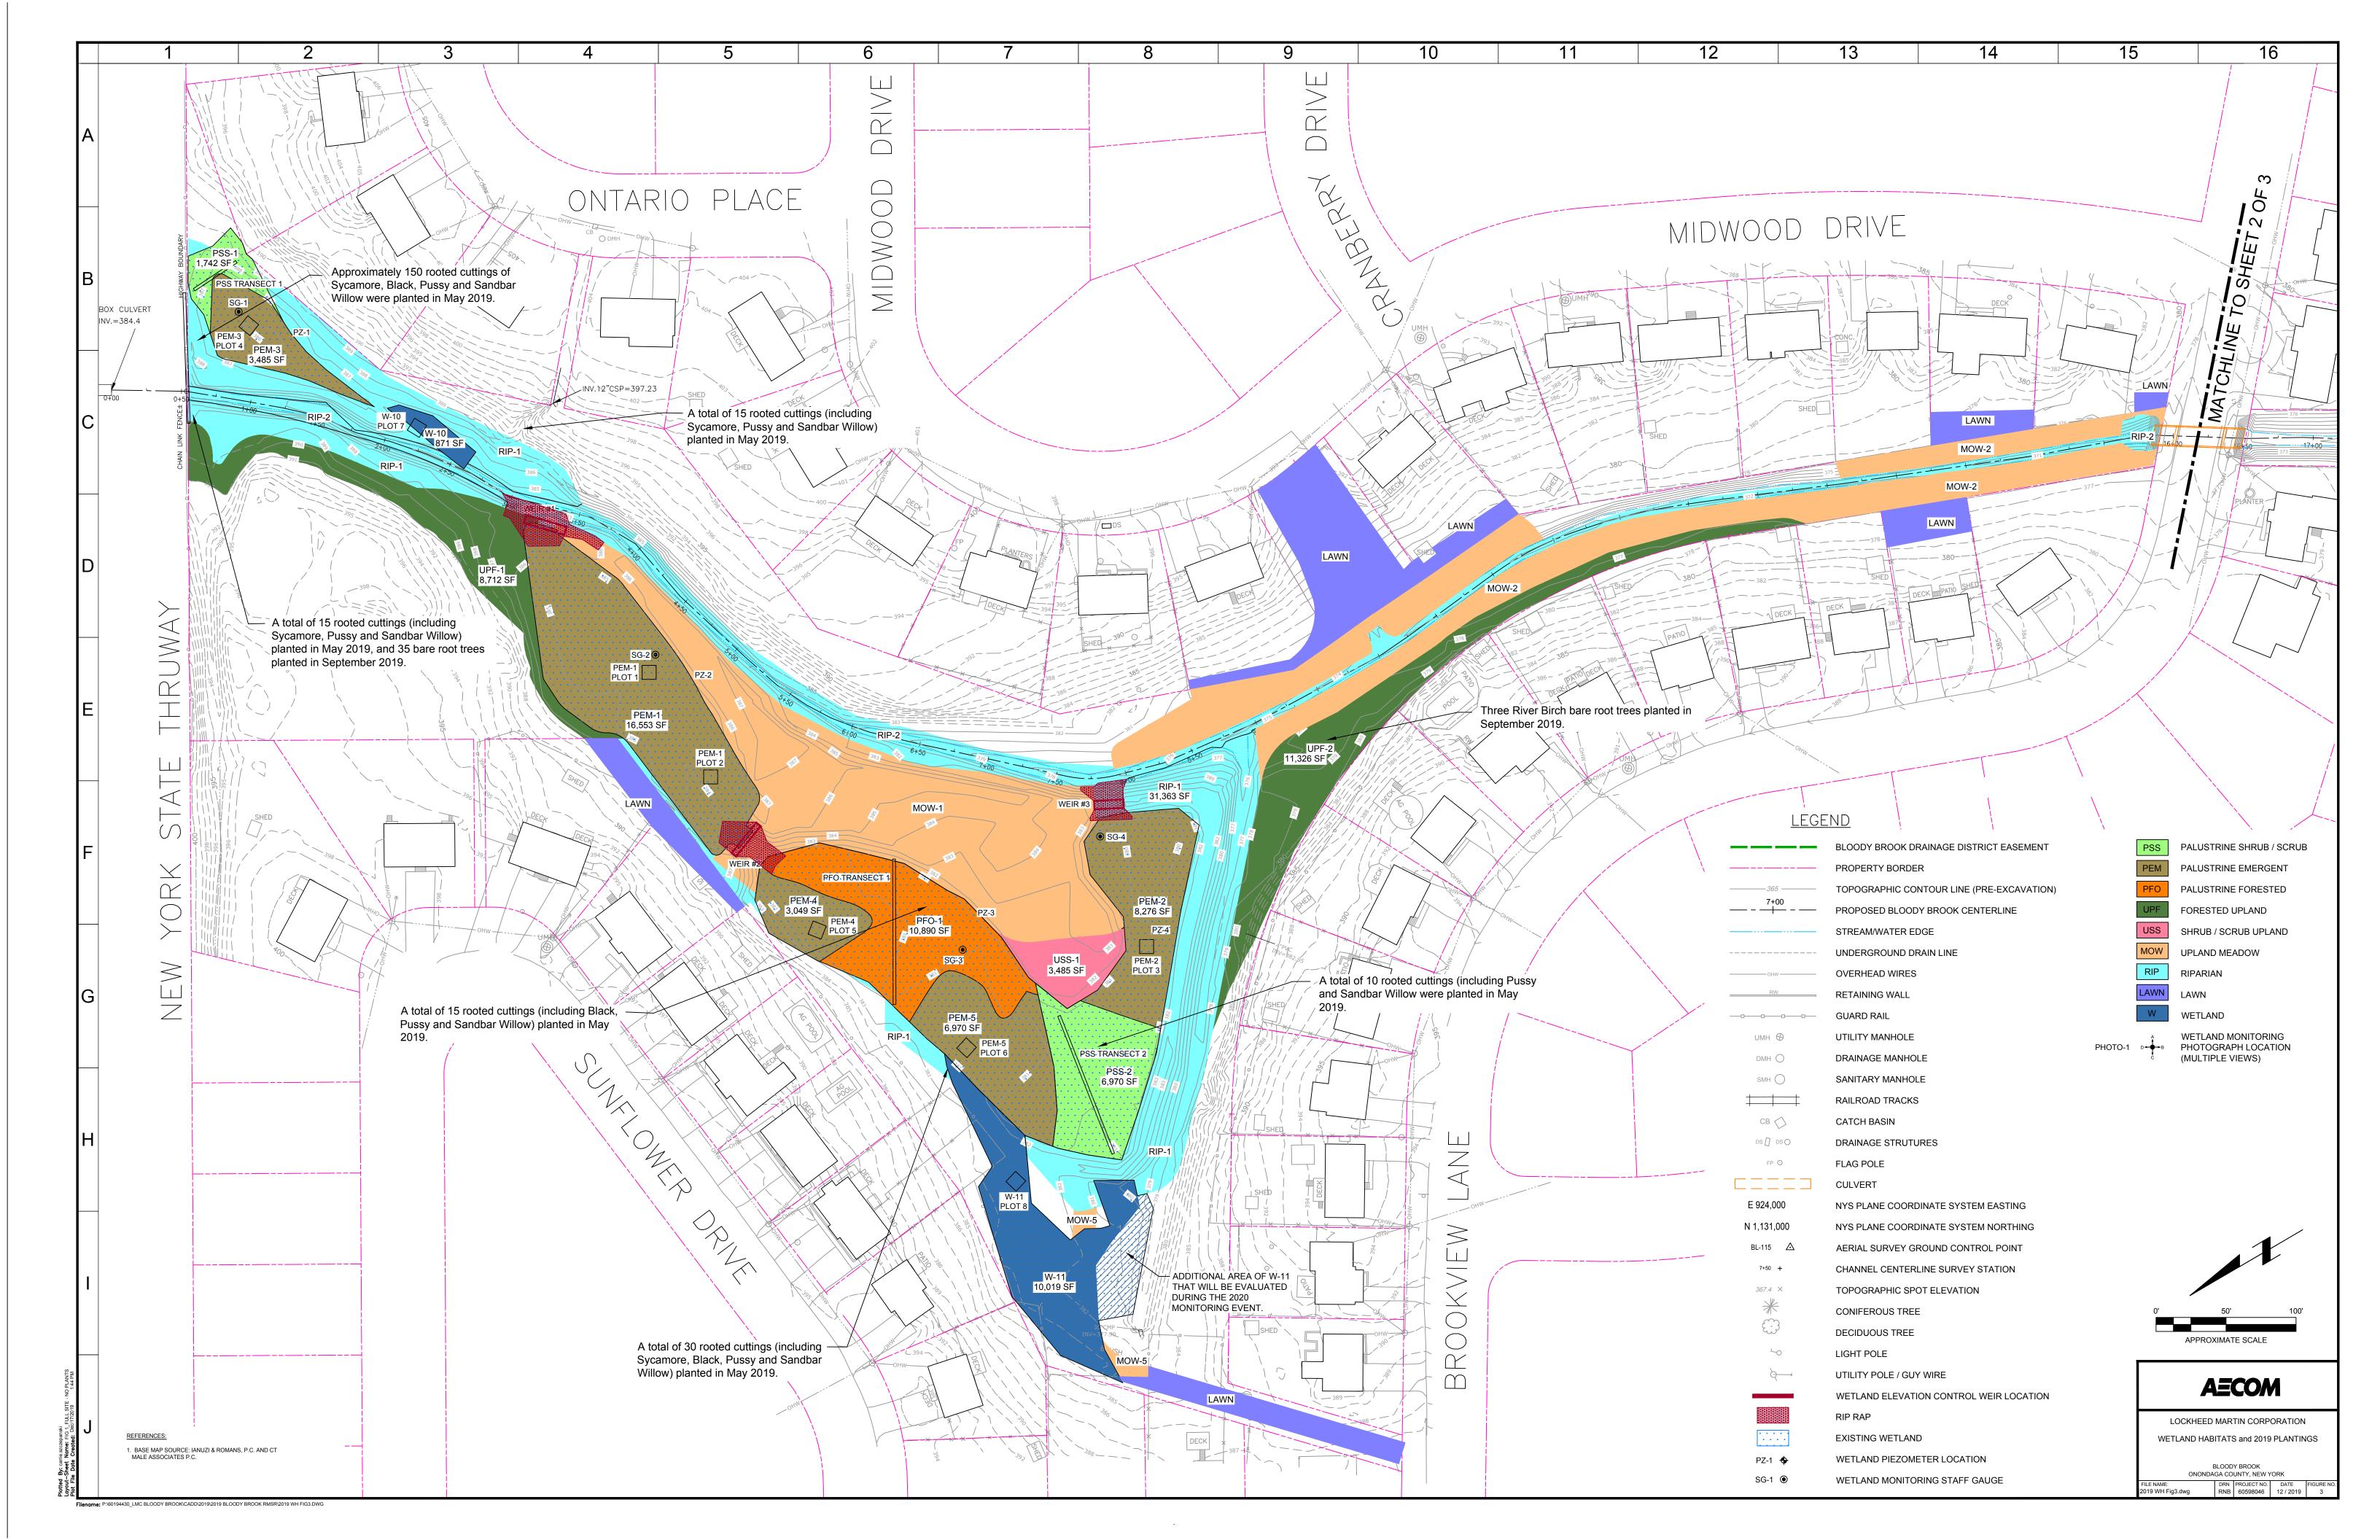
Thirty-five bare root trees were planted in September 2019 in the area of RIP-1 and UPF-1 just south of the Thruway fence line (Figure 3). These trees, planted as gravel bed bare root 1 to 1.5-inch diameter at breast height (DBH) trees, included the following species, approved by NYSDEC:

The locations for planted bare root trees will be provided in the next updates to the SMP prior to the 2020 monitoring inspections. General locations are shown on Figure 3 herein. Thirteen Canadian serviceberry (*Amelanchier canadensis*) will be planted as bare root in these areas of RIP-1 and UPF-1 in spring 2020.

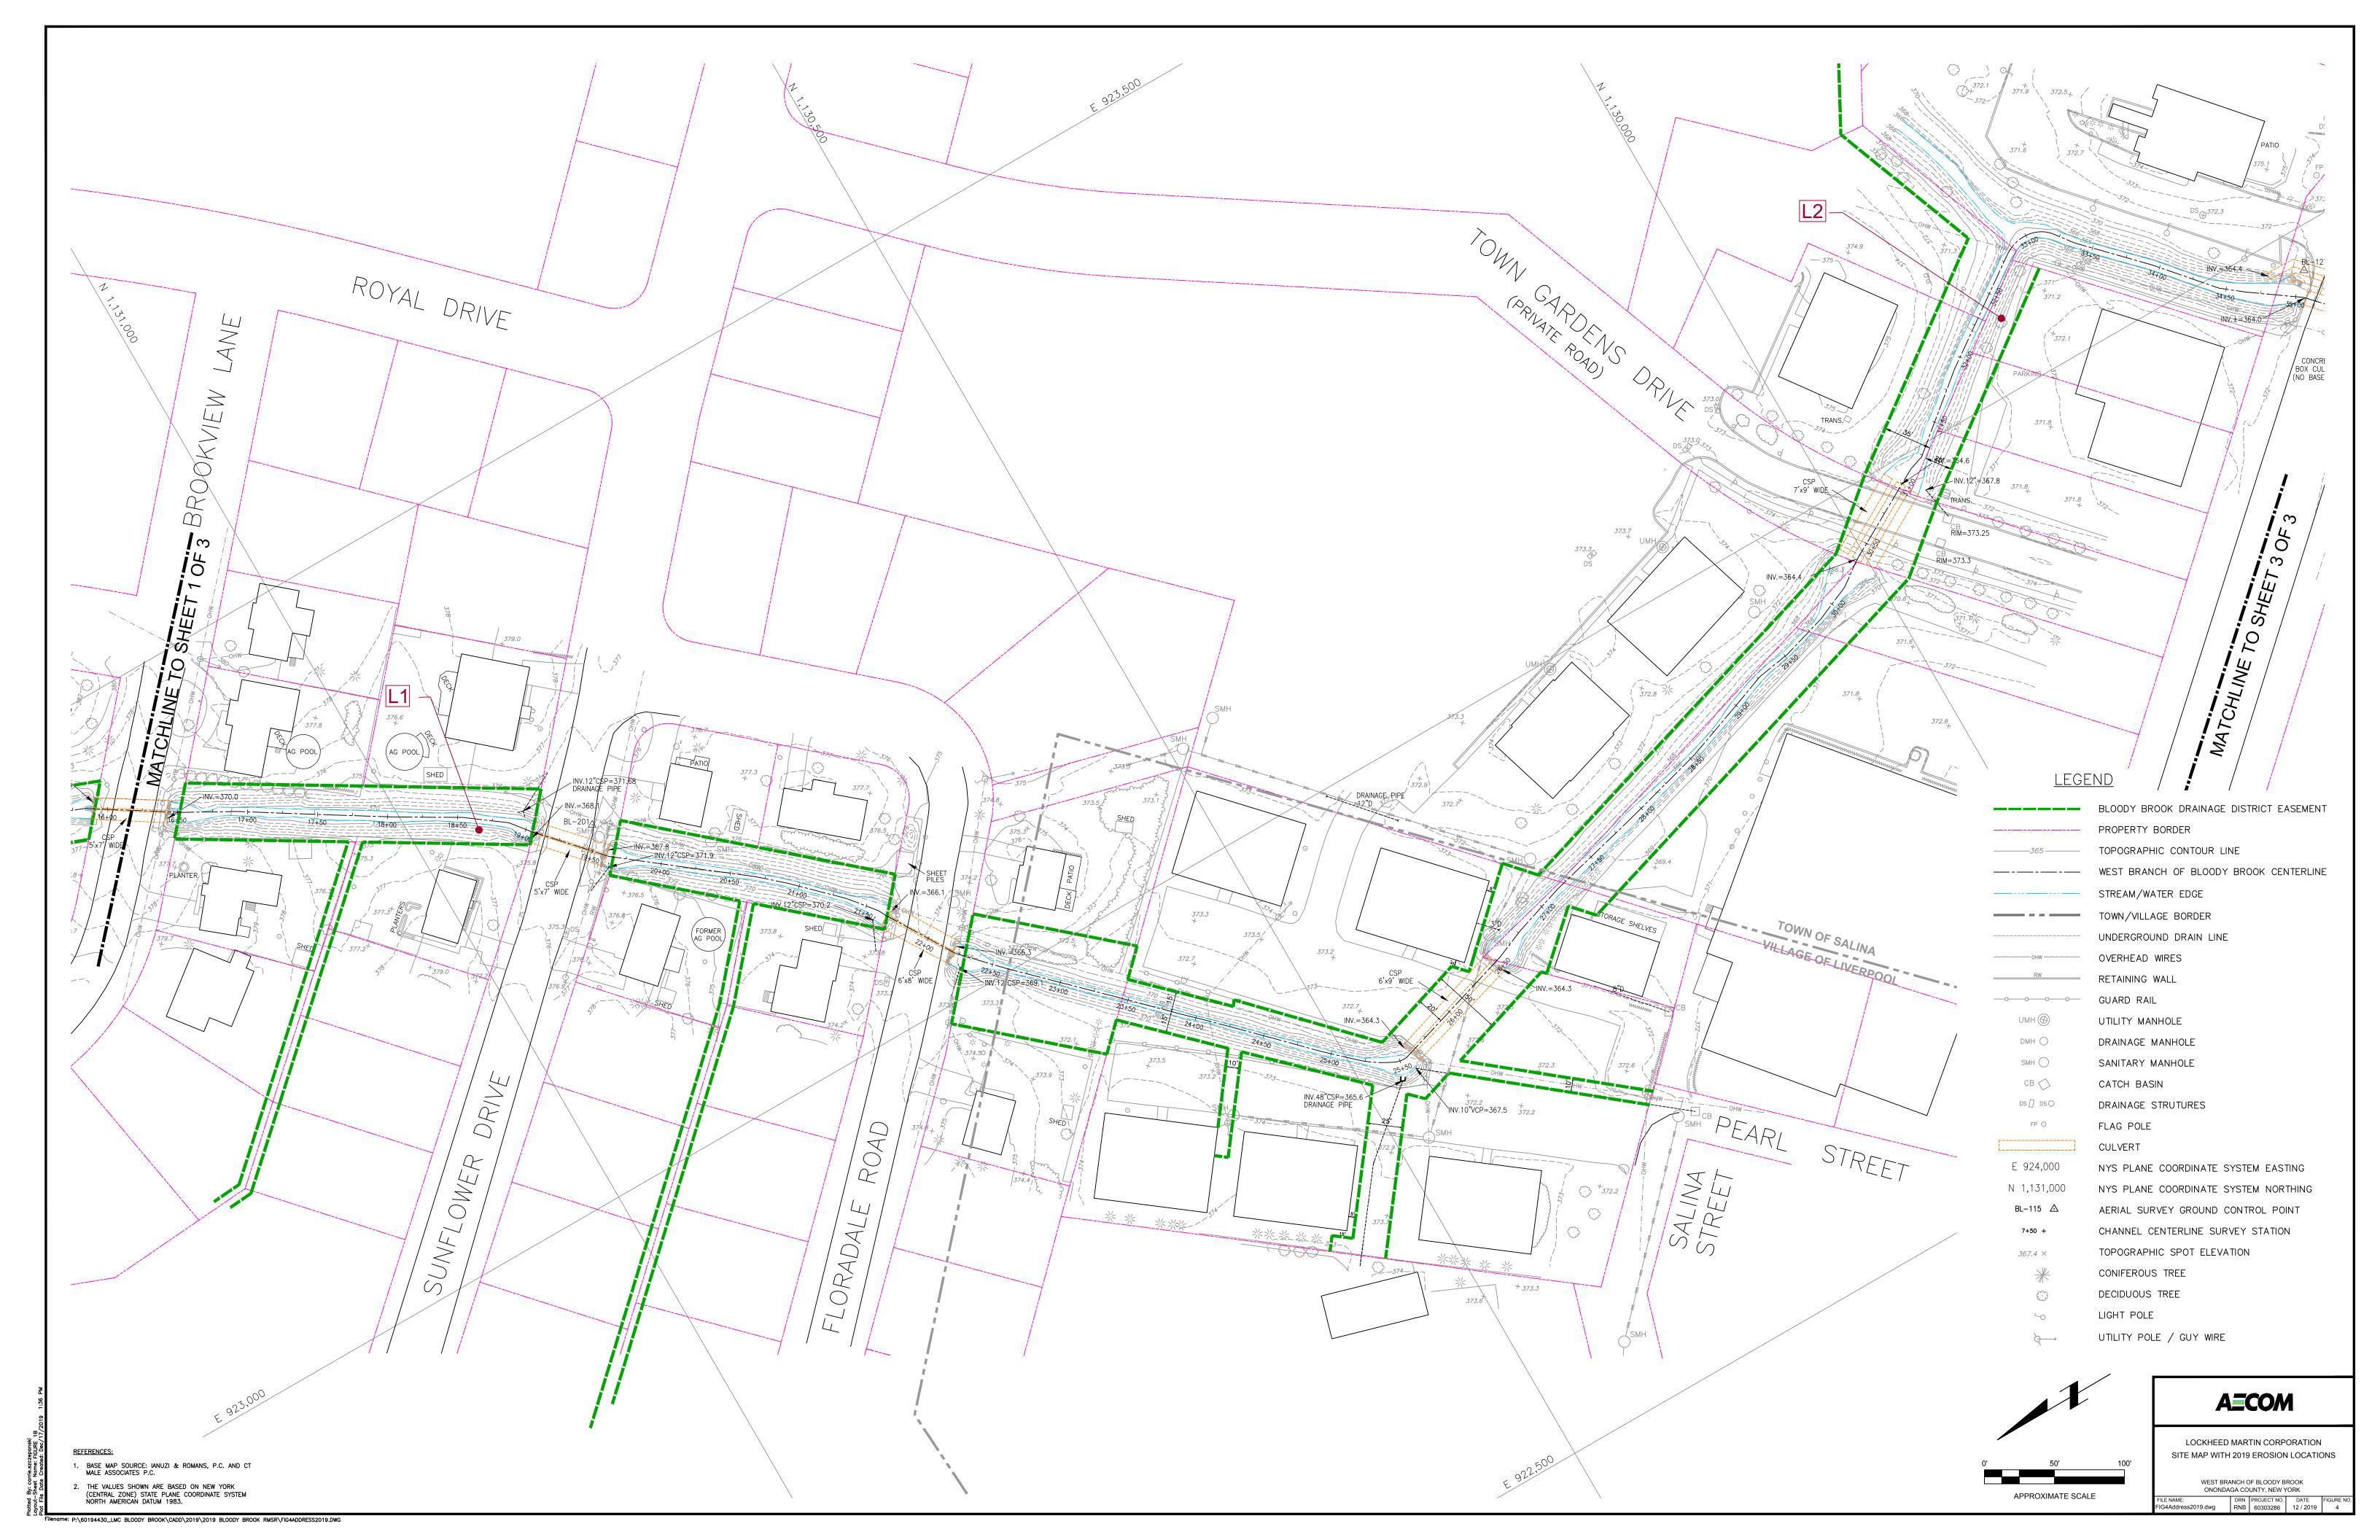
As discussed in the 2019 work plan, the erosion inspection completed in June 2019 indicated the stream bottom and side banks are intact and show little signs of damage. At two locations identified as L-1 and L-2 on Figure 4, small portions of side bank showed areas of minor rip rap erosion and required adjustment. These adjustments were completed by hand during a subsequent monthly site walk.

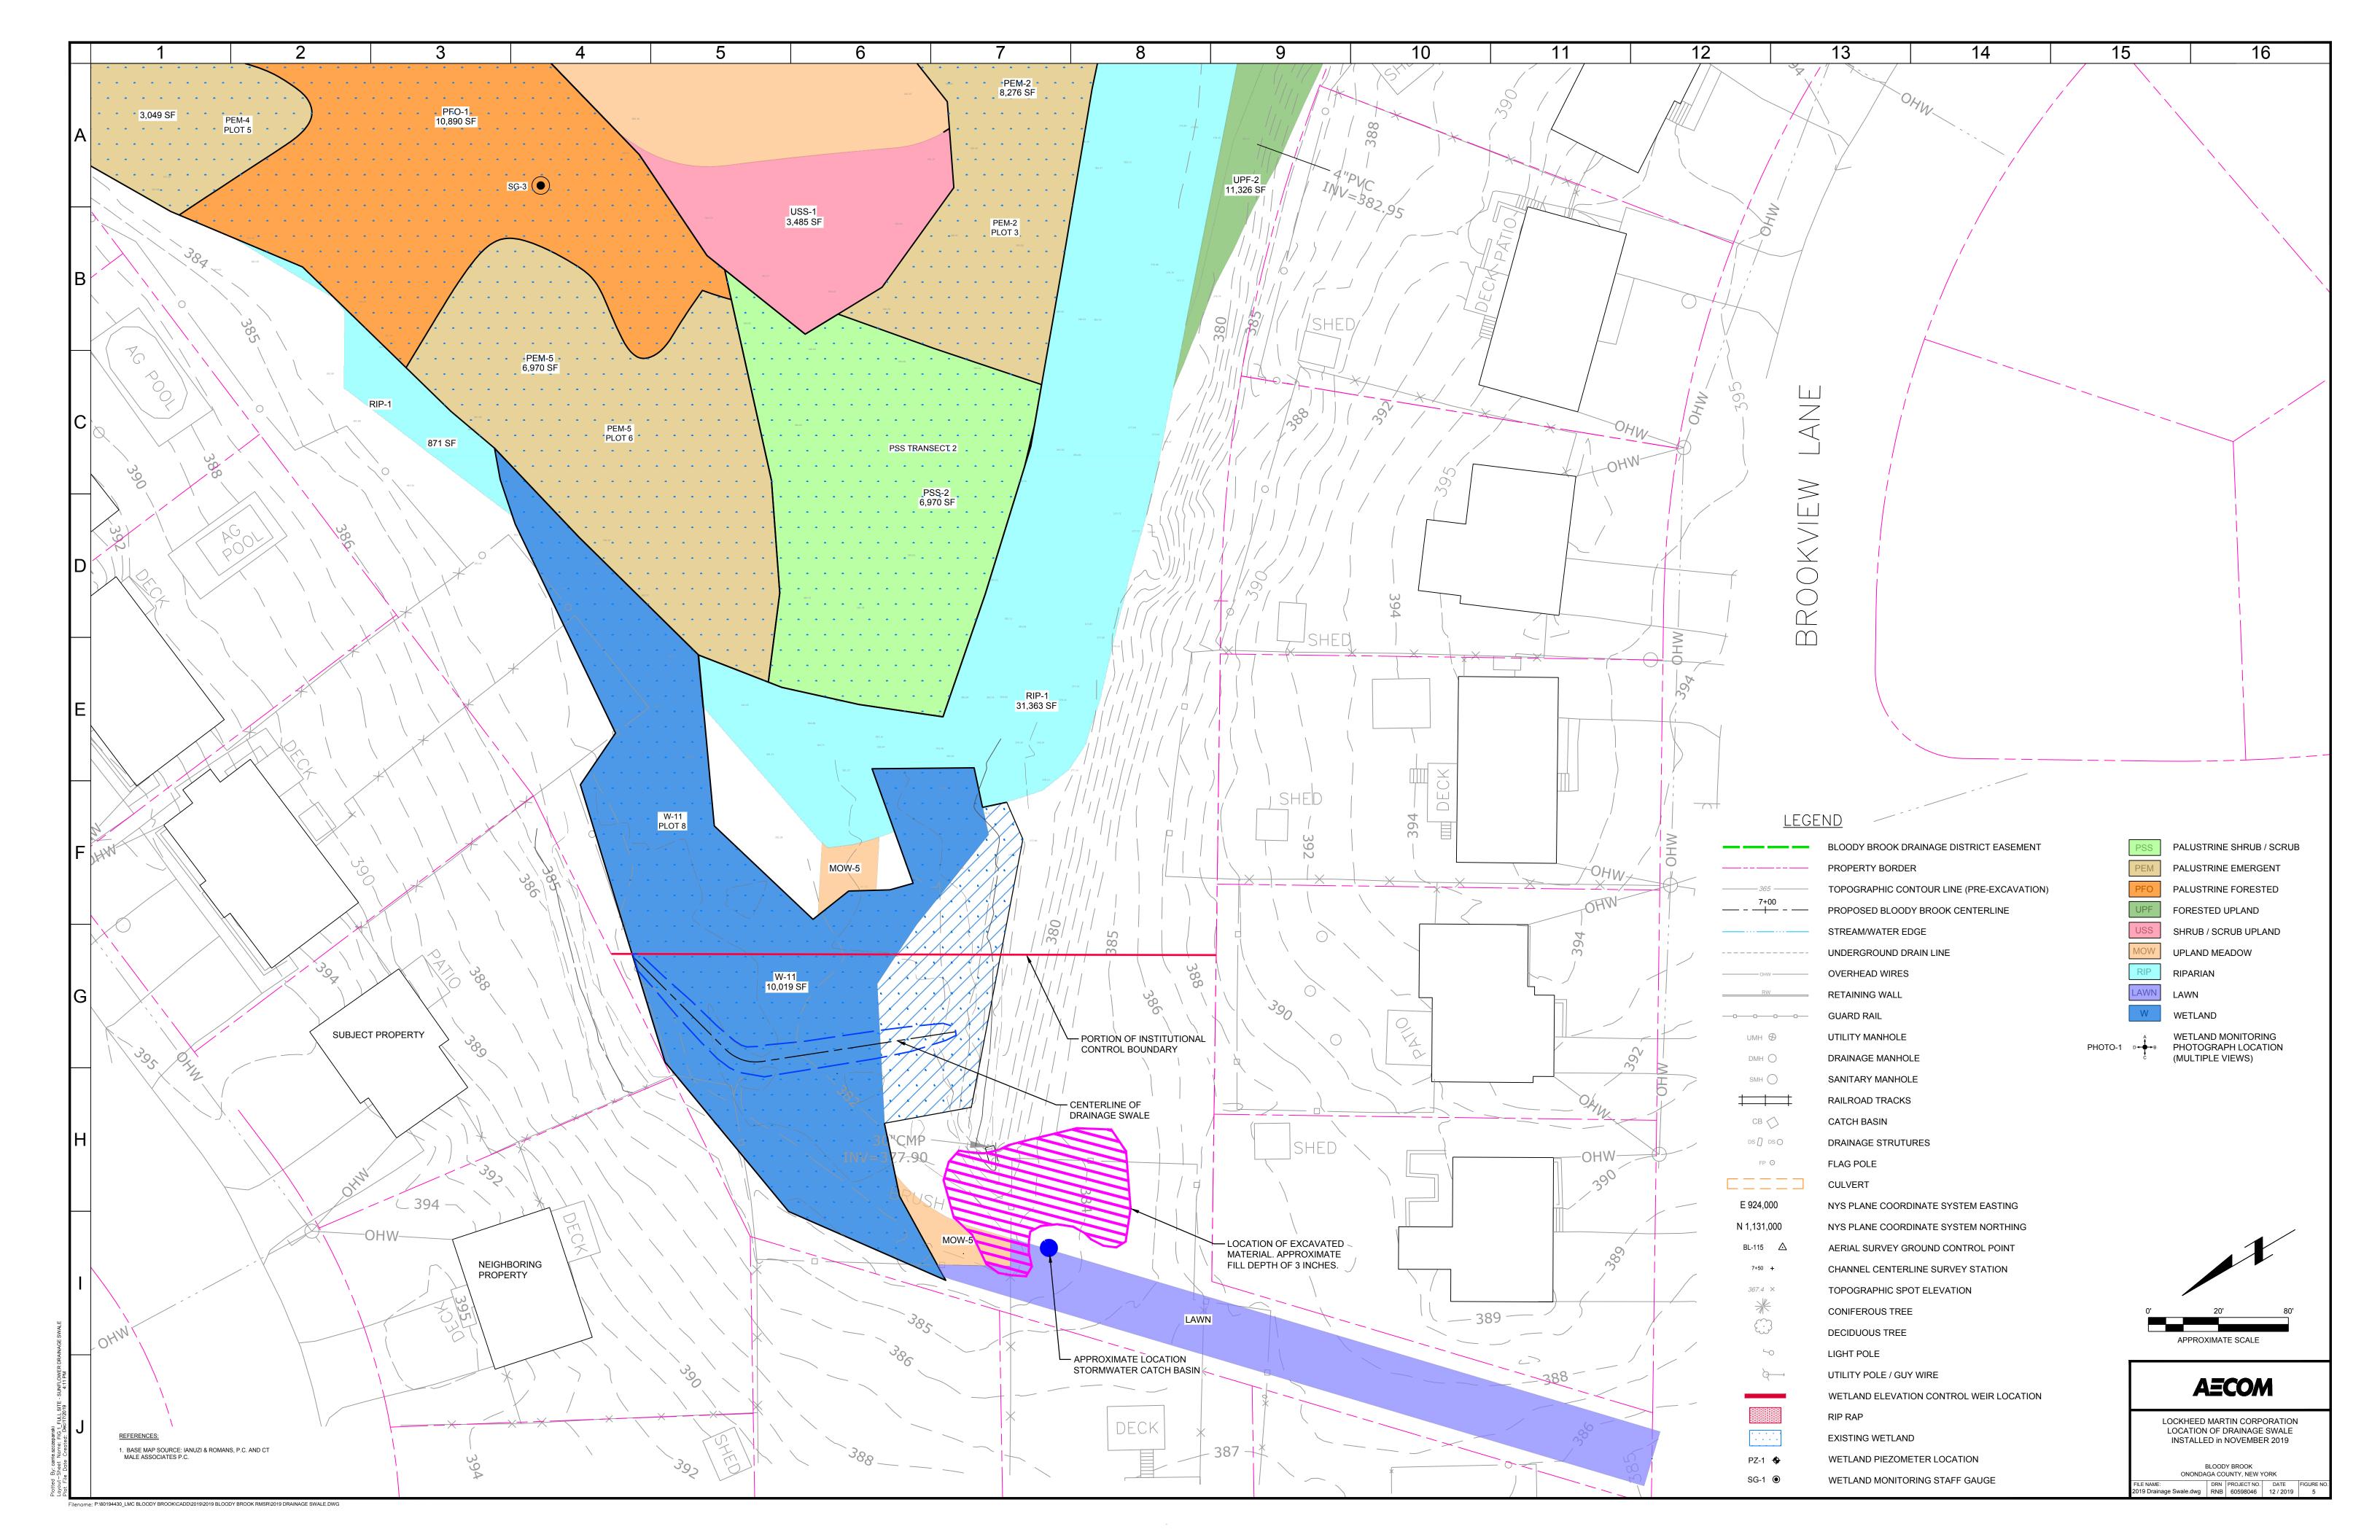
The corrective measure to improve drainage adjacent to the wetlands, discussed above in Section 1, included the construction of a swale designed to drain the area directly behind the residences to an area of the site away from the property lines towards the nearby wetland habitat areas. The location of the constructed swale is shown on Figure 5. The swale was constructed on November 20 and November 21, 2019 and is approximately 103 feet long with a 1-foot maximum cut. All

work was completed outside of the Institutional Control boundary in accordance with the Bloody Brook SMP. The average depth of excavation was 10 inches over the length for an approximate removal of 14.5 cubic yards (cy). In order to minimize the volume of soil removed, the drainage slope was decreased midway from 2 percent to 1 percent. The 14.5 cy of soil excavated for the swale was spread in the area identified on Figure 5 to an approximate depth of and not to exceed 3 inches.

Following completion of construction, the area was raked, erosion control socks were placed, and straw was spread over the area. In spring 2020, restoration of the swale and the area where the excavated soil was spread will be completed, as needed. Additional planting in areas with elevated salinity, discussed above in Section 2.1, is planned in the general area of the swale construction for spring 2020.
