Lockheed Martin Corporation
6801 Rockledge Drive MP: CCT-246
Bethesda, MD 20817
Telephone (301) 548-2227

October 31, 2017

Subject: **Building C Air Sampling due to Recent Flooding**
 Sampling and Analysis Summary
 Middle River Complex, Middle River, Maryland

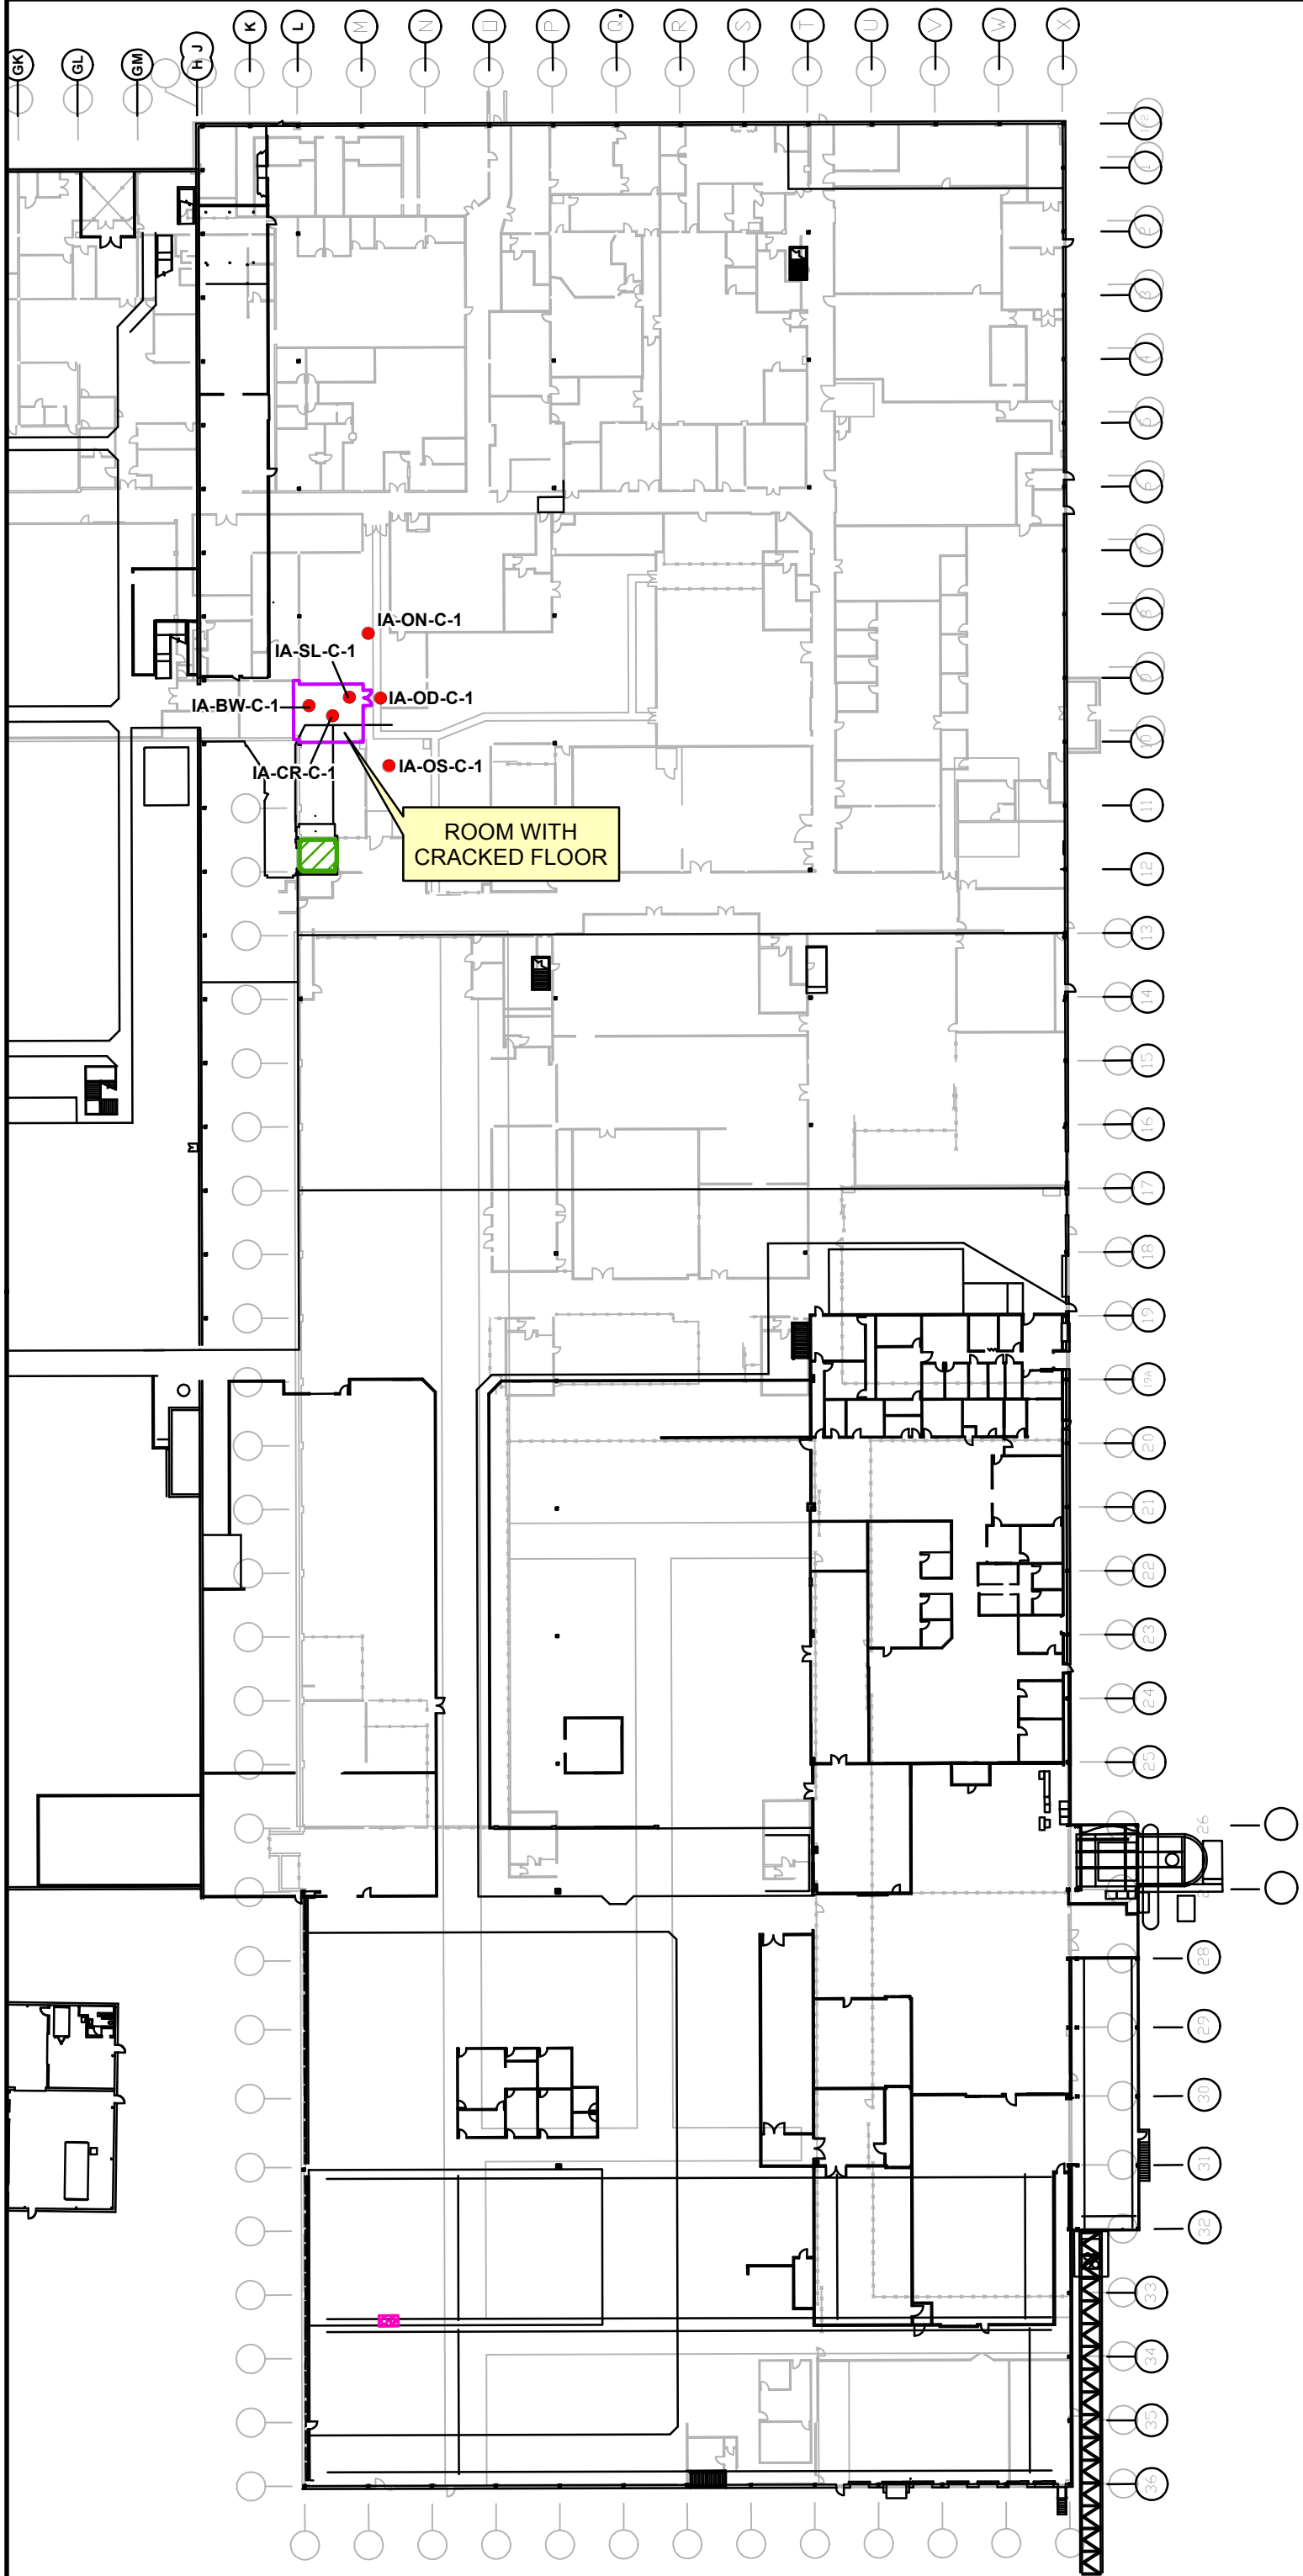
FIGURE 1
BUILDING C
BASEMENT FLOODING
AIR SAMPLING LOCATIONS

TestAmerica Laboratories, Inc. (TestAmerica) and received six Summa canisters the following day on Tuesday July 18, 2017. Mr. Apanavage conducted the air sampling activities between the hours of 9:25am and 5:30pm on July 18, 2017. The location of the vacant room with the cracked floor (sampling area) and six sampling locations are shown on Figure 1.

IA-BW-C-1	Located inside the room along the back wall (west side) at floor level
IA-CR-C-1	Located in the middle of the room at floor level right above one of the major cracks in the floor
IA-SL-C-1	Located inside the room immediately adjacent to the storm drain lid at floor level
IA-OD-C-1	Located immediately outside the door leading into the room elevated a few feet off the floor (door closed when sampling was initiated but the door was observed open at 5:00 p.m. toward end of sampling period)
IA-OS-C-1	Located outside about 30 feet north of the room elevated a few feet off the floor
IA-ON-C-1	Located outside the room about 30 feet south of the room elevated a few feet off the floor

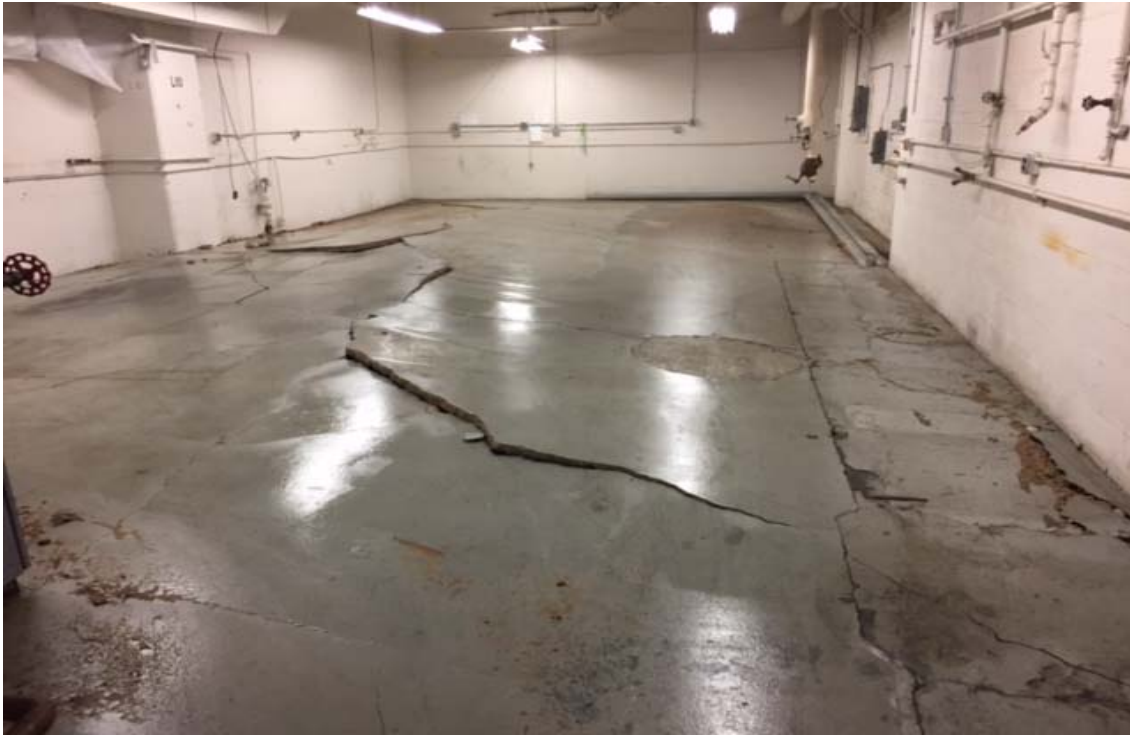
columns M9/10 and K9/10 where the floor lifted up and cracked did not have any water present, however, the floor had significant damage and had been uplifted approximately 1 to 1.5 feet. The room has no windows, and one double door on the eastern side of the room provides access. The attached Photographic Log shows the site conditions including the cracked floor and standing water. No discoloration or sheen was observed on the standing water. During the site visit, a fairly strong odor was detected upon entering the room, however, the odor was not detected outside the room. The odor was chemical in nature, but could not be definitively identified. Present at the site during the visit were six people. One was an employee who works in the nearby printing shop (this area was also flooded with up to 1 inch of standing water), one EMCOR employee, and four people who were conducting general water cleanup activities. Mr. Apanavage reported back to the Lockheed Martin Corporation (Lockheed Martin) and Remedial Technical Operations (RTO) team and stated he would revisit the site on Monday July 17, 2017 to assess the site conditions.

Vacant room between columns M9/10 and K9/10 showing cracked floor

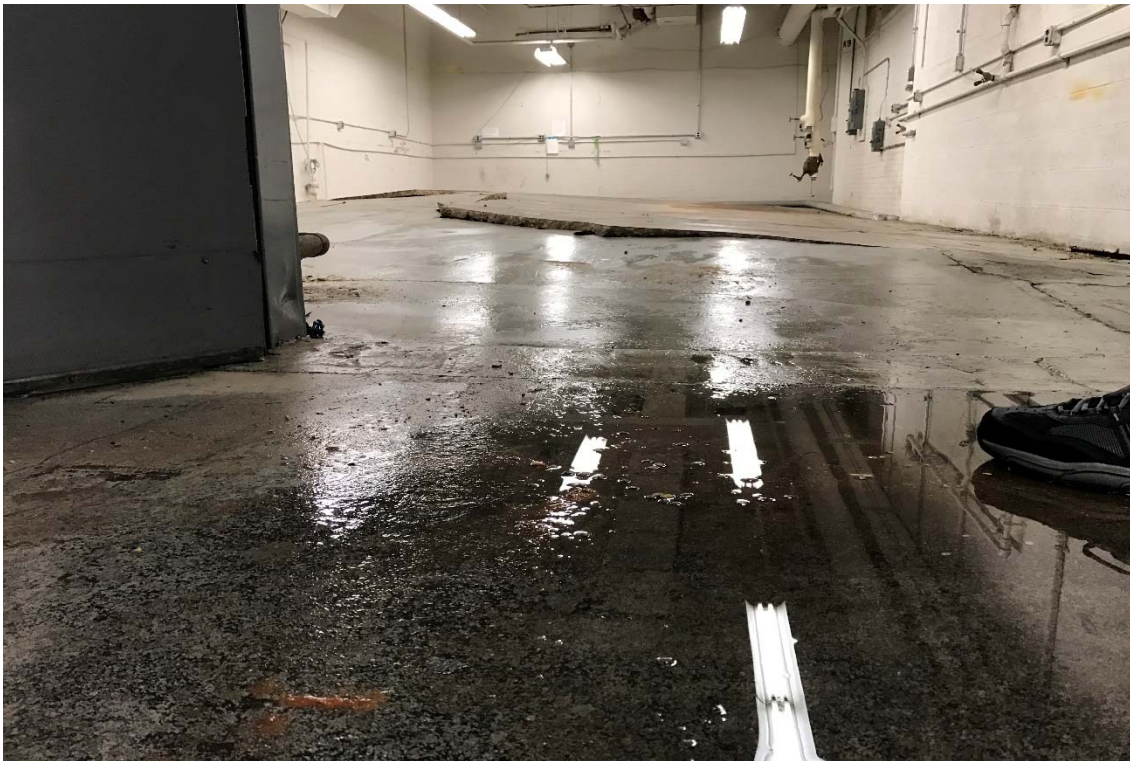
Ground level view of vacant room showing uplift of floor

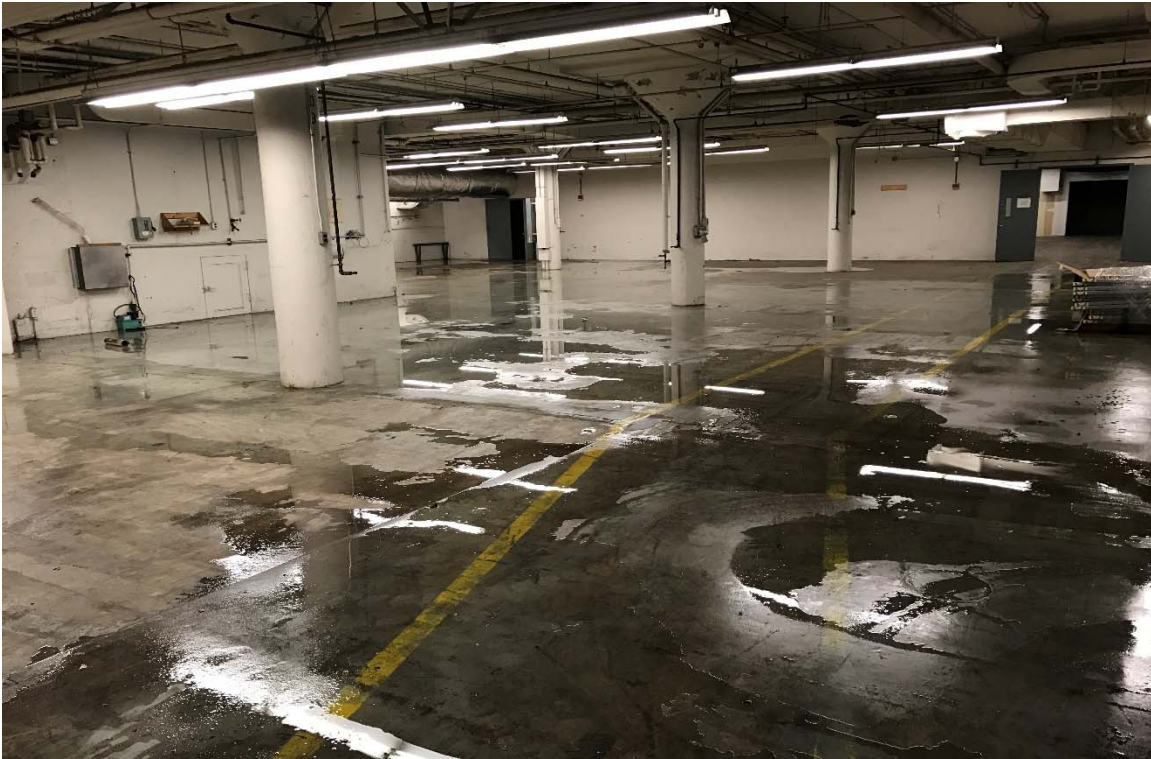
Upon arrival to the site, standing water was observed throughout the northern portion of Building C basement up to 1 inch in depth in various areas. The concrete-walled room between

Flooding in northern portion of Building C basement

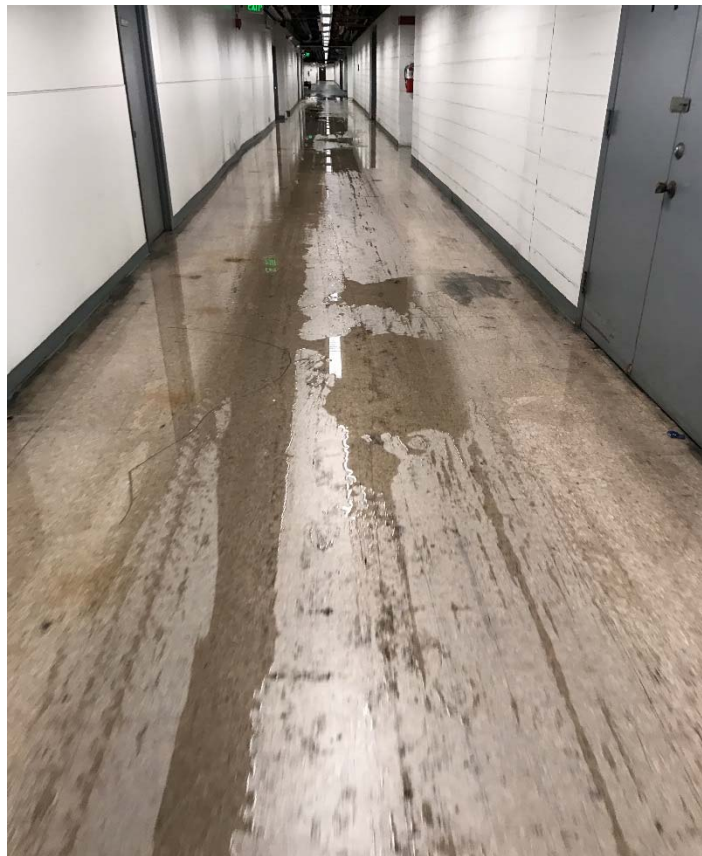
Flooding down hallway in northern portion of Building C basement

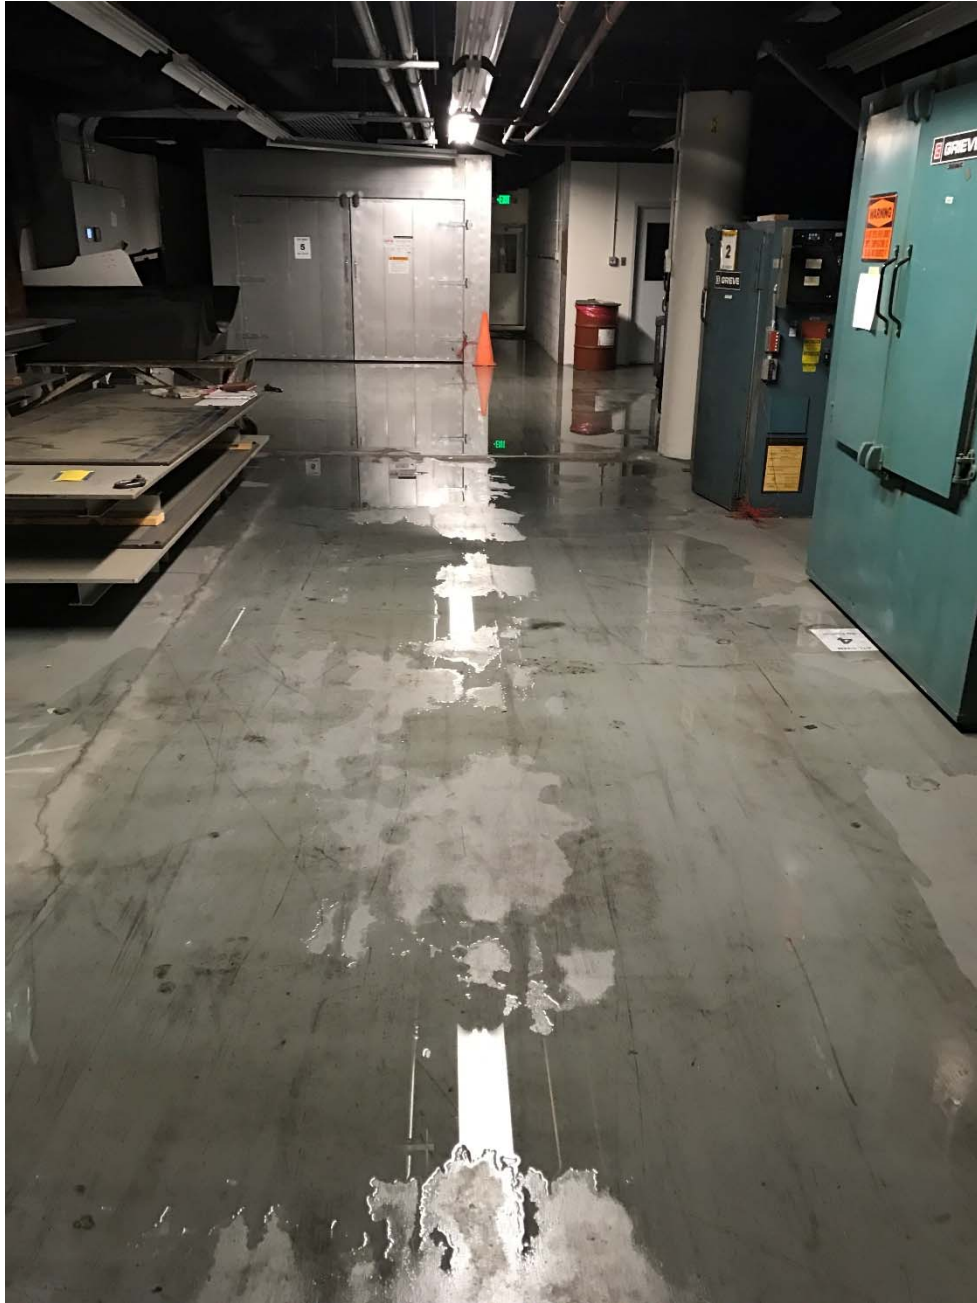
Flooding in northern portion of Building C basement
