A SERVICE PUBLICATION OF LOCKHEED AERONAUTICAL SYSTEMS COMPANY-GEORGIA

NESA WINDOWS

Vol. 15, No. 1, January-March 1988

NESA WINDOWS: All About Electrically Heated Glass

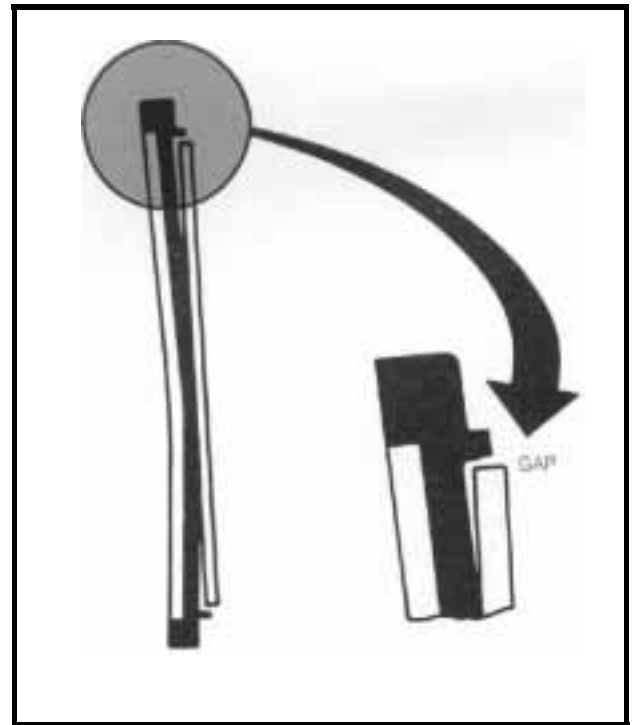
Figure 9. Gap development caused by pressurization cycling and vinyl shrinkage.

In many cases where arcing is noted, it is found in the vicinity of the bus bars. The problem can often be traced to an area along the top of the window where the vinyl layer and the outer glass have begun to separate. The separation of the layers allows moisture to enter and cause arcing, which in turn can cause further delamination and deterioration of the window.

The remedy for arcing problems of this kind is to seal the mating line between outer glass and vinyl to keep out moisture. Although this area may have been sealed when the panel was first installed, pressurization loads cause the glass to be pushed outward repeatedly, which tends to open the parting line between the outer glass panel and the vinyl (Figure 9).

These potential sources of trouble mean that it is advisable to inspect the edges of the glass periodically for loose, cracked, or weathered sealant. New sealant should be applied as necessary to prevent moisture from entering, even when the windows are not being replaced.
