VOL. 15, NO. 2, APRIL-JUNE 1988

SERVICE NEWS

TROUBLESHOOTING ENGINE OIL LOSS

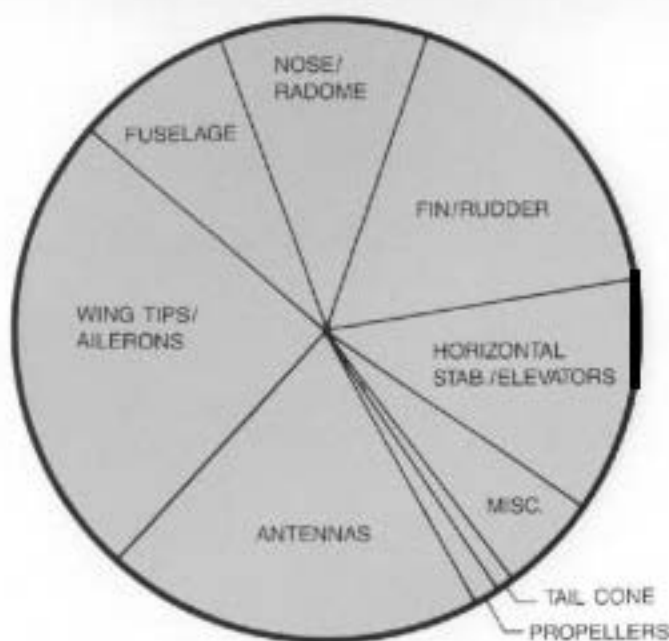
TYPICAL DISTRIBUTION OF LIGHTNING STRIKE LOCATIONS

Pointed structures, such as control surfaces and the tips of propellers, are also vulnerable because of their shape and location. These are the components that are most often damaged by lightning strikes, as shown in the pie chart on page 15.
