SERVICE NEWS

A Service Publication of Lockheed Aeronautical Systems Company

Vol. 18, No. 2, April - June 1991

Engine Run Safety

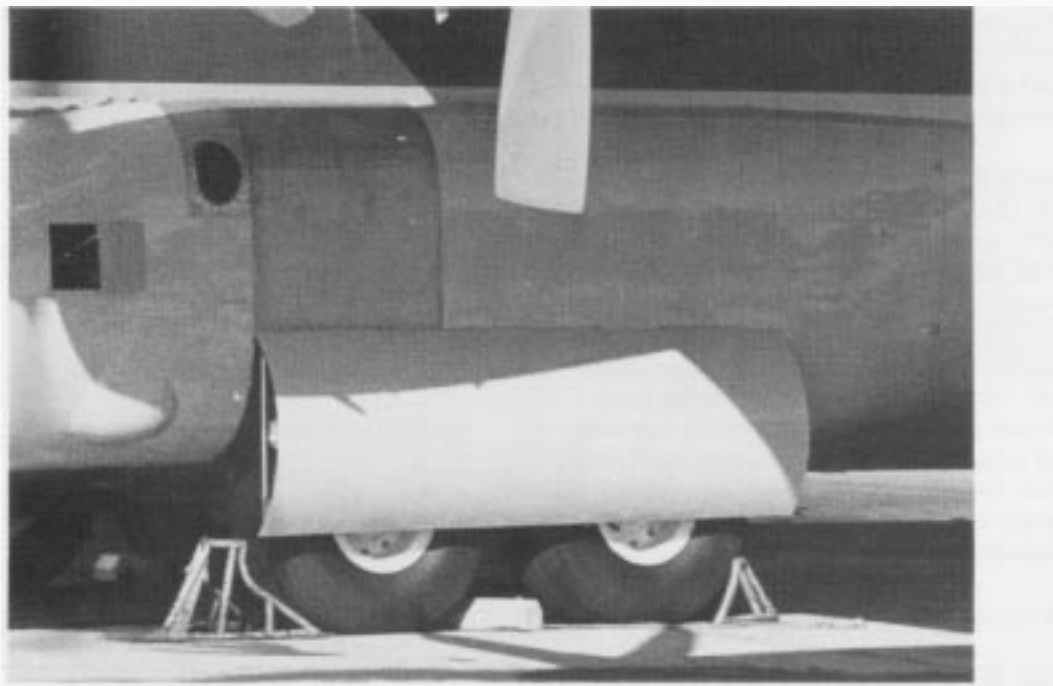
Properly designed, cage-type chocks can go a long way toward preventing “jumped chocks” incidents.

To prevent mishaps, a unique chocking system was devised. It consists of very large, cage-type chocks which pin into steel plates anchored to foundation blocks in the ramp (see photo above). Aircraft cannot roll up and over these chocks. Once the main landing gear tires are up against them, the aircraft is completely secure.

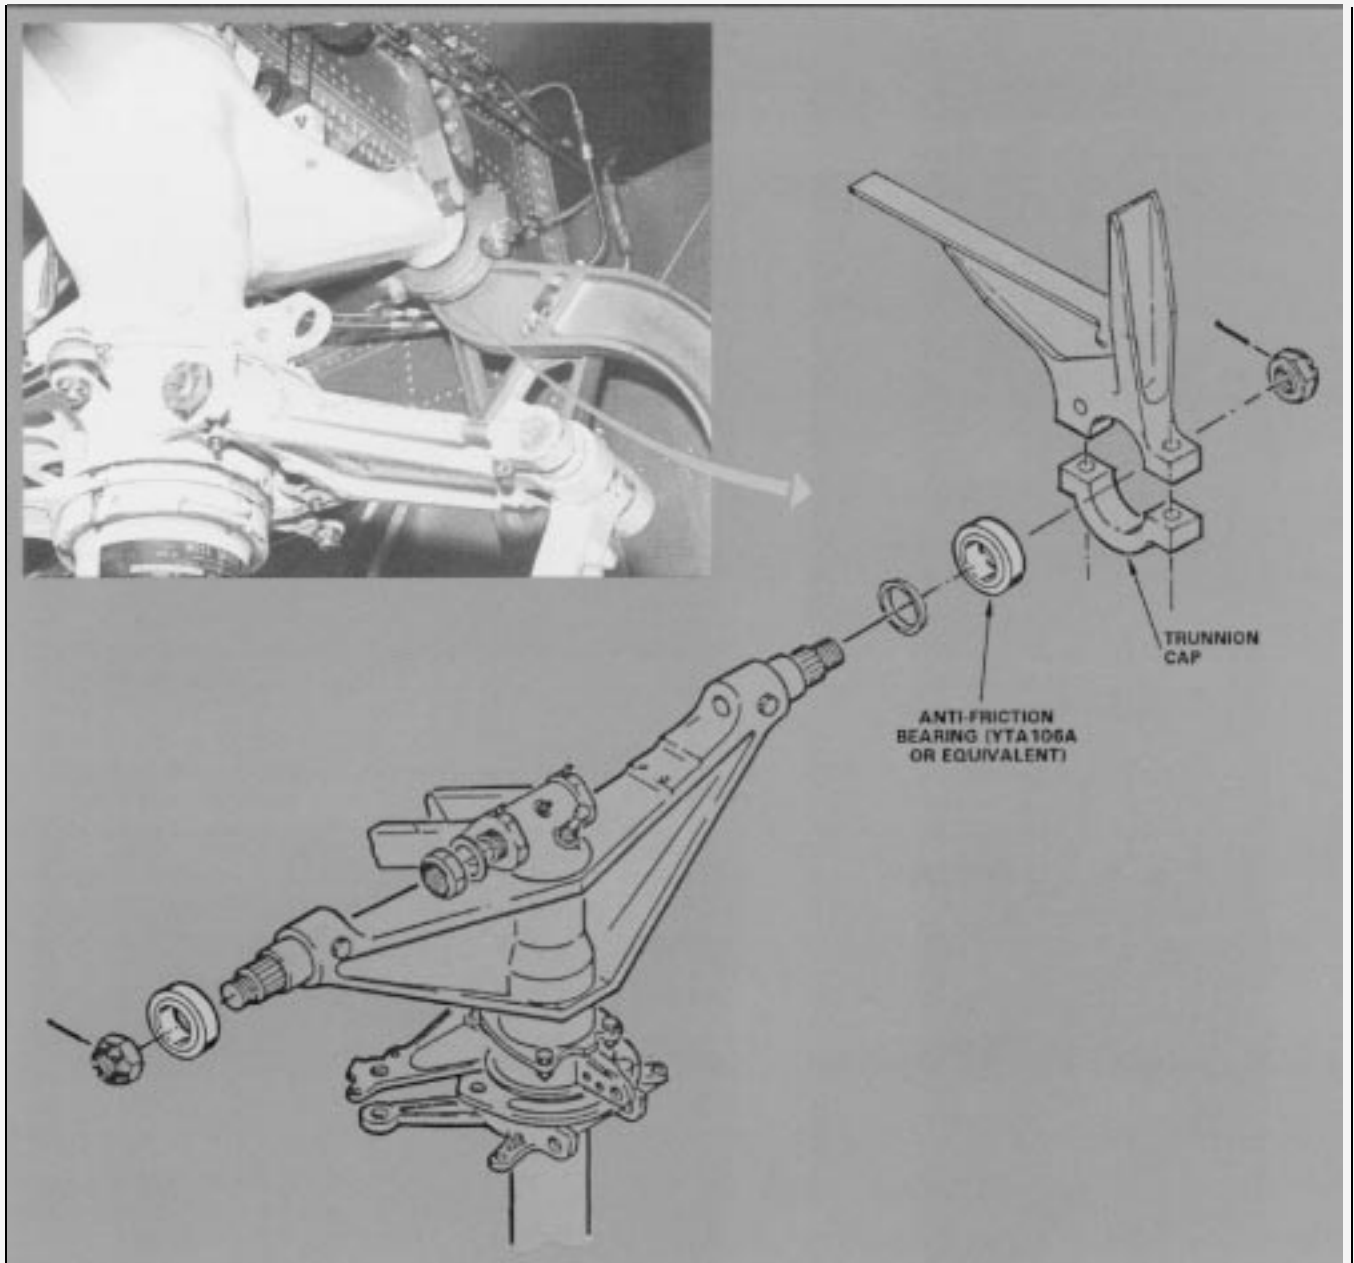
Grinding or popping sounds from the nose wheel well during taxi may indicate the presence of wear in the PN YTA106A fulcrum anti-friction bearings. These bearings have a number of critical functions to perform. They must support the weight of the nose of the aircraft during landings and operations on the ground, and they must also operate smoothly during extension and retraction of the NLG strut.

In addition to the stresses imposed by these important functions, the NLG fulcrum anti-friction bearings are located in an area where they are exposed to a host of abrading and corrosive agents such as sand, salt, dirt, dust, and ice. Over a period of time, these environmental hazards can take a toll. It is no coincidence that the aircraft affected by wear in these areas have usually been in service for a number of years.

Hercules nose landing gear assembly-note PN YTA106A anti-friction bearing.

Worn bearings should be replaced. The inner race of new bearings should be lubricated with a film of fresh, general-purpose grease. If the inside diameter of the outer race is Teflon-lined, only the inside diameter of the inner race need be lubricated. The strut should then be reassembled as described in the authorized maintenance instructions. If new bearings are not immediately available, a temporary solution that will usually eliminate the noise is to rotate each bearing 90° and reinstall it. This serves to expose a different area to the load, which ensures a better fit and helps protect the already affected areas from further wear until new bearings can be installed.

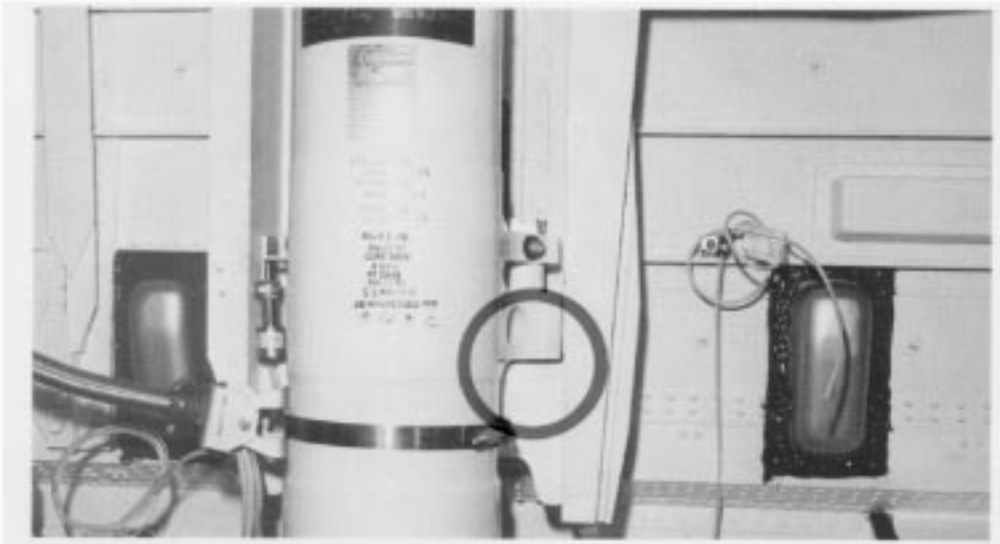
Figure 7. Normal landing configuration: the drag pin has fully engaged the shelf bracket (view looking inboard).

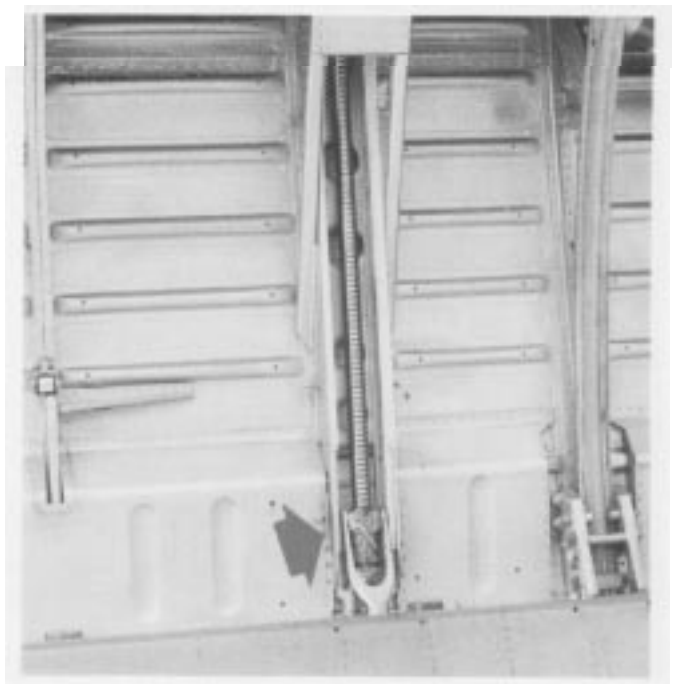
With continued use, jackscrews tend to wear on those surfaces where the shaft rotates inside the ball nuts, as well as in the bumper regions. The normal 50% flap takeoff and 100% flap landing settings will also tend to concentrate wear in these areas. Over time, this will necessitate removal of the jackscrews and their replacement with new, compatible units.

With continued use, the flap jackscrews tend to wear on the surfaces where the shaft rotates inside the ball nuts.
