SERVICE NEWS

Vol. 18, No. 4, October-December 1991

Understanding Thermocouples

by Darel A. Traylor, Service Analyst Coordinator,
Airlift Field Service Department

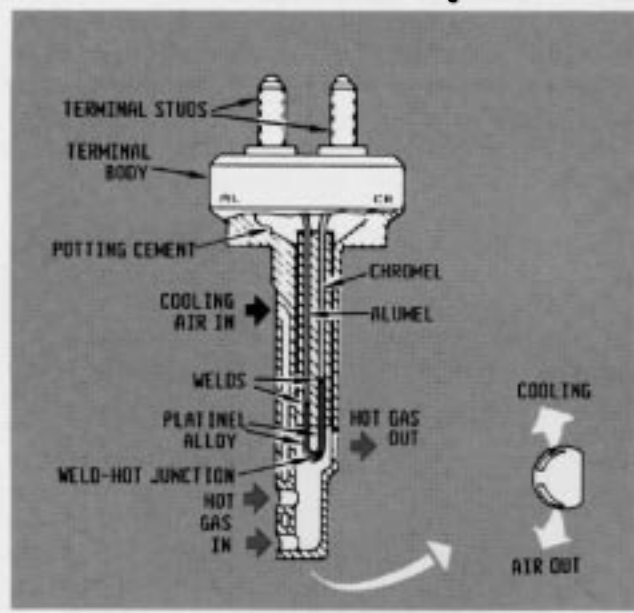
Figure 1. This thermocouple is typical of the air-cooled design used in the T56-A-15 and other series-111 engines.

When a thermocouple develops an open circuit, it generally occurs adjacent to the weld point of the two platinel alloys in the sensing element (Figure 1). For the purposes of the following discussion, we will assume that this has occurred and that both circuits in a thermocouple have failed simultaneously.

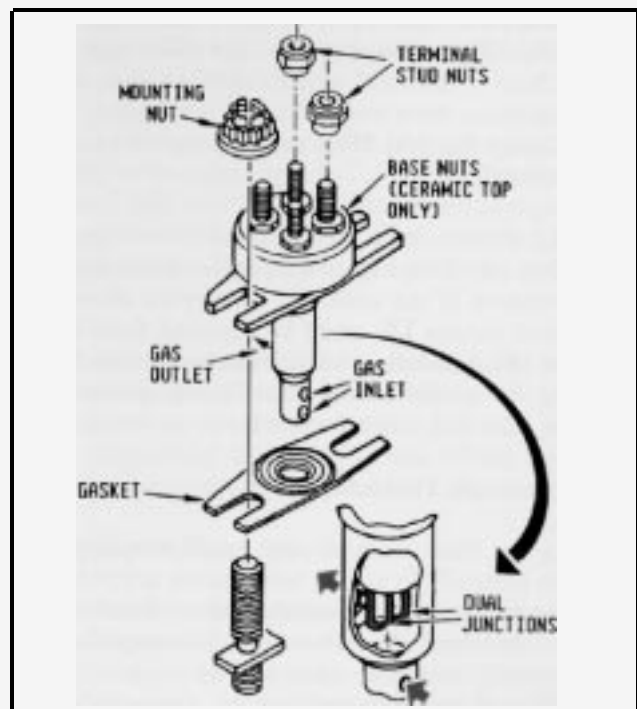
Figure 2. Both thermocouple types have two separate sensing elements. This unit is of the older, non-air-cooled kind.

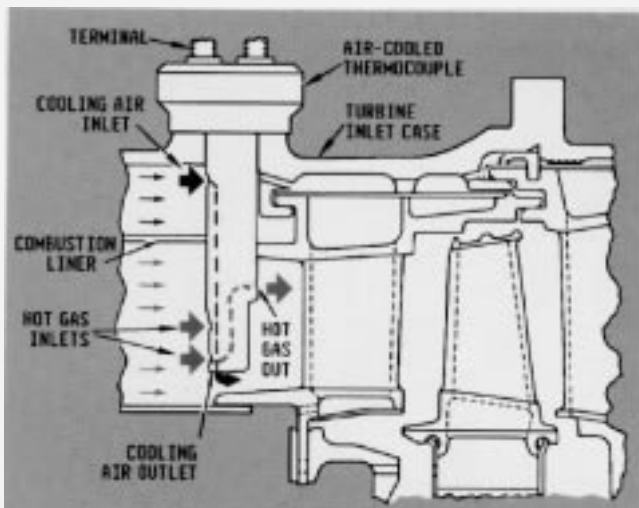
Figure 3. The thermocouple probes sample the gas stream at two levels and measure the composite result.

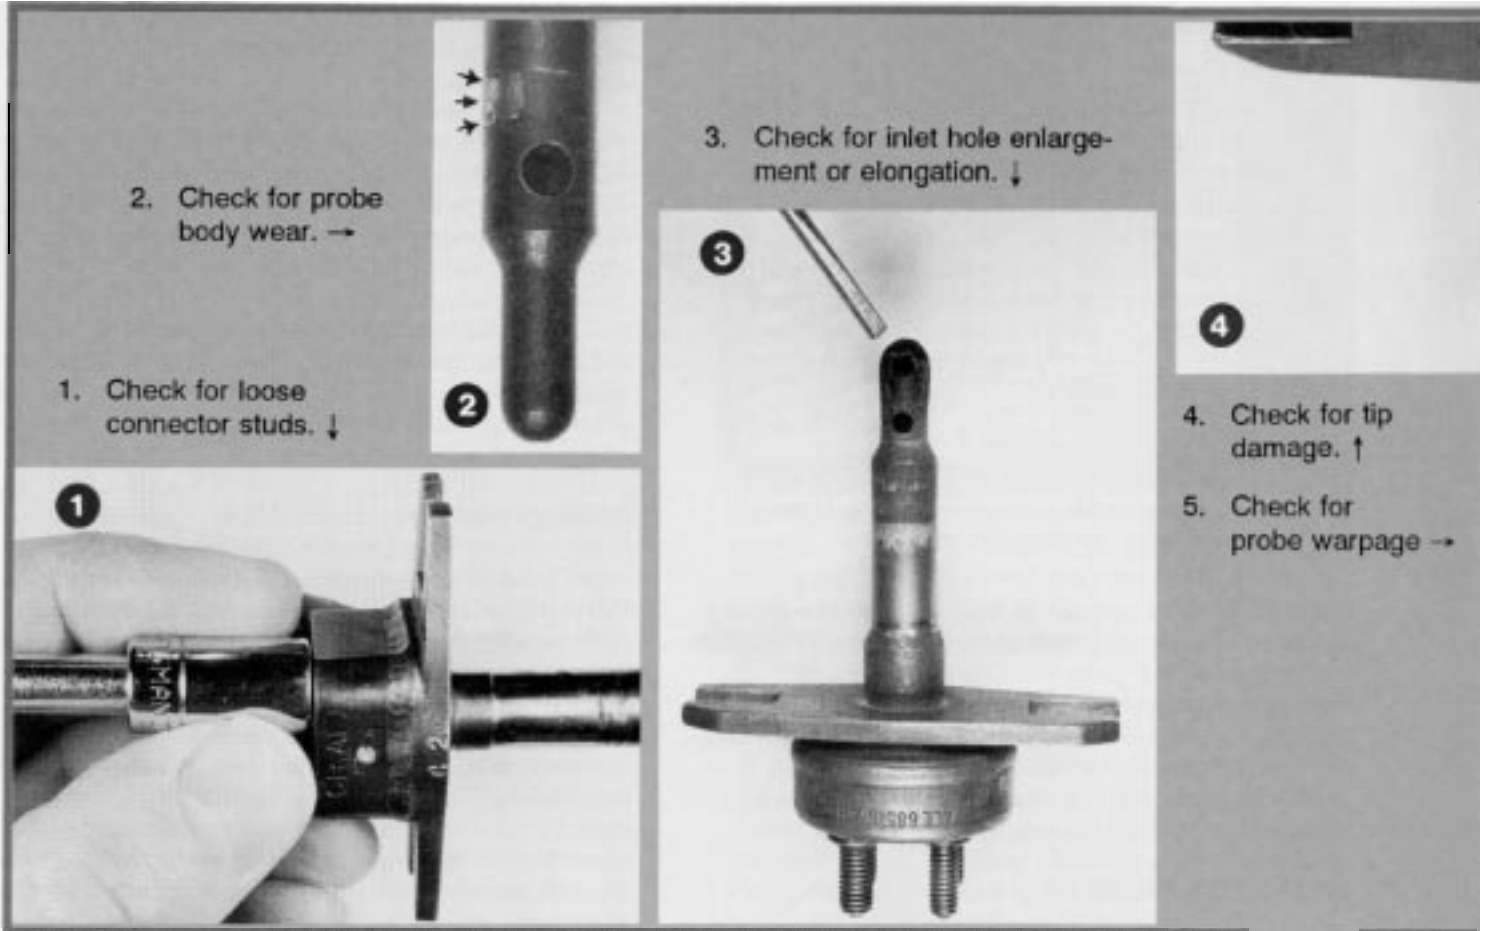
THERMOCOUPLE INSPECTION Checklist

1. Connector studs. Check the four connector studs for security. Condemn the thermocouple if any stud will turn when you apply a maximum of 25 inch-pounds (2.8 N.m.) of torque to the connector nut when it is bottomed on the stud flange.

2. Probe wear. Check for local probe body wear.

- Reject non-air-cooled thermocouples with local wear exceeding 0.020 inch in diameter on the surface of the main part of the probe body. The probe body in this area is 0.350 to 0.353 inch in diameter.
- Reject air-cooled thermocouples **with** local wear on the main part of the probe that exceeds 0.011 in depth. This section of the probe is 0.409 to 0.415 inch in diameter.

4. Probe tip damage. Reject thermocouples which exhibit burned-off probe tips, or distortion or melting affecting metal strength. The inlet holes must not show a metal buildup. No probe foreign object damage is permitted.

5. Warped probes. Reject any air-cooled thermocouples with a bent or bowed probe. This indicates that an over-temperature condition has existed in this area. Replace the associated fuel nozzle and make a special borescope inspection for damage to the turbine first-stage vanes and blades. Check thermocouples for warpage as follows:

The purpose of thermocouple inspections is to find deteriorating thermocouples before they have failed completely and caused reduced turbine life. Allison recommends that all thermocouples be able to pass each of the following inspection criteria. If a thermocouple fails any of the inspections or test requirements, it must be scrapped.

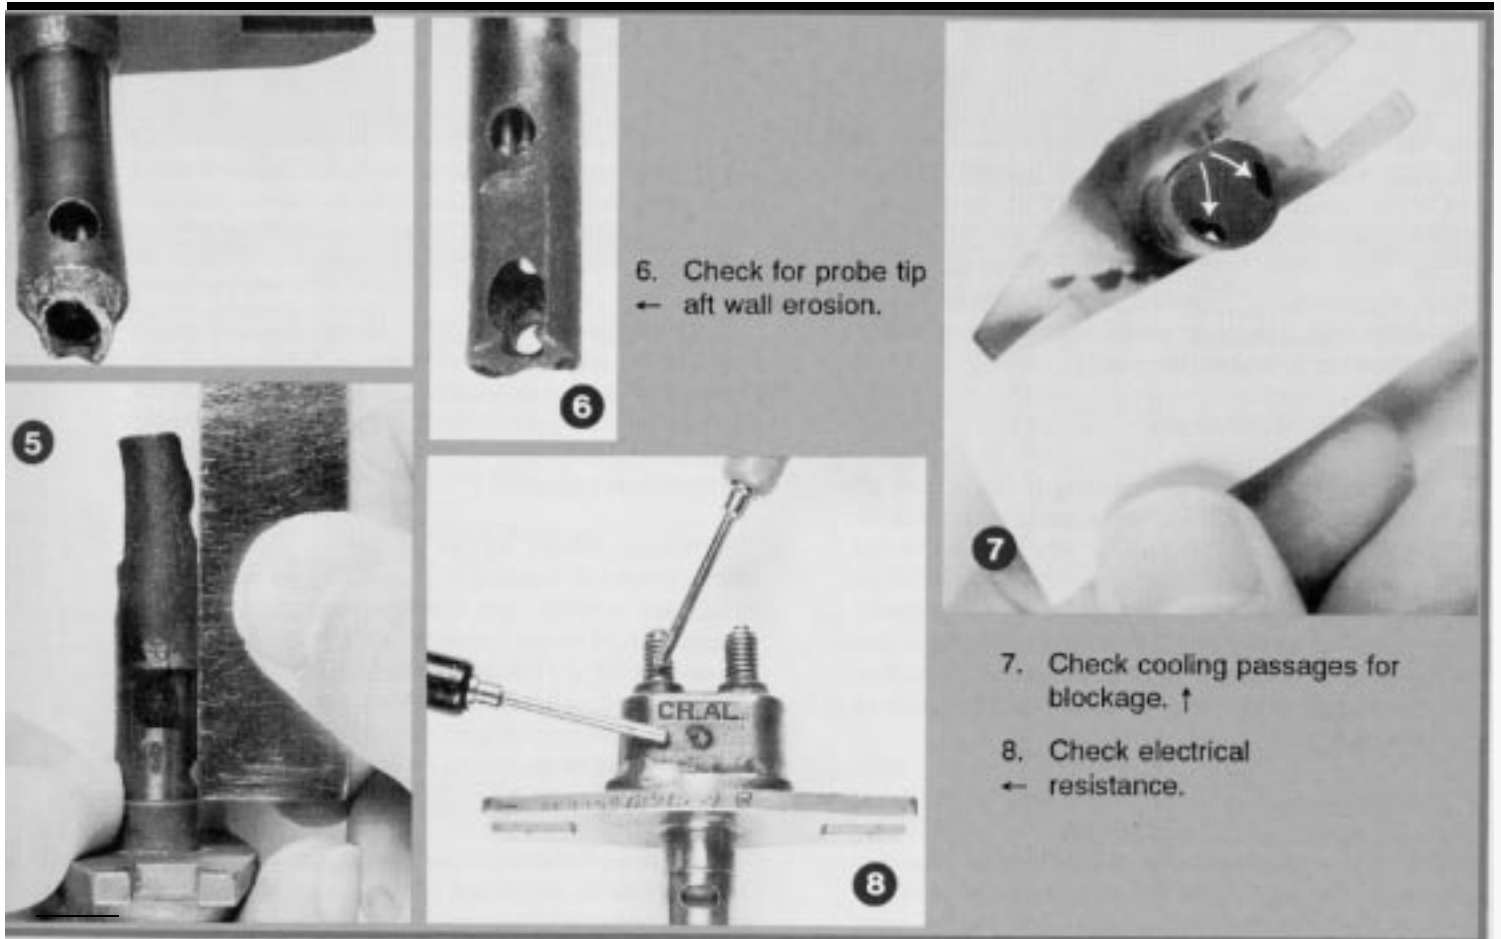
6. Probe tip aft wall erosion. Reject any air-cooled thermocouple that has aft wall erosion or gas exit hole enlargement that affects gas flow through the probe.

7. Blocked cooling passages. Check air-cooled thermocouples for obstruction of the cooling air inlet and discharge holes, or for any restriction of flow through the cooling air cavity. Inspect the interior area by using a piece of white paper to reflect light into the cooling passage. Use a scribe or similar tool to remove any foreign particles found during inspection. If the blockage cannot be removed, reject the thermocouple.

8. Electrical resistance. Check the resistance between the terminal studs and probe body, and also between the indicator and amplifier studs. If the resistance is less than 20,000 ohms, subject the thermocouple to a temperature of 400°F (204°C) for 30 minutes to drive moisture out of the thermocouple assembly. Allow the thermocouple to cool to room temperature in a dry atmosphere and recheck the resistance. If the resistance reading is still less than 20,000 ohms, reject the thermocouple.
