2018 Restoration Maintenance Work Plan

Bloody Brook Onondaga County, New York

October 2018

2018 RESTORATION MAINTENACE WORK PLAN BLOODY BROOK ONONDAGA COUNTY, NEW YORK

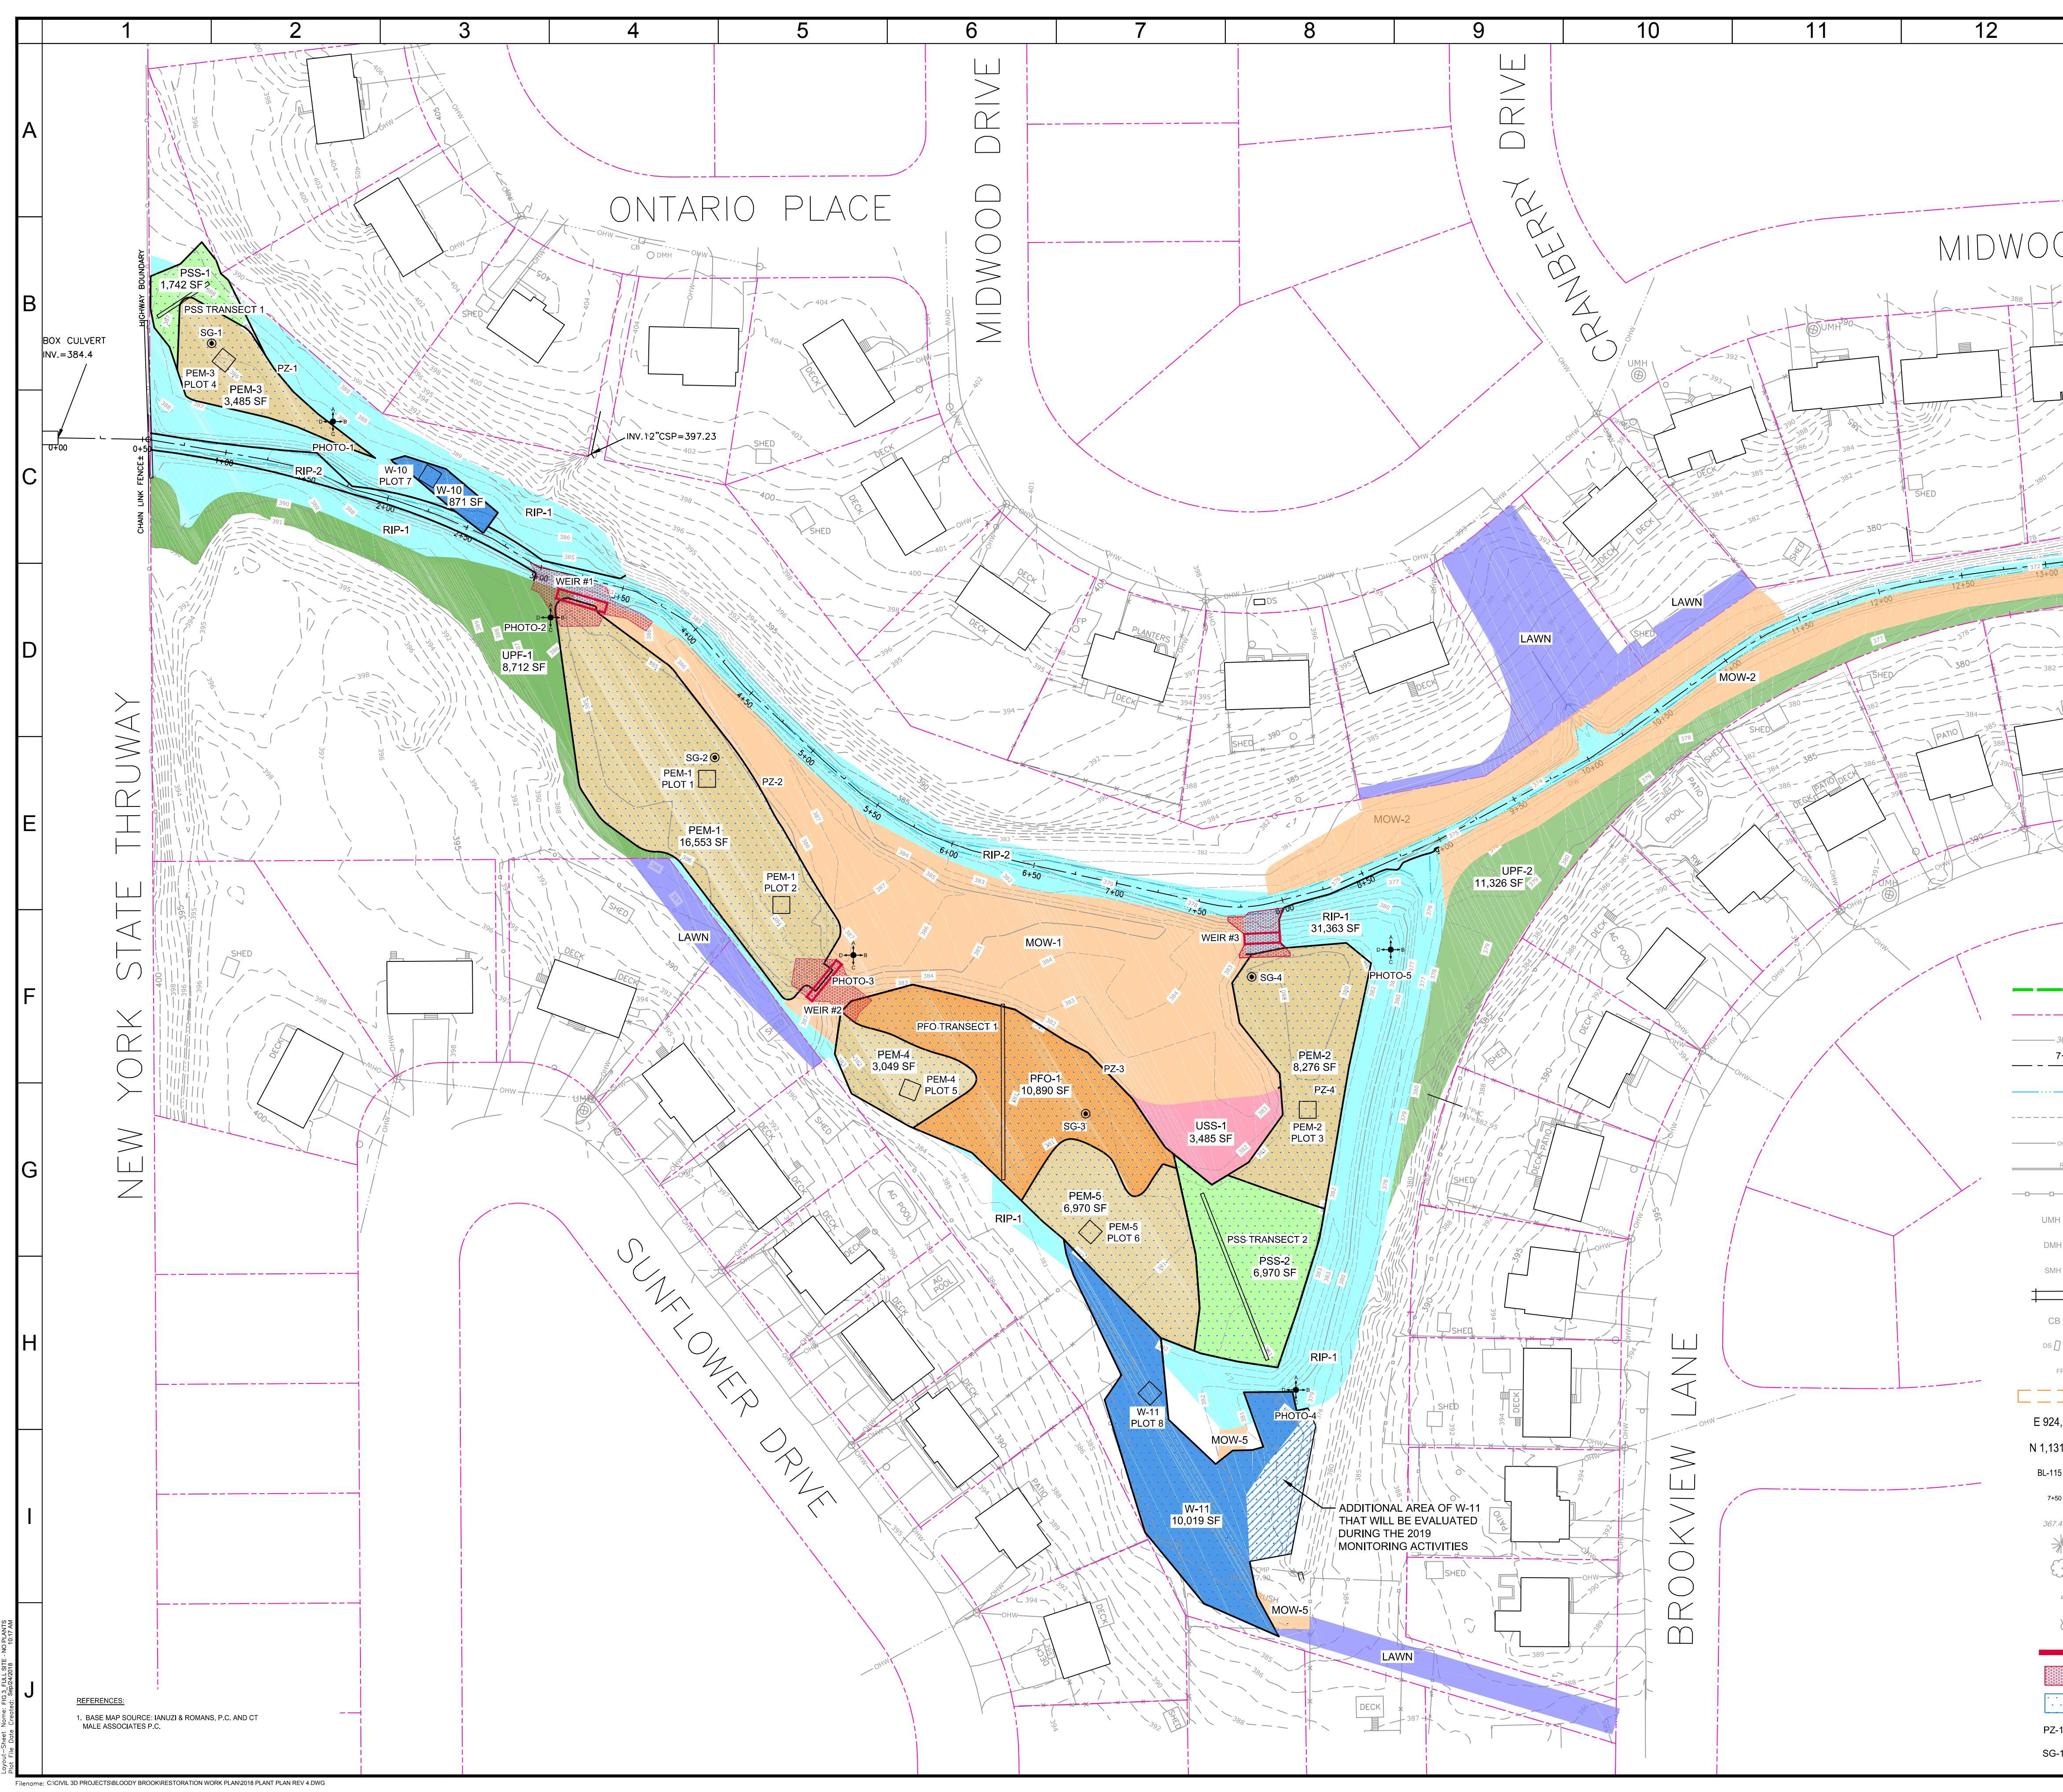
- W-11, shown on Figure 3, has developed a strong population of emergent vegetation. However, there are still large areas where the wetland seed mix did not germinate. These bare spots will be overseeded again this fall with PA New England Province FACW Mix (ERNMX-251) (Attachment C). If the 2019 monitoring results indicate the seed mixture again failed to germinate, other options will be evaluated.

- For the majority of MOW-1 and MOW-2 (Figure 3), the seed mixture placed during restoration activities has been successful. However, there are large bare spots in MOW-1 where the temporary construction staging area was located. Those bare spots will be hand raked to loosen the ground surface and reseeded with the upland meadow seed mix (Northeastern U.S. Road Native Mix [ERNMX-105]) (Attachment C). The placement of additional topsoil may be needed prior to overseeding. If topsoil is placed, it will be bagged topsoil purchased from a local retail store.

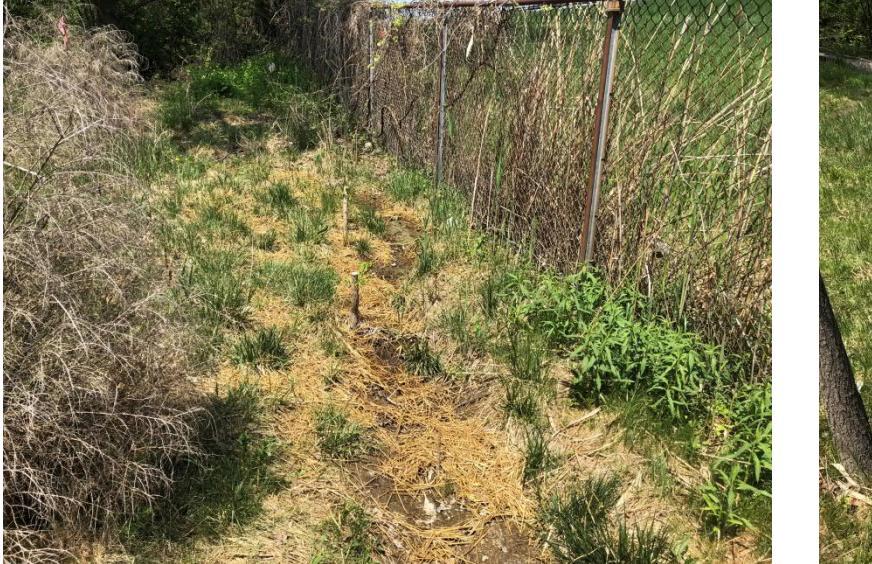
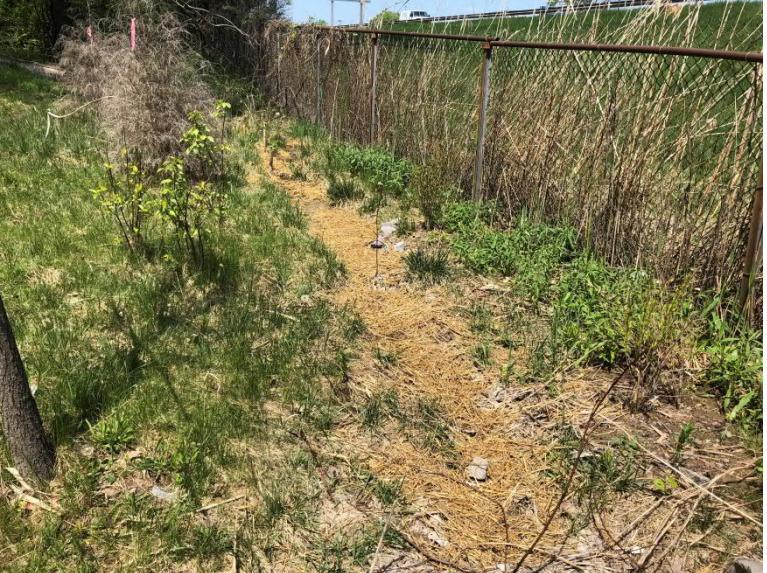
May 2018 Bloody Brook Erosion Inspection Photos Location 1* *See Figures 4A, 4B, and 4C for Photo Locations

Location 1 is located in the upland forested area adjacent to the New York State Thruway property (Figure 4A). At the time of the May 2018 inspection, minor vegetation loss within the area disturbed by remedial activities was noted for this location. However, the area had just been recently overseeded; therefore only monitoring will be conducted at this time.

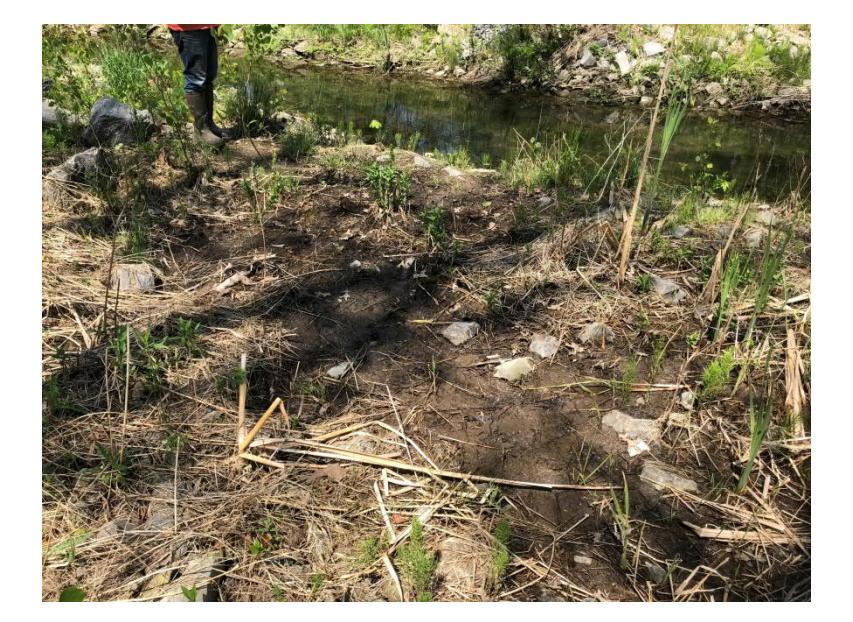
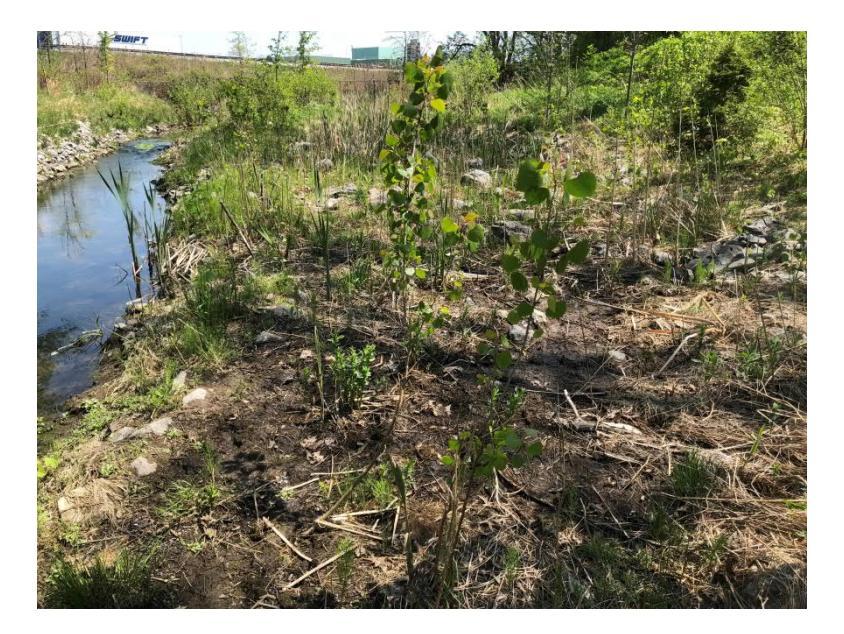
May 2018 Bloody Brook Erosion Inspection Photos Location 2* *See Figures 4A, 4B, and 4C for Photo Locations

Locations 2 and 3 are located in the riparian area just upstream of Weir 1 (Figure 4A). Minor vegetation loss and erosion within the areas disturbed by remedial activities was noted for these locations during the 2018 inspection (Attachment B). These locations will be overseeded with PA New England Province Riparian Mix (ERNMX-253) (Attachment C), and live stakes may be planted at Location 2 to improve bank stability. At Location 3, live stakes will be planted, and rip rap will be placed, if needed, to stabilize the ground to allow the live stakes to take root. The use of rip rap at this location will be minimized.

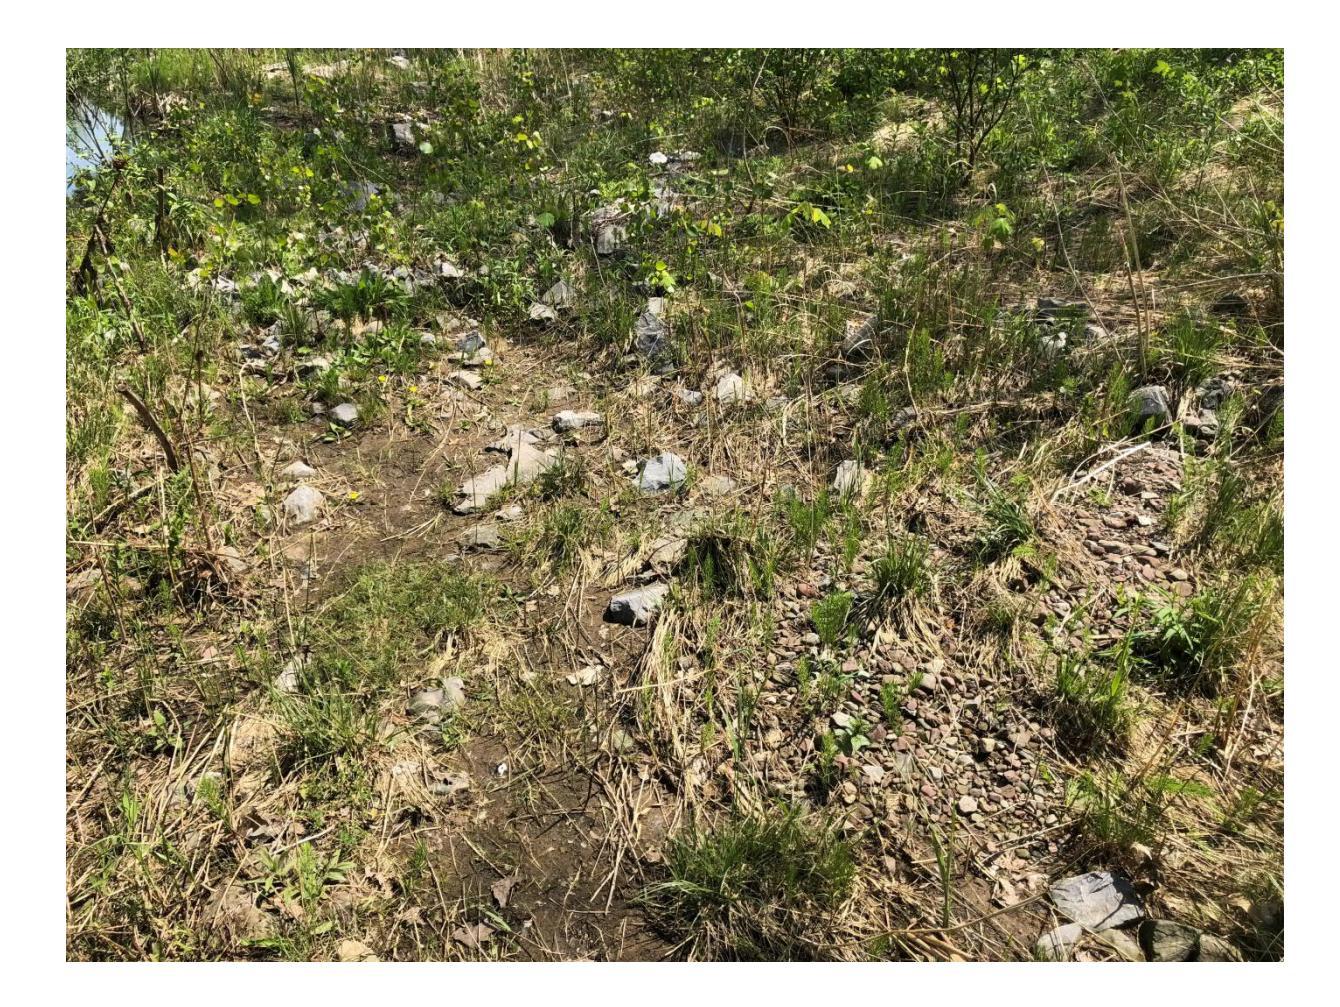
May 2018 Bloody Brook Erosion Inspection Photos Location 4* *See Figures 4A, 4B, and 4C for Photo Locations

Location 4 is located in the riparian area adjacent to Weir 1 (Figure 4A). Minor vegetation loss within the area disturbed by remedial activities was noted for this location during the 2018 inspection (Attachment B). This location will be overseeded with PA New England Province Riparian Mix (ERNMX-253) (Attachment C), and live stakes may be planted in some areas to improve bank stability.

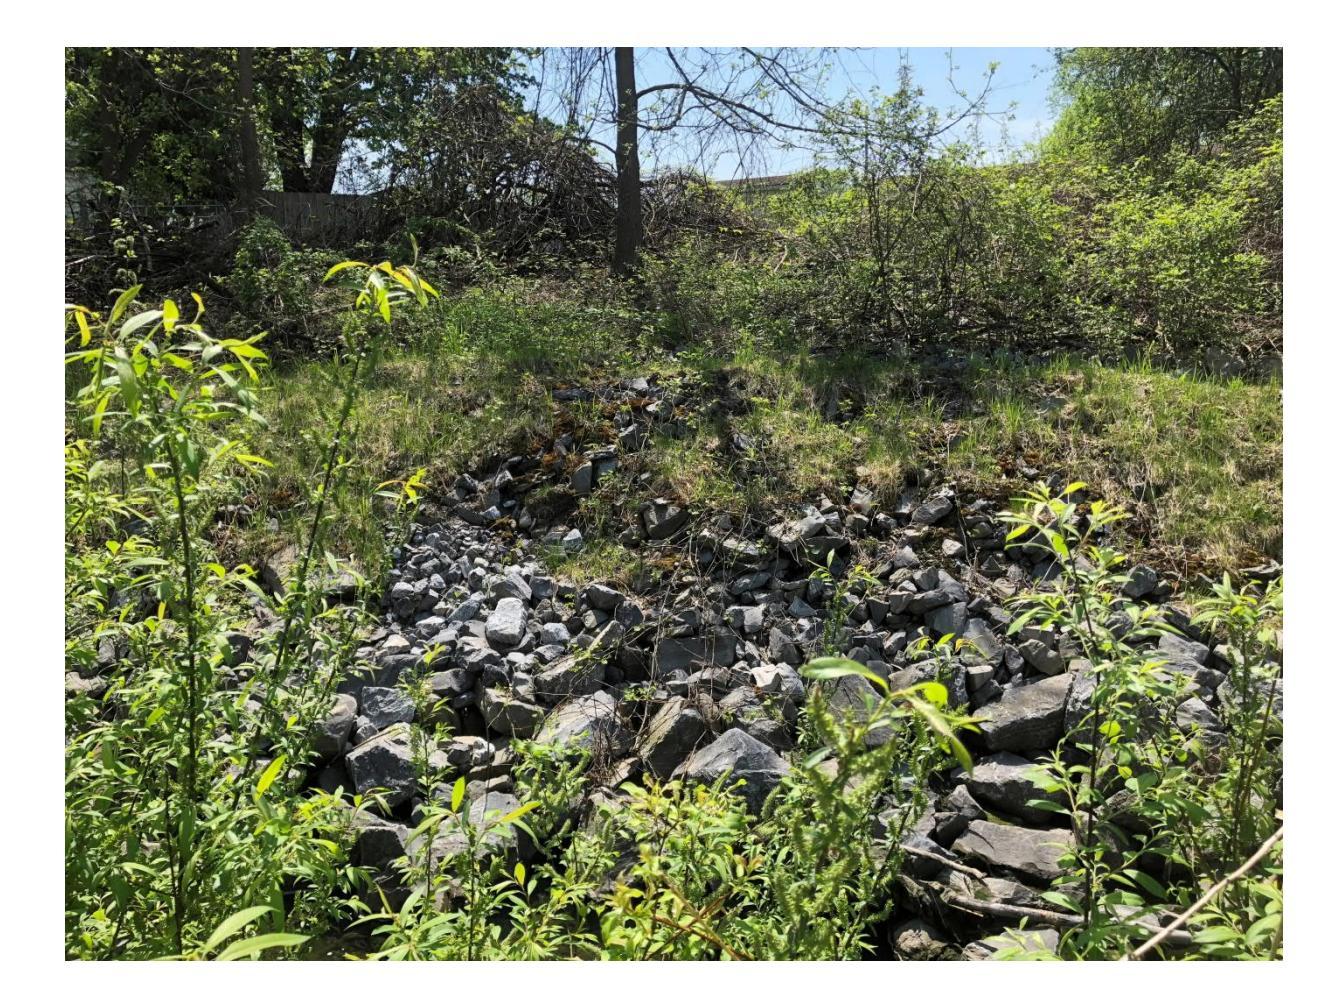
May 2018 Bloody Brook Erosion Inspection Photos Location 5* *See Figures 4A, 4B, and 4C for Photo Locations

Location 5 is located in the riparian area downstream from Weir 1 (Figure 4A). During the 2018 inspection, portions of the side bank were noted as having sparse vegetation growth and minor riprap erosion (Attachment B). This location will be overseeded with PA New England Province Riparian Mix (ERNMX-253) (Attachment C), and live stakes may be planted in some areas to improve bank stability. The rip rap will also be adjusted in this area to prevent future erosion.

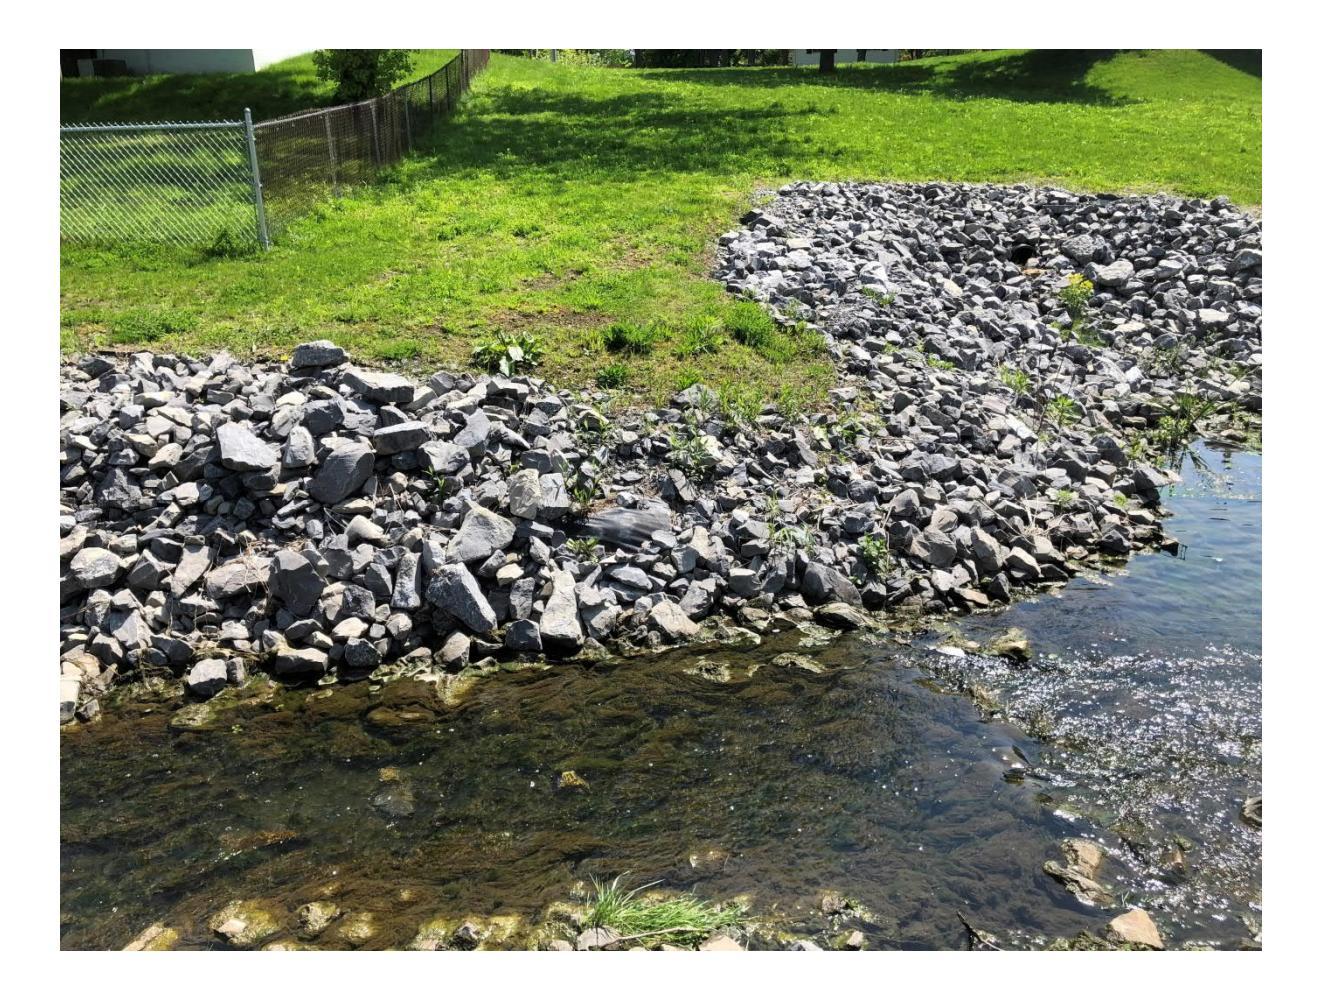
May 2018 Bloody Brook Erosion Inspection Photos Location 6* *See Figures 4A, 4B, and 4C for Photo Locations

Location 6 is located along the side bank adjacent to the empty lot on Midwood Drive, and Location 7 is located on the opposite bank just downstream from Location 6 (Figure 4A), both in a residential area. During the 2018 inspection, portions of the side bank showed signs of minor rip rap erosion at both of these locations (Attachment B). Rip rap adjustment will be needed at both areas to help prevent future erosion, and the areas will be overseeded as needed with Northeastern U.S. Road Native Mix [ERNMX-105]) (Attachment C) to help improve bank stability.

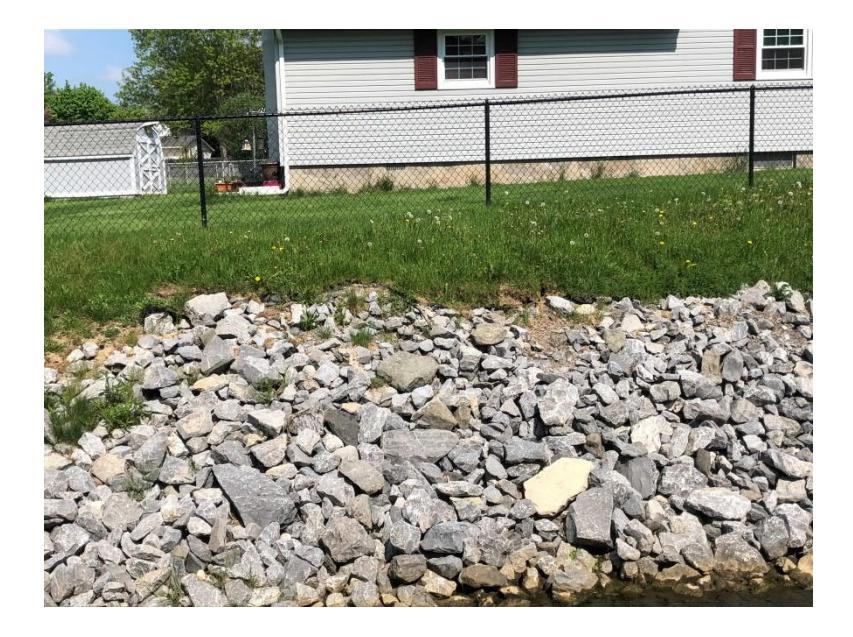
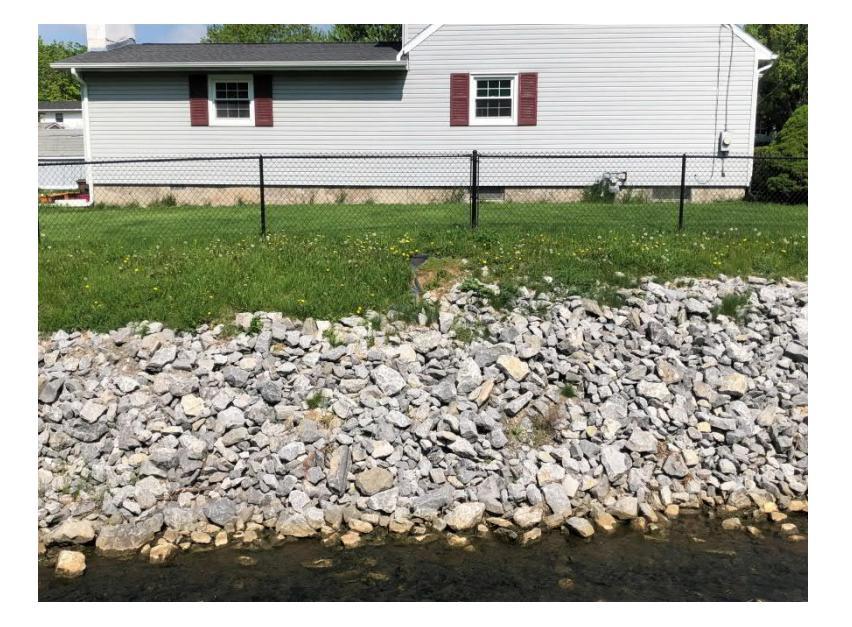
May 2018 Bloody Brook Erosion Inspection Photos Location 8* *See Figures 4A, 4B, and 4C for Photo Locations

Locations 8 and 9 are located in a residential area along the side bank between Brookview Lane and Sunflower Drive (Figure 4B). During the 2018 inspection, portions of the side bank showed signs of minor rip rap erosion (Attachment B). Rip rap adjustment will be needed at both areas to help prevent

future erosion, and the areas will be overseeded as needed with Northeastern U.S. Road Native Mix [ERNMX-105]) (Attachment C) to help improve bank stability. The placement of additional topsoil may be needed prior to overseeding. If topsoil is placed, it will be bagged topsoil purchased from a local retail store.

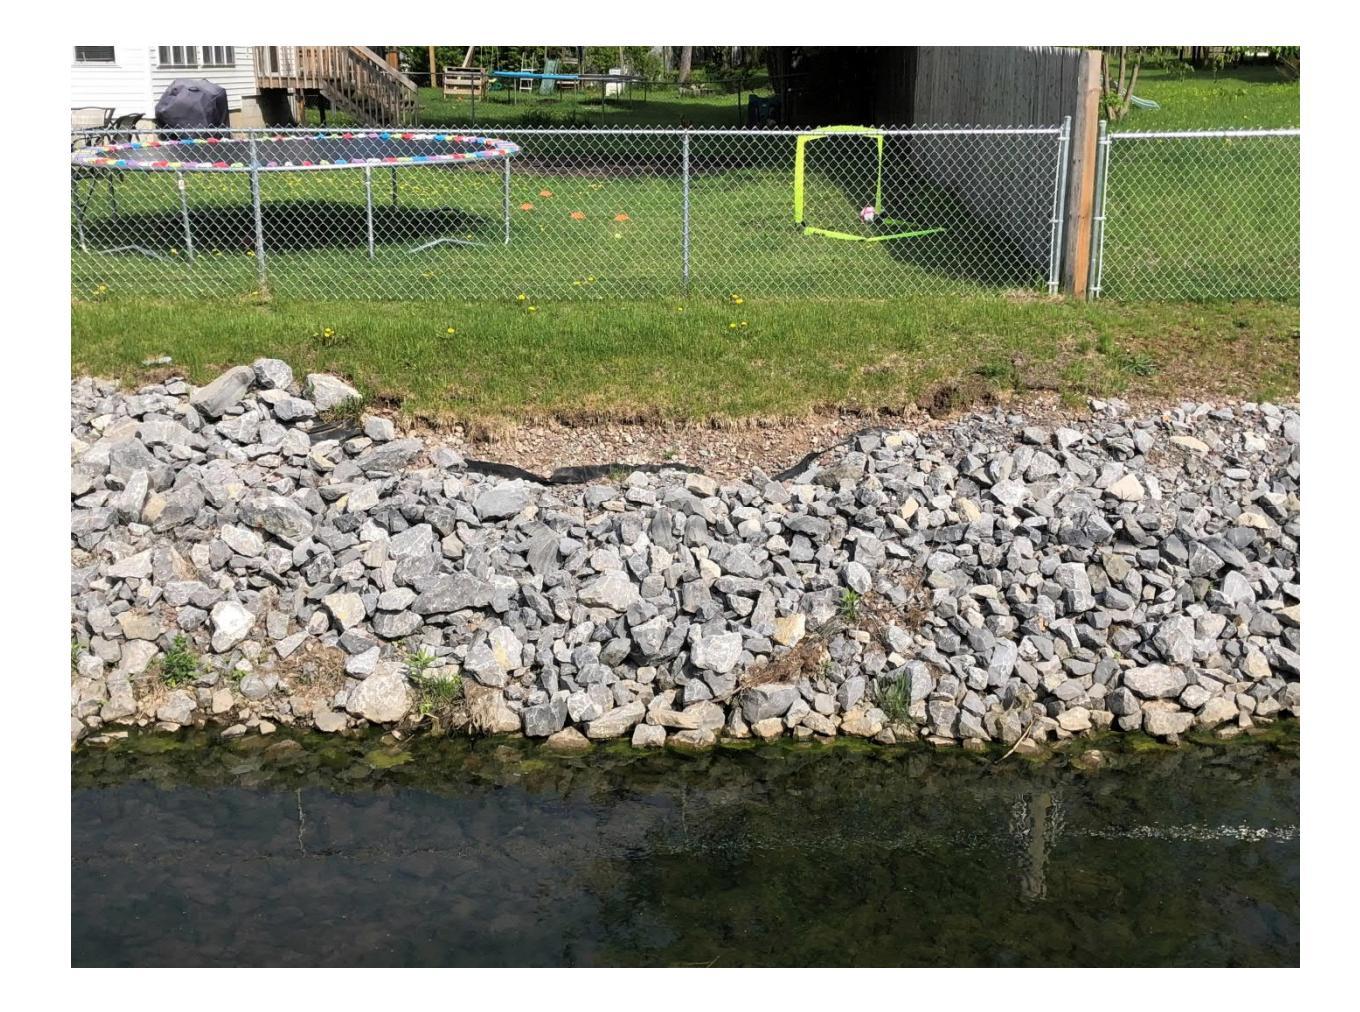
May 2018 Bloody Brook Erosion Inspection Photos Location 10* *See Figures 4A, 4B, and 4C for Photo Locations

Location 10 is located in the residential area between Sunflower Drive and Floradale Road (Figure 4B). During the 2018 inspection, portions of the side bank showed signs of minor rip rap erosion (Attachment B). This bank area will be addressed by adjusting the rip rap to help prevent future erosion.

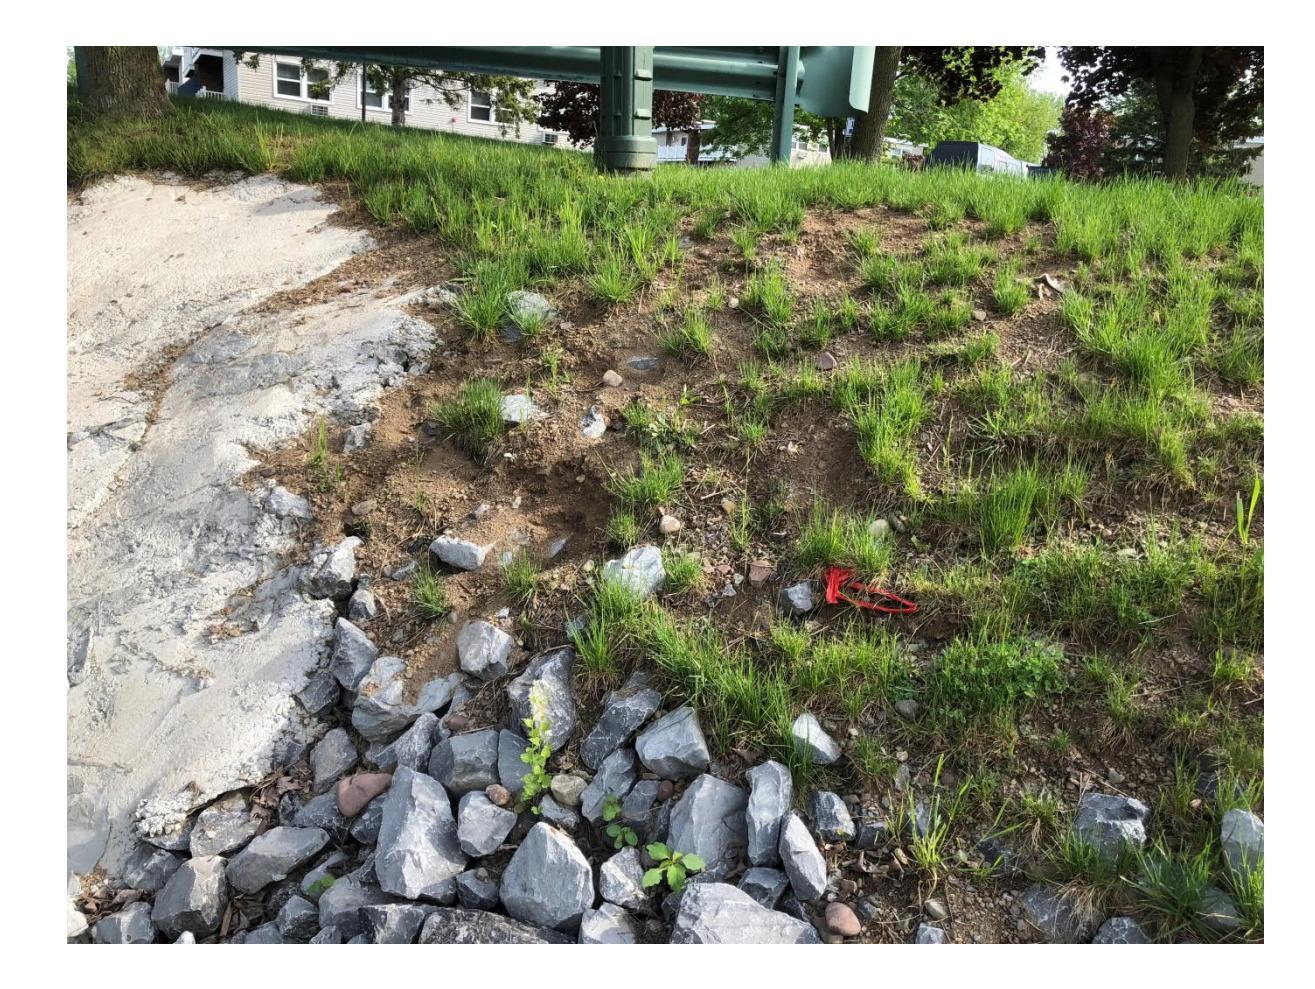
May 2018 Bloody Brook Erosion Inspection Photos Location 11* *See Figures 4A, 4B, and 4C for Photo Locations

Location 11 is located along the side bank within the apartment complex area (Figure 4B). During the 2018 inspection, portions of this side bank showed signs of soil erosion (Attachment B). This bank area will be addressed by placing additional topsoil (i.e., bagged topsoil purchased from local retail store) and overseeding with Northeastern U.S. Road Native Mix [ERNMX-105]) (Attachment C) to help improve bank stability. The need for an erosion mat will be evaluated at the time of the maintenance.

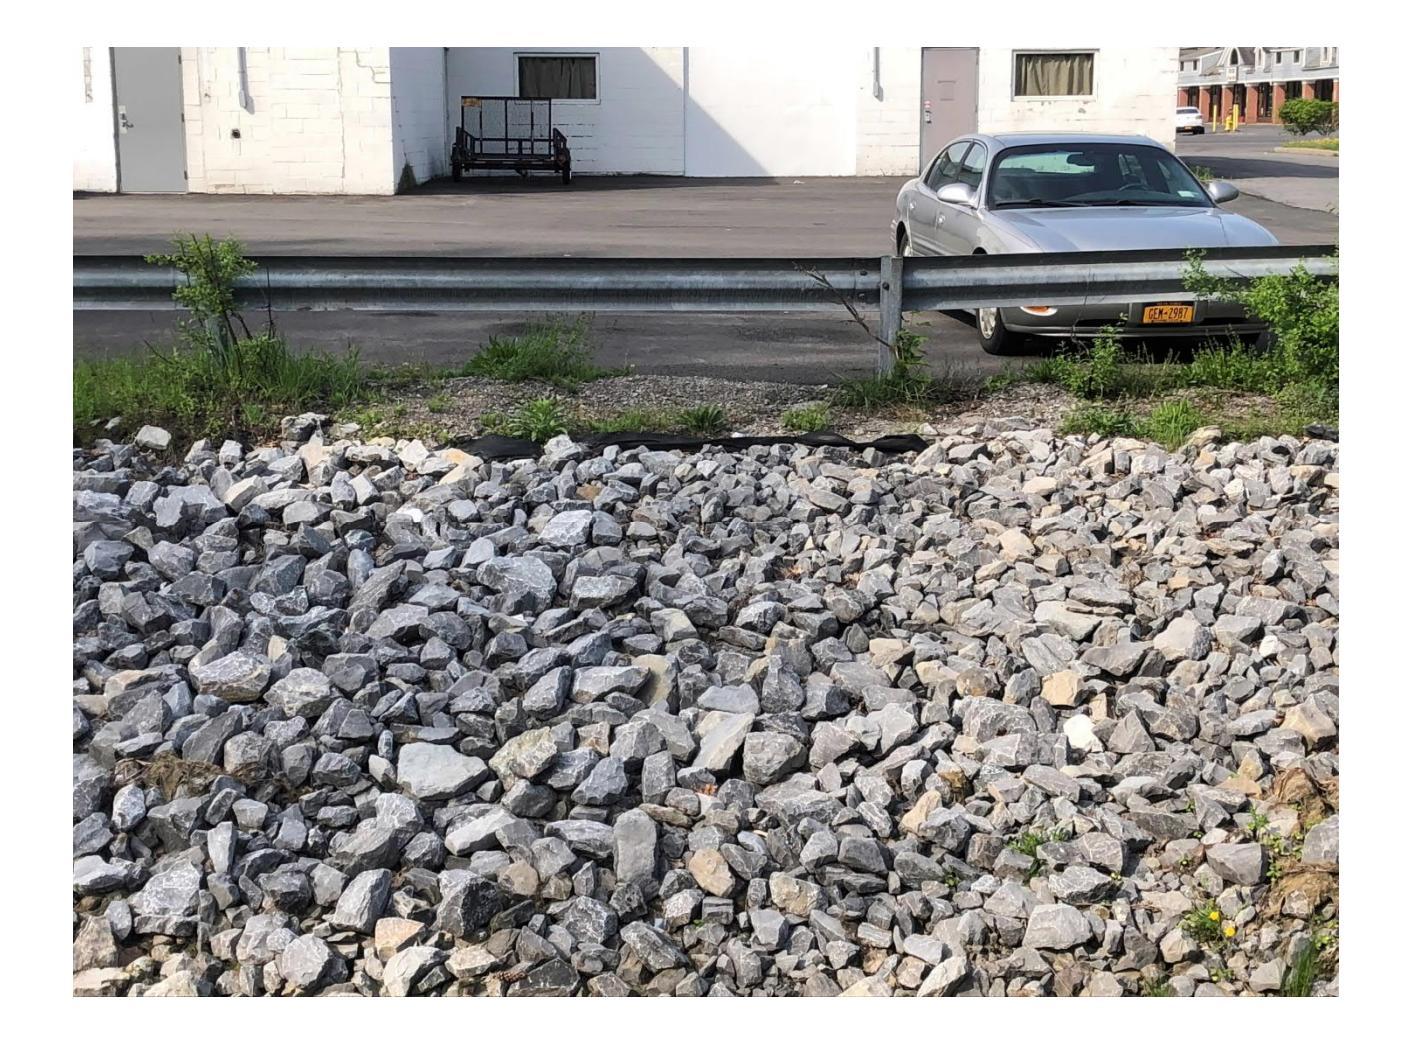
May 2018 Bloody Brook Erosion Inspection Photos Location 12* *See Figures 4A, 4B, and 4C for Photo Locations

Location 12 is located along the side bank within a commercial property across from the apartment complex area (Figure 4B). During the 2018 inspection, portions of this side bank showed signs of minor rip rap erosion (Attachment B). This bank area will be addressed by adjusting the rip rap to help prevent future erosion.

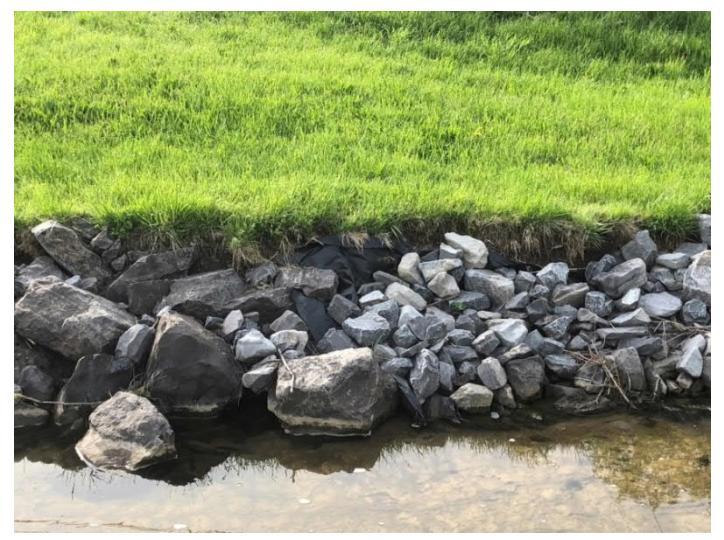
Bloody Brook Erosion Inspection Photos (May and July 2018) Location 13* *See Figures 4A, 4B, and 4C for Photo Locations

Location 13 is located in the commercial-light industrial area along the side bank below Old Liverpool Road (Figure 4C). As discussed in Section 2.3, OCDWEP notified AECOM in July 2018 that armor material had washed away from a portion of the channel bank below Old Liverpool Road following a heavy rain event. In May 2018, this location had been identified as Location 13 during the inspection and was noted as being an area with some rip rap erosion requiring installation of additional armor material.

May 17, 2018- Before armor material failure

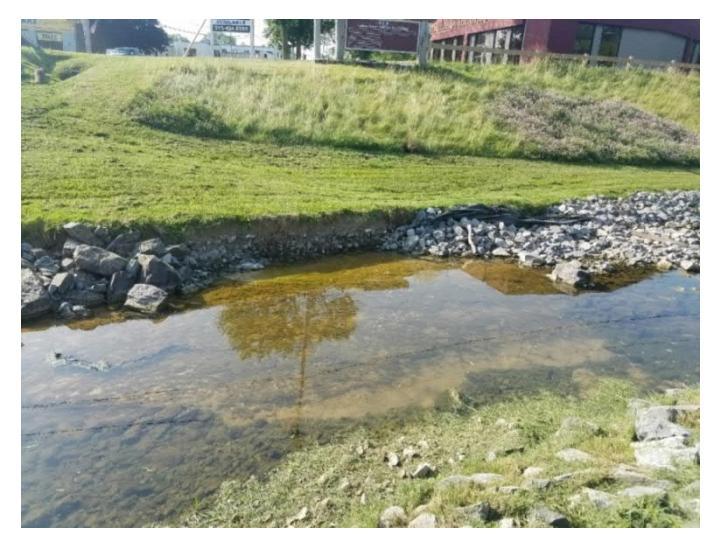
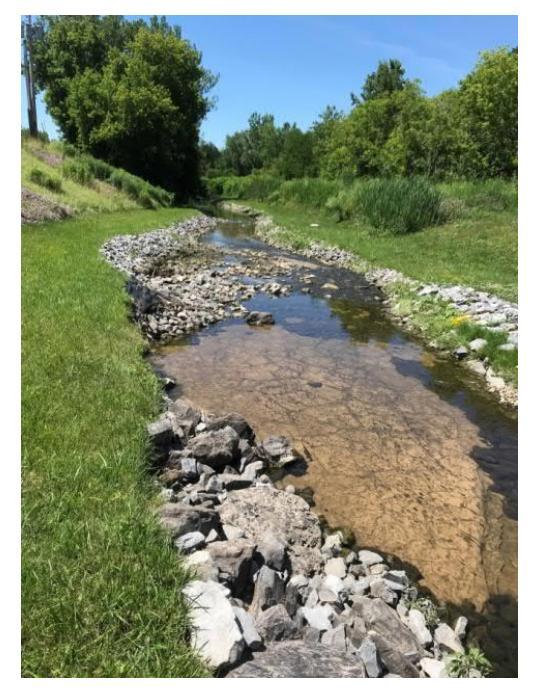
Following completion of the 2018 monitoring activities, AECOM was notified by Onondaga County Department of Water Environment Protection (OCDWEP) that armor material had washed away from a portion of the channel bank below Old Liverpool Road following a heavy rain event. This location had been identified as Location 13 during the earlier May 2018 inspection and was noted as being an area with some rip rap erosion requiring installation of additional armor material. As an interim corrective measure, the armor material was placed by hand onto the channel slope. This area was and will be monitored at least monthly and after significant rainfall events until the permanent corrective measure proposed in this work plan can be implemented during the 2018 maintenance activities. Photos of this area before and after the interim repair are provided in Attachment B.

7/13/18 - Before interim corrective measure

Similar to the installation of rip rap located upstream and downstream of Location 13, soil will be
removed to a depth of one foot from the top of the stream side bank to match the angle and
anchoring of rip rap. Approximately 2.5 cubic yards of soil will be removed. The removed soil will
remain onsite to be used for filling in the transitional areas between the rip rap and the existing
ground cover as well as to repair/reseed the access areas used to complete the repairs.

- Install demarcation fabric (Mirafi FW700 or equivalent) similar to the original restoration and restoration completed for the remainder of the site.
- Over demarcation layer, lay 24- to 36-inch rip rap at the bottom of the stream side bank and 6- to 12-inch stones around the larger stones and at the top of the bank. The rip rap will be placed with two larger stones staggered on top of one another with the smaller stones filling in the gaps, and additional smaller stones placed at the top of the stream side bank.

The work will be done using an excavator to remove soil and place the rip rap. The channel will be accessed from 911 Old Liverpool Road and crane mats will be used as needed to stabilize the work area and minimize damage caused by equipment. The maintenance activities are to replace eroded rip rap and will not change the stream dimensions. All intrusive work (including soil removal) will be completed outside of the brook. Additionally to minimize turbidity concerns, removal of rip rap currently in place along the bottom of the side bank will be completed by hand.

Following armor repairs, the area will be restored by overseeding with Northeastern U.S. Road Native Mix [ERNMX-105]) (Attachment C).

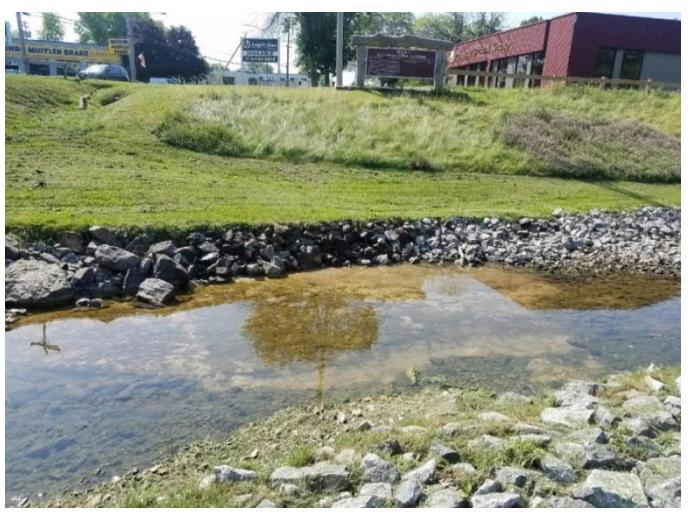
7/13/18 – After interim corrective measure

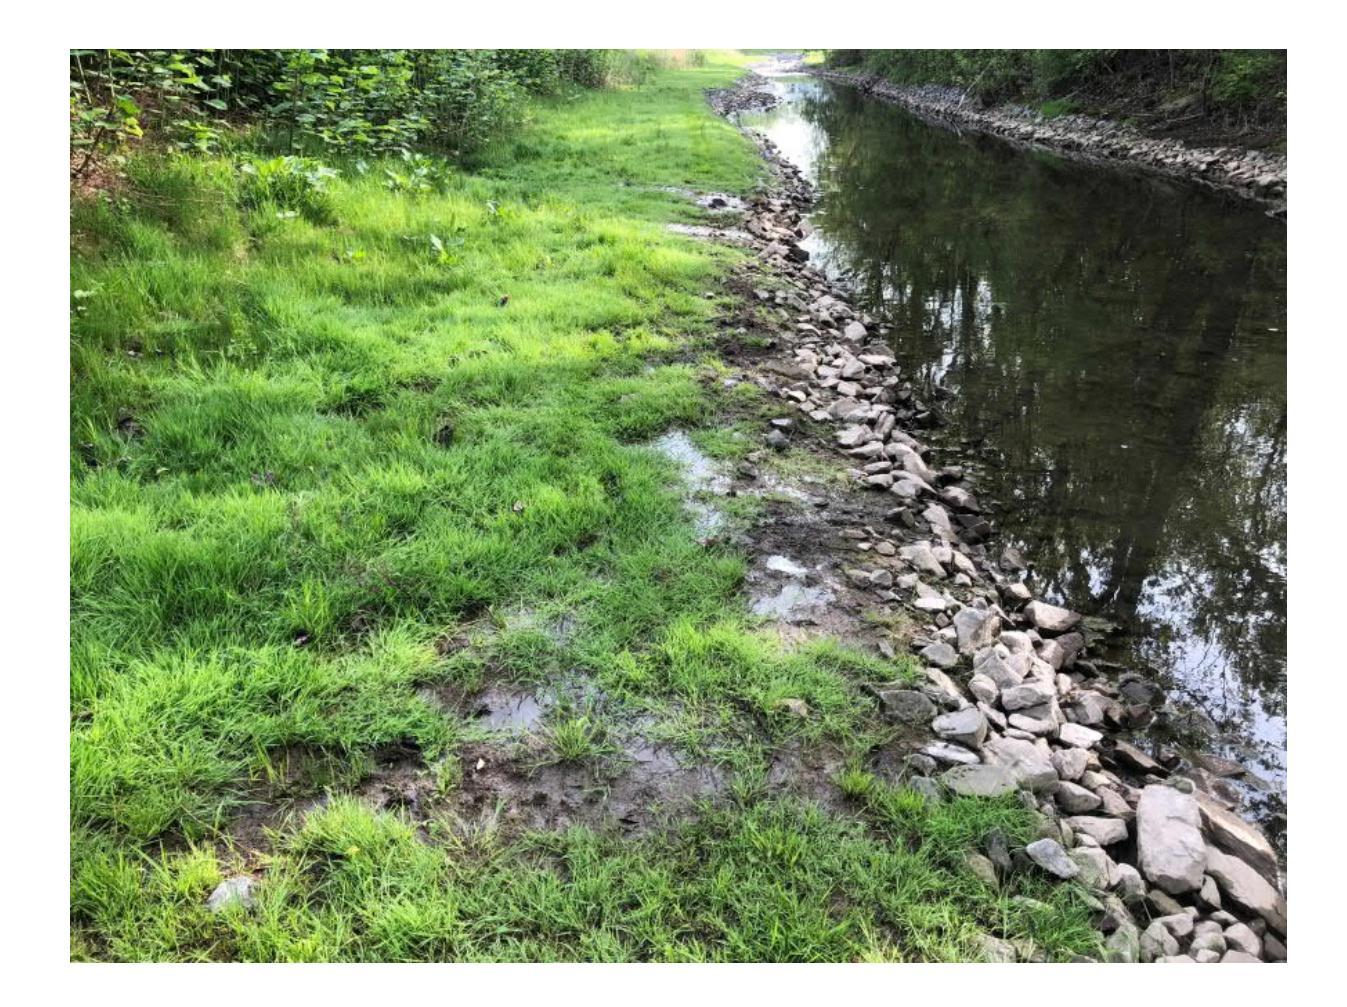
May 2018 Bloody Brook Erosion Inspection Photos Location 14* *See Figures 4A, 4B, and 4C for Photo Locations

Location 14 is located in the commercial-light industrial area upstream from the CSX property (Figure 4C). During the 2018 inspection, vegetation loss was noted for a portion of the side bank. To address this issue, the area will be overseeded with Northeastern U.S. Road Native Mix [ERNMX-105]) (Attachment C) to help improve bank stability.
