VOL. 10, NO. 4. OCTOBER - DECEMBER 1983

3 New Heat Exchangers for the Hercules Aircraft

6 Terminal Lugs: Stacking Them Safely

Keeping the Front Ream Clean

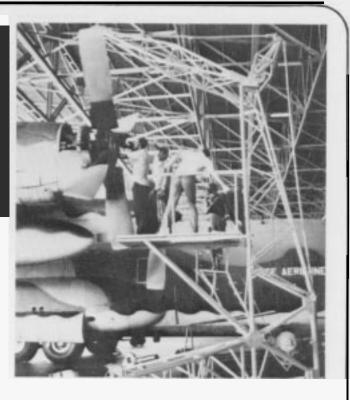
The modification involved attaching a work platform to the J-l B crane. One end of a platform 83 inches long by 47 inches wide was welded to the upright structure of the crane 106 inches above floor level. The other end of the platform, which uses an expanded metal floor like the ones used on B-4 and B-5 stands, was supported

After the platform was secured to the J-1B crane, the boom was adjusted to establish an 11.5inch gap between the hoist cable and the end of the platform. The 11.5inch clearance provides adequate room to raise and lower propellers.

To make the platform safer to work from and more accessible, rails and steps were added. The operator also made a drip pan which could be attached to the platform to catch prop dome oil when the dome is removed. The drip pan was fitted with a tube which allows oil to be drained into a suitable container on the floor. After the oil is drained from the dome, the drip pan can be removed for cleaning.
