SERVICE NEWS

Troubleshooting APQ-122 Radar
The Amazing Hercules

Troubleshooting APQ-122 radar

In the Oct.-Dec 1977 issue of the Service News (Vol. 4, No. 4), we presented a general, introductory article on the APQ-122(V)5 radar system. In this issue we are presenting some troubleshooting procedures for the APQ-122 which we have found helpful on the Lockheed-Georgia flight line.

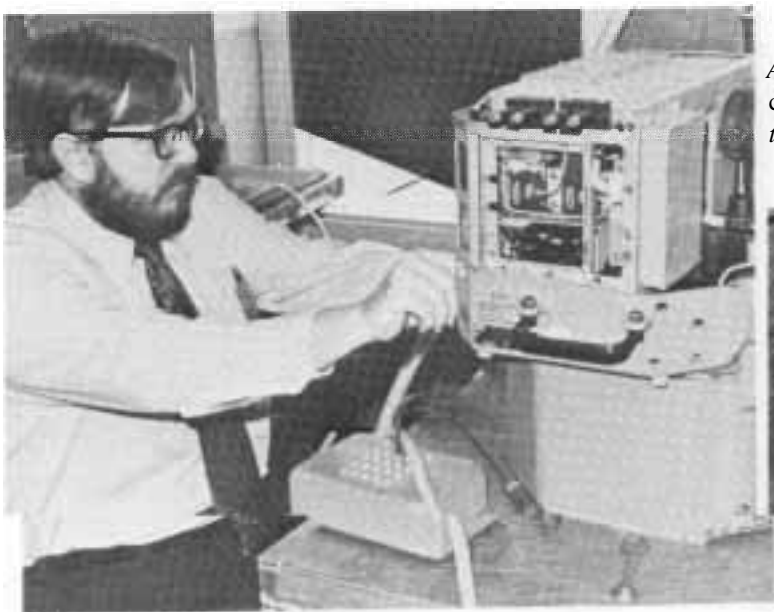
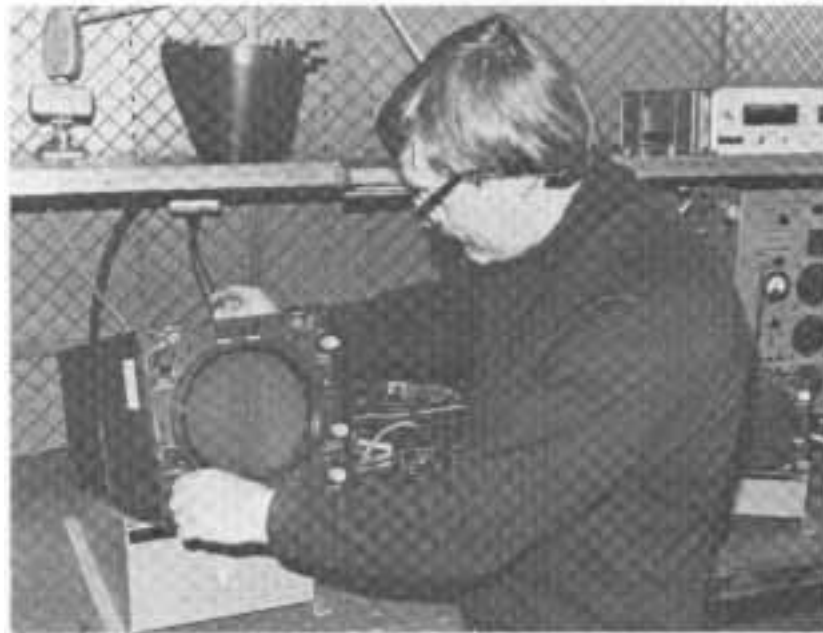
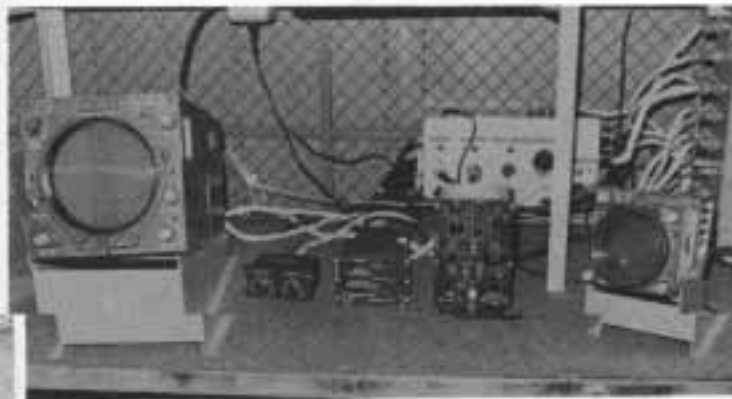
Above: The navigator's indicator being set up for checkout in the lab. Left: Lab testing of the receiver-transmitter. Below: Flight station radar components.

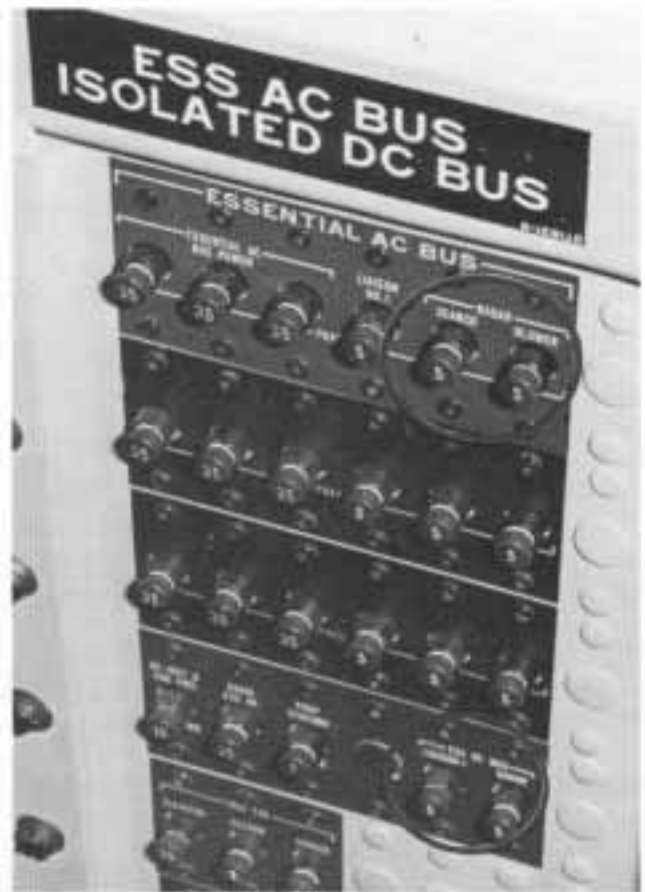
Circuit breakers for the APQ-122 radar.

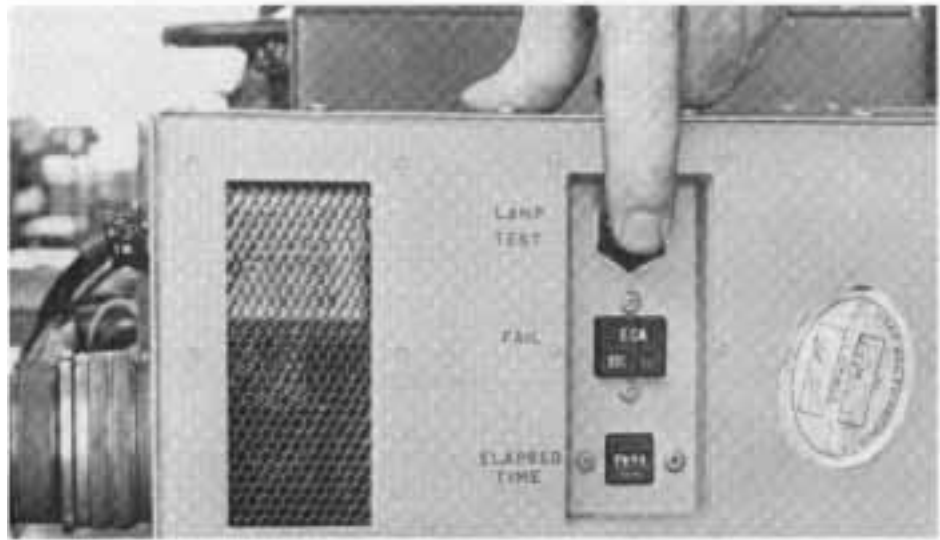
Checking the fail lights and circuit with the LAMP TEST switch.

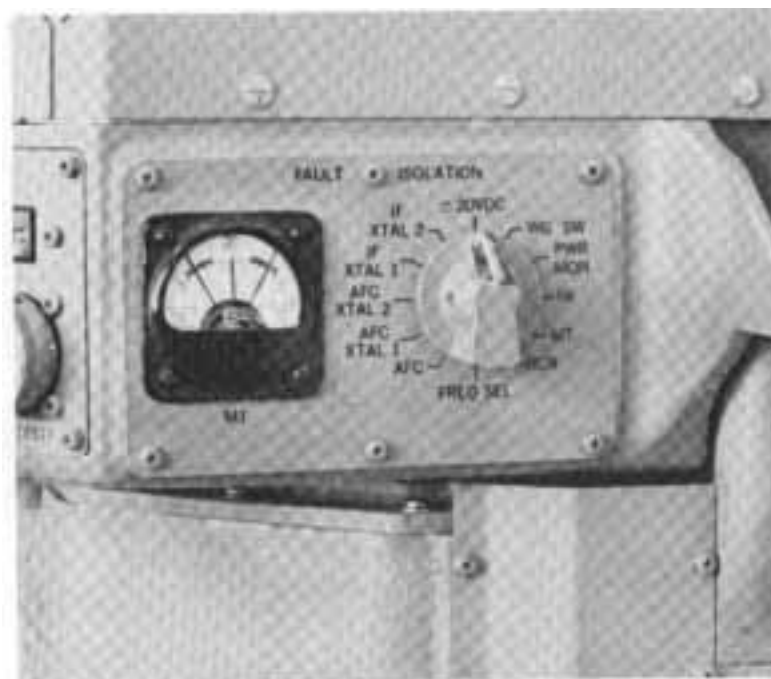
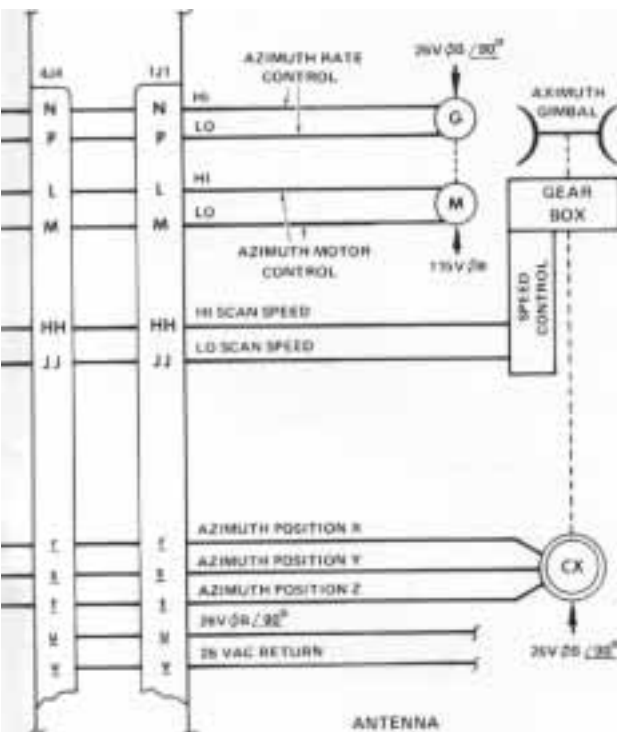
The fault isolation *switch* and indicator are located on the R/T *unit* in the nose *wheel well*.

If the R/T fail light on the radar set control cannot be extinguished by any of the above steps, go into the nose wheel well and, with the system still in the mode in which the failure occurred, rotate the FAULT ISOLATION test switch and observe in which of the 12 test positions a failure is indicated on the test meter.

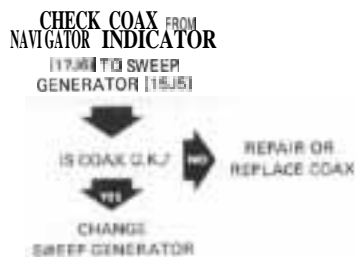
TROUBLESHOOTING CHART 11

Problem: No video on the pilot's indicator. Sweep and range marks are normal.

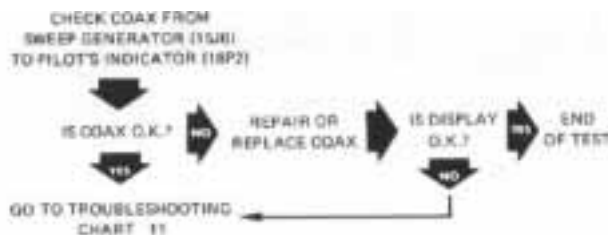
TROUBLESHOOTING CHART 12

Problem: No video or range marks on the pilot's indicator. Sweep is normal.

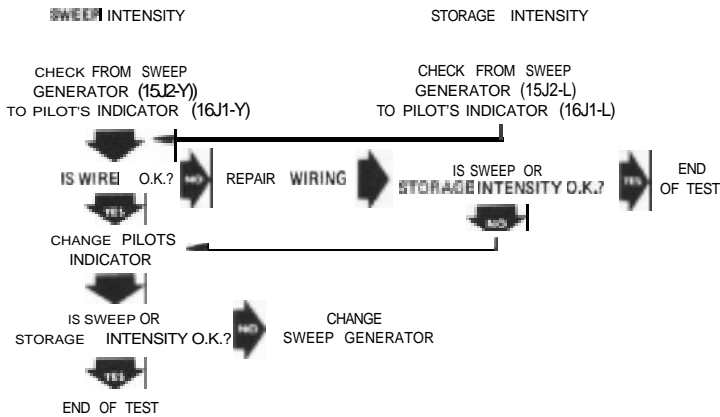
TROUBLESHOOTING CHART 16

Problem: Sweep and storage intensity adjustments.

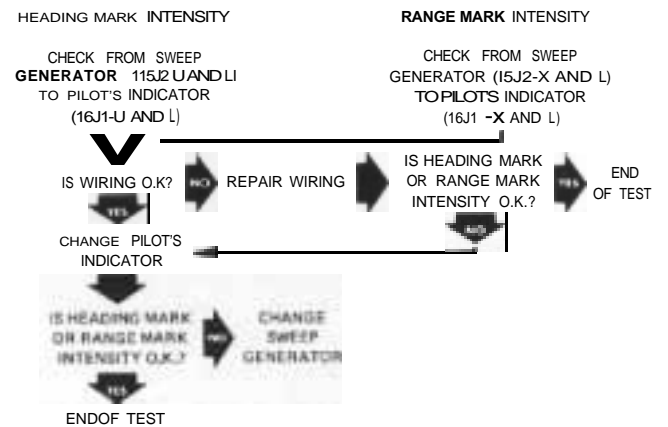
TROUBLESHOOTING CHART 17

Problem: Heading mark and range mark intensity adjustments.

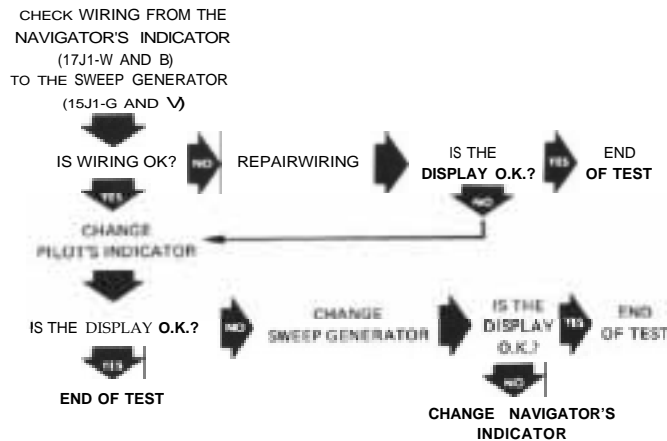
TROUBLESHOOTING CHART 18

Condition (a): AZ STAB switch is in the SLV position. There is no sweep on the pilot's indicator but the navigator's indicator does have sweep.

Go to Troubleshooting Chart 13. If there is no sweep in one position only of the switch, continue with Chart 18 or 19 procedure. In either of the preceding conditions, note that the navigator's indicator does have sweep.

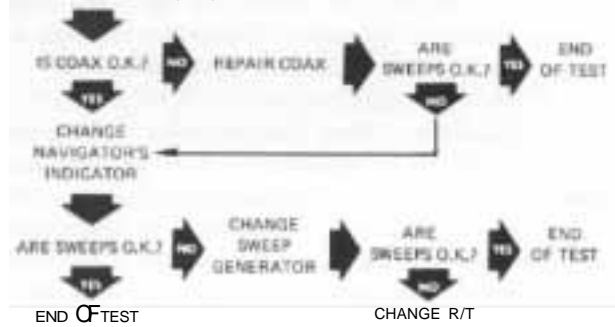
TROUBLESHOOTING CHART 23

CHECK COAX FROM R/T (7J31 TO NAVIGATOR'S INDICATOR (17J4) AND FROM NAVIGATOR'S INDICATOR (17J5) TO SWEEP GENERATOR (15J4)

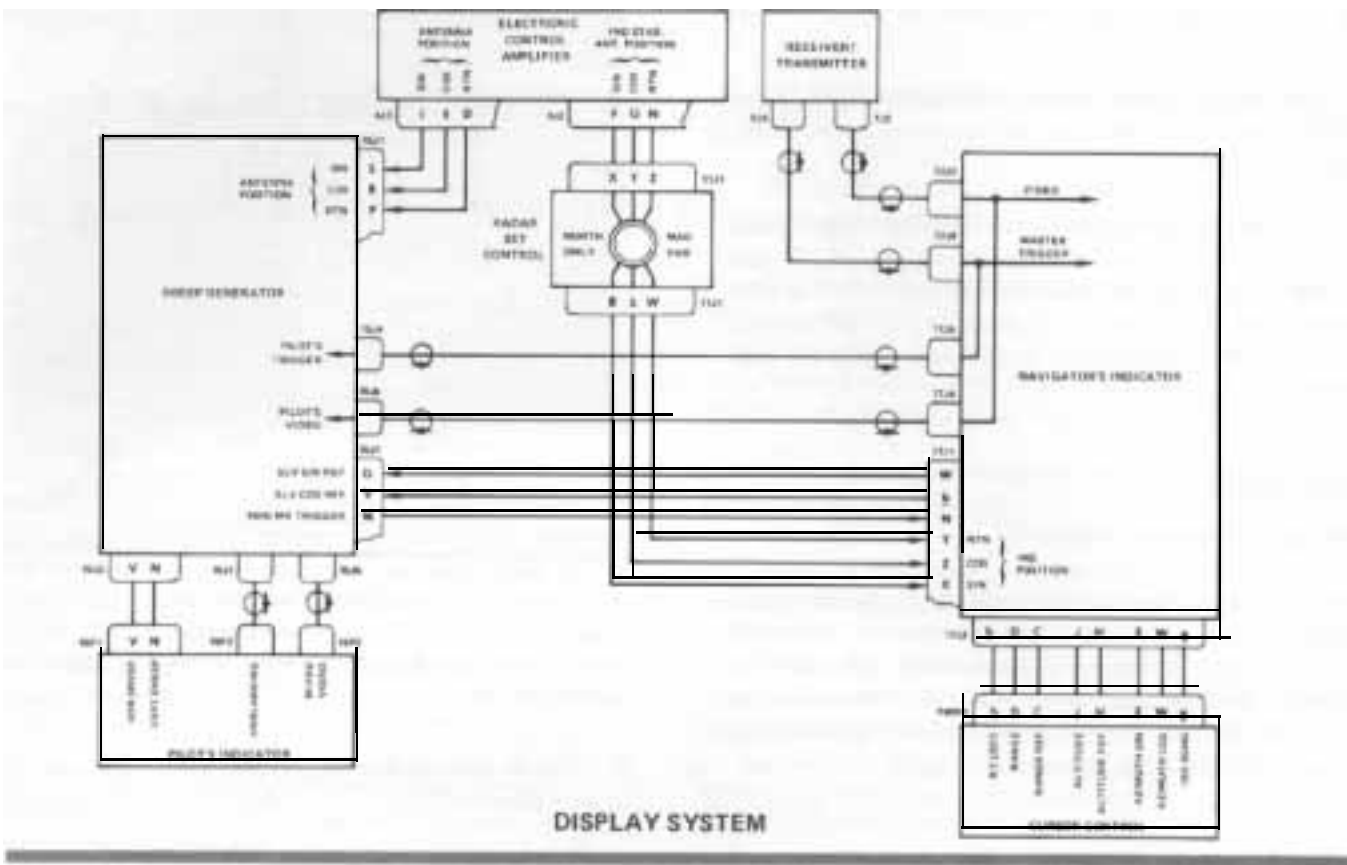
Figure 3. Location of navigator's indicator adjustment points.

3. Adjust the relative bearing control on the antenna control panel to 0°.
4. Adjust potentiometer A1 8A1 R3 (Figure 3) to center the vertex of the vertical sweep (cosine adjustment).
5. On the antenna control panel rotate the relative bearing control to 90°.
6. Adjust potentiometer A1 8A2R3 (Figure 3) to center the vertex of the horizontal sweep (sine adjustment).
7. On the antenna control panel rotate the relative bearing control to 0°, and adjust potentiometer A18A1R73 (Figure 3) until the entire fifth range mark appears at the edge of the display.

8. Rotate the relative bearing control on the antenna control panel to 180', and check that the fifth range mark appears at the same relative position at the bottom of the display. It may be necessary to adjust potentiometers A18A1R3 and A18A1R73 (Figure 3) to fine adjust the sweep in the vertical plane.

9. On the antenna control panel, rotate the relative bearing control to 90', and adjust potentiometer A18A2R73 (Figure 3) until the entire fifth range mark appears at the edge of the display.

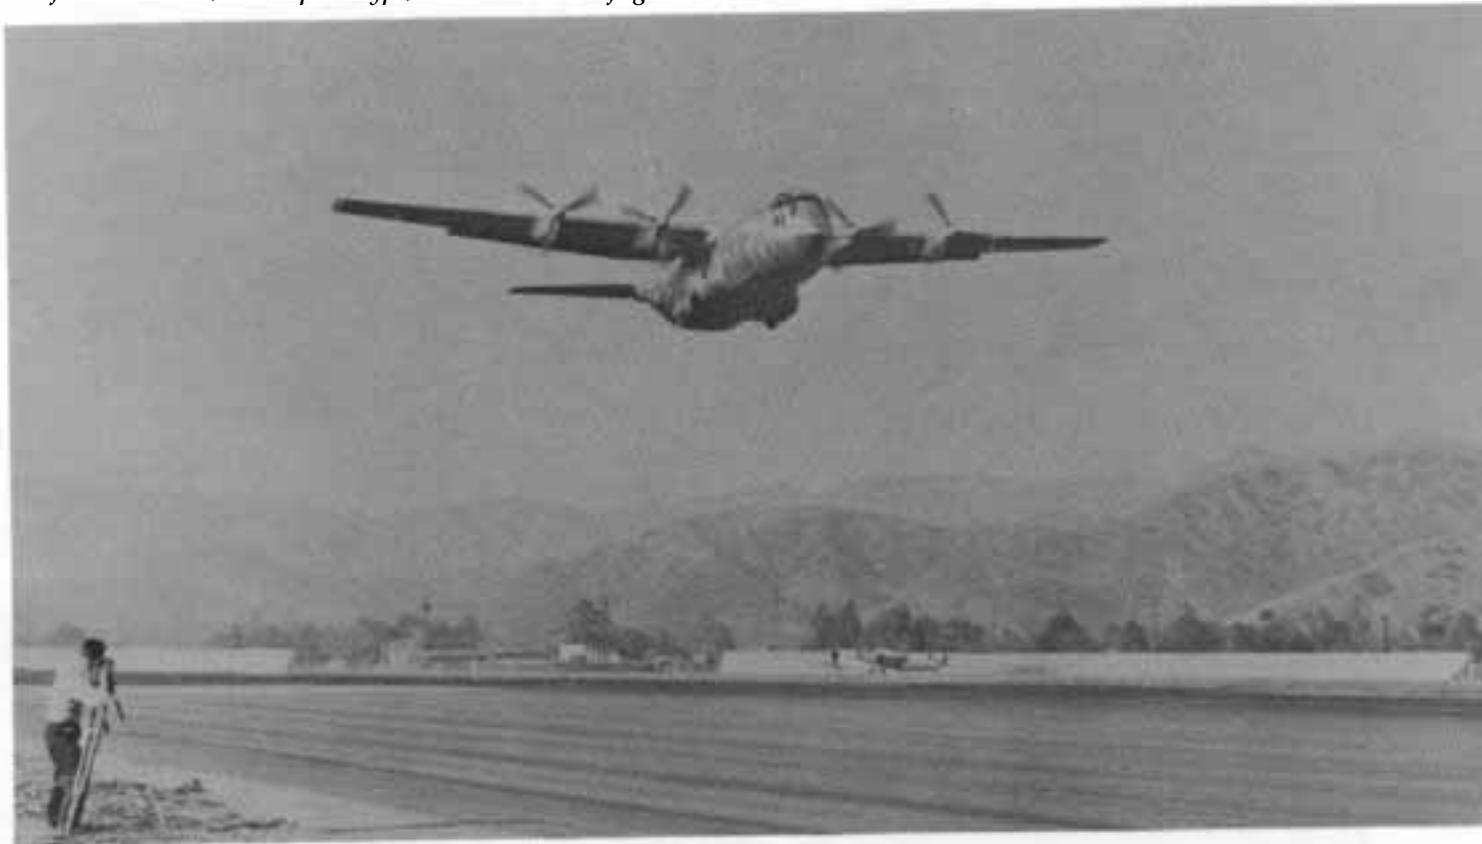
Taking off *from the Burbank airport,*
the first Hercules (YC-130 prototype) makes its maiden flight.

The initial flight of the Hercules prototype took place on August 23, 1954: and lasted 61 minutes. It took the aircraft from the Lockheed Air Terminal at Burbank to Edwards Air Force Base, where the airplane was to be evaluated by the IISAF.

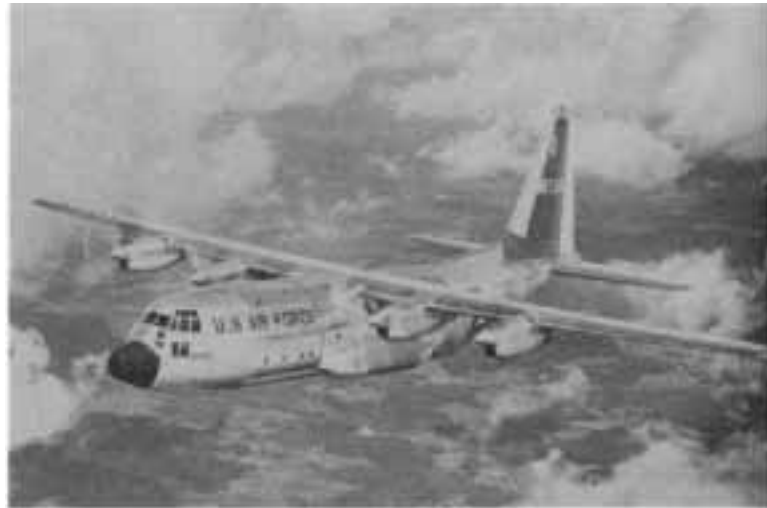
An early B model Hercules.

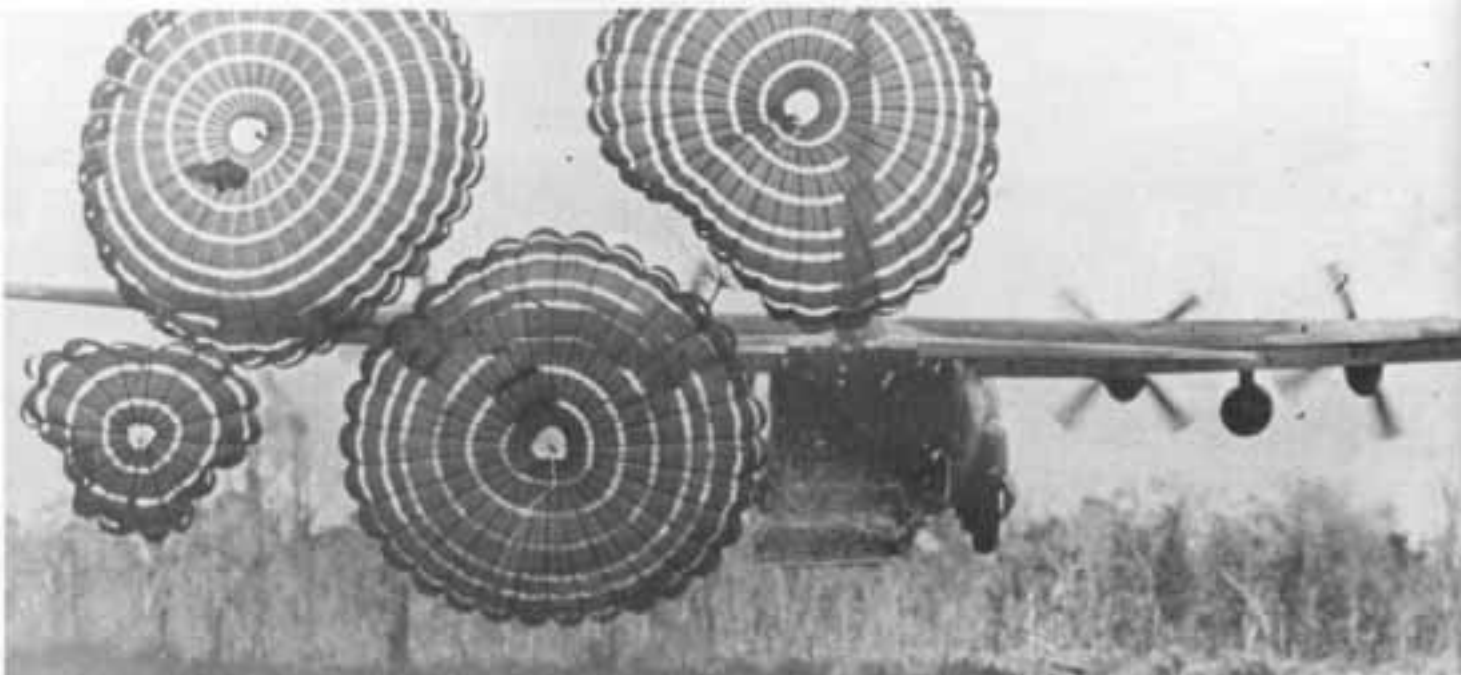
Precision low-level cargo delivery is made possible by utilizing the low altitude parachute extraction system (LAPES).

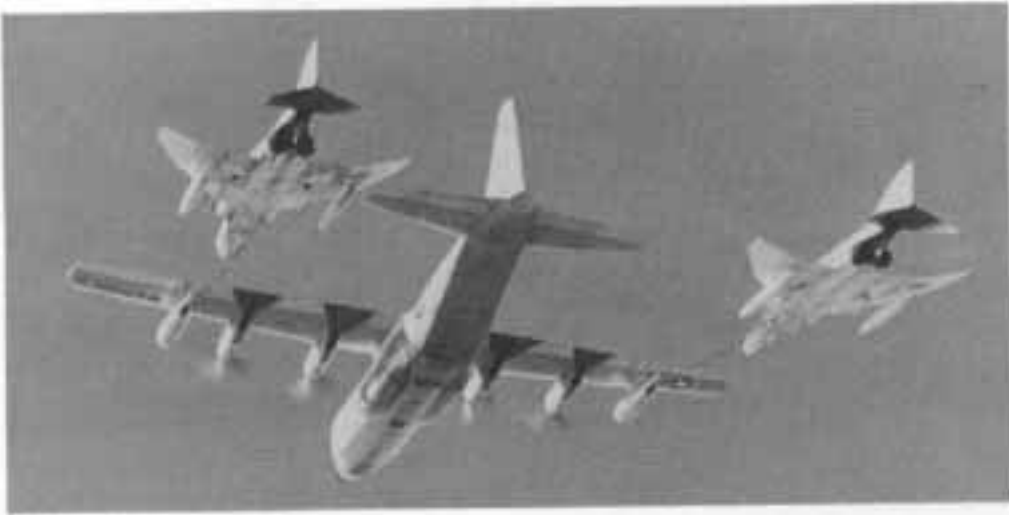
U.S. Marine Corps KC-130F refueling two F4Hs.

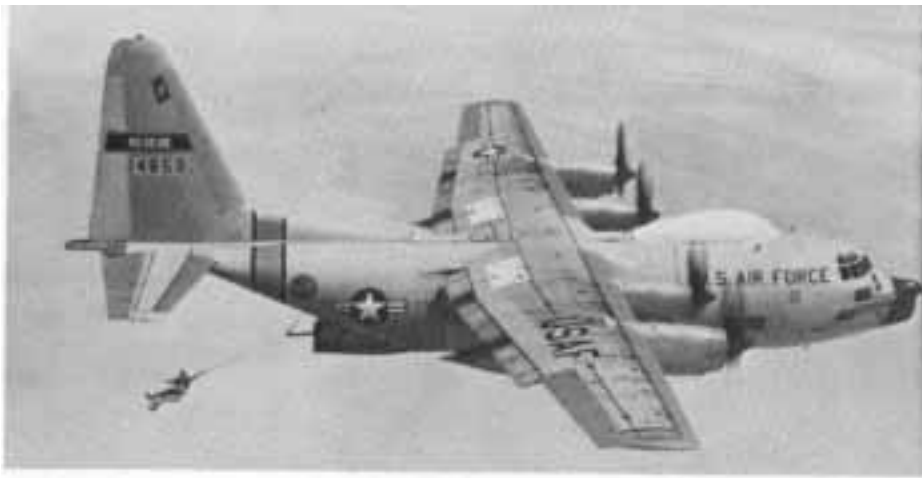
An Air Rescue Service Hercules demonstrates *an* inflight pickup of personnel *from the* surface.

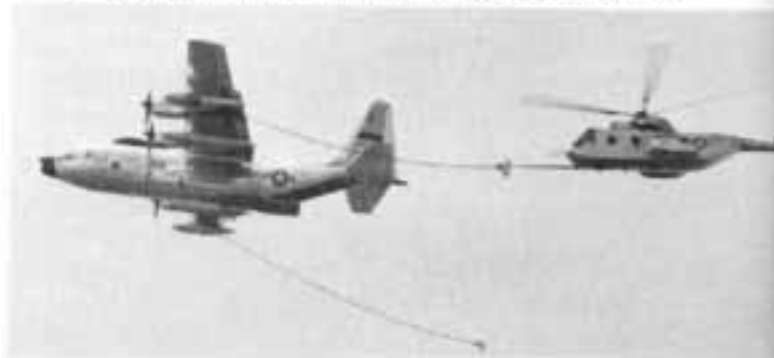
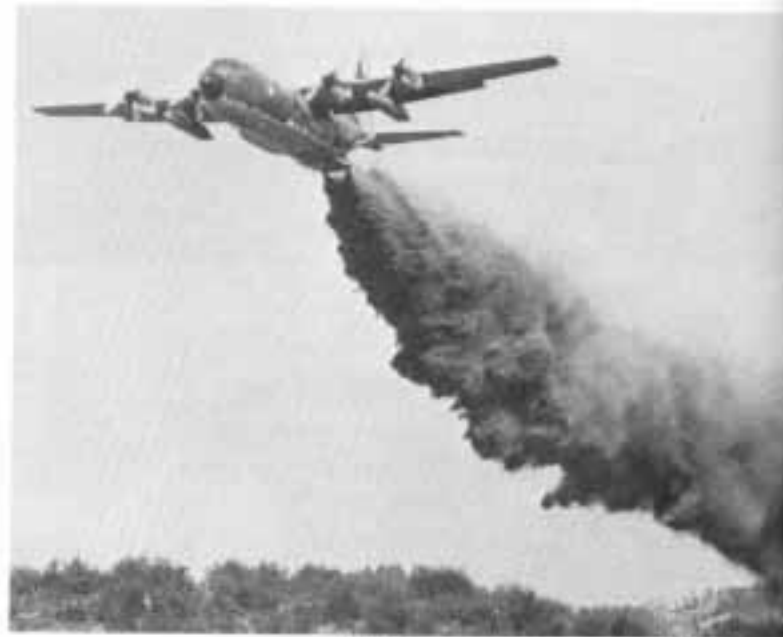
An Air Rescue and Recovery Service HC-130P refuels a helicopter. Below: Installation of a modular airborne fire fighting system converts the Hercules into a water bomber.

The Hercules has also been converted into an aerial fire truck, spraying 3000 gallons of fire retardant in a 150-foot wide by 2000-foot long path in less than six seconds. Again, it is obvious that the Hercules derivatives have **been** used in many wide-range and valuable services.

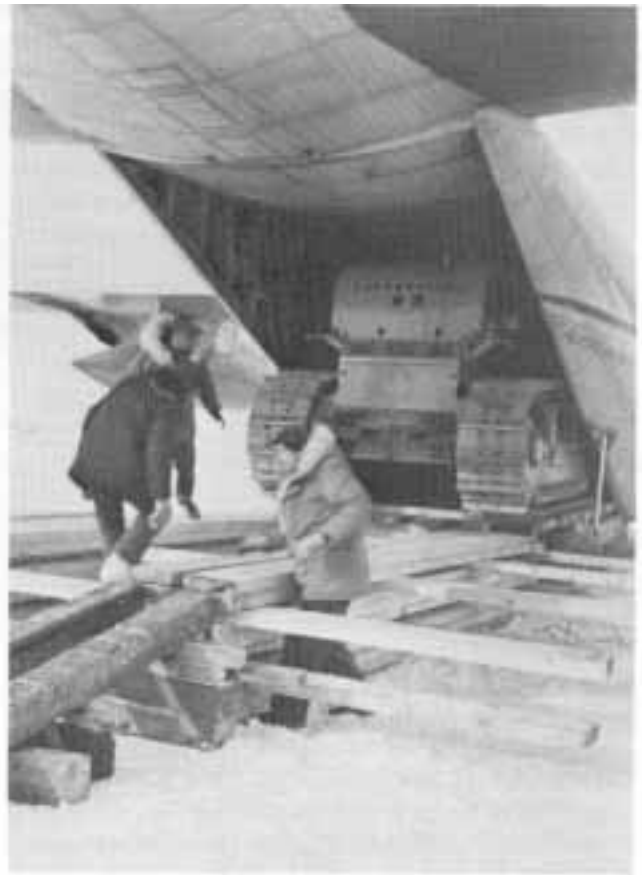
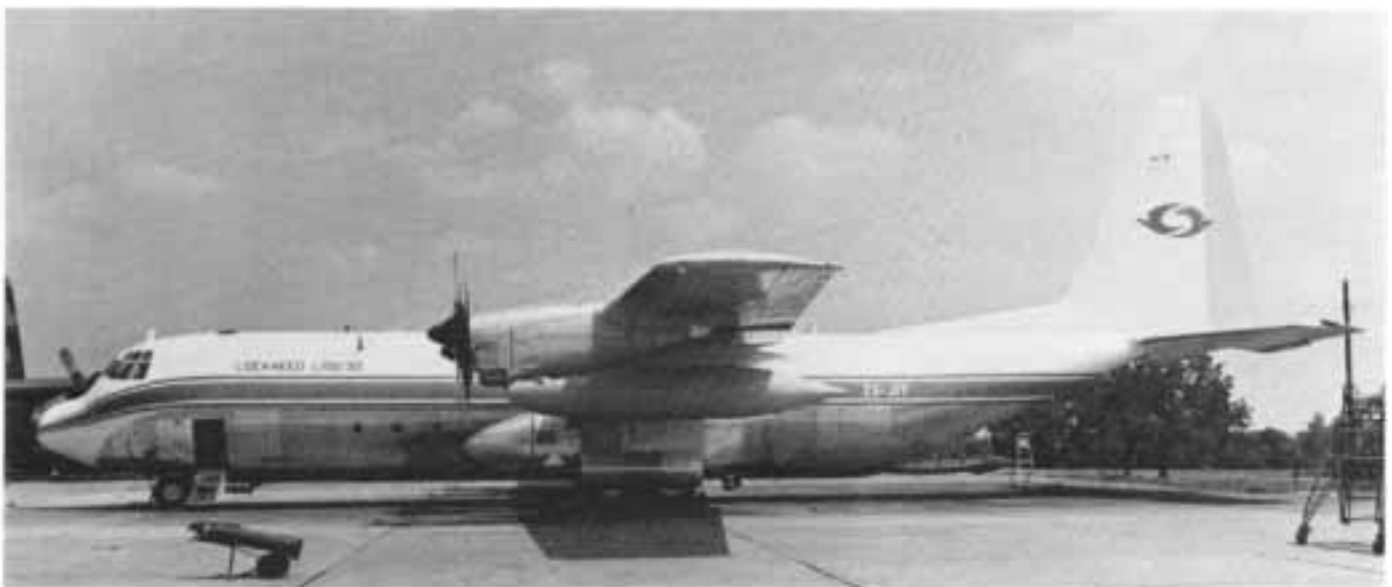
Above: The Hercules delivering *heavy* equipment to the North Slope in Alaska. Below: The L-100-30 stretch model of the Hercules.

To give the Hercules even better operating economics in the civil role, Lockheed embarked on a stretched version during 1967: the L-100-20. Extra fuselage sections were added ahead of and behind the wing, increasing the fuselage length by 8 feet, 4 inches. This expanded the L100 to the point where seven pallets could be accommodated. One of the major applications of the L-100 at this time came as a result of the oil exploration activities on the Alaskan North Slope. Here the Hercules proved ideal because of its ruggedness, its ability to operate from rough terrain and small areas, and its capacious cargo hold. Further stretching resulted in the L-100-30 which would accommodate eight pallets or more, and longer outsize loads.

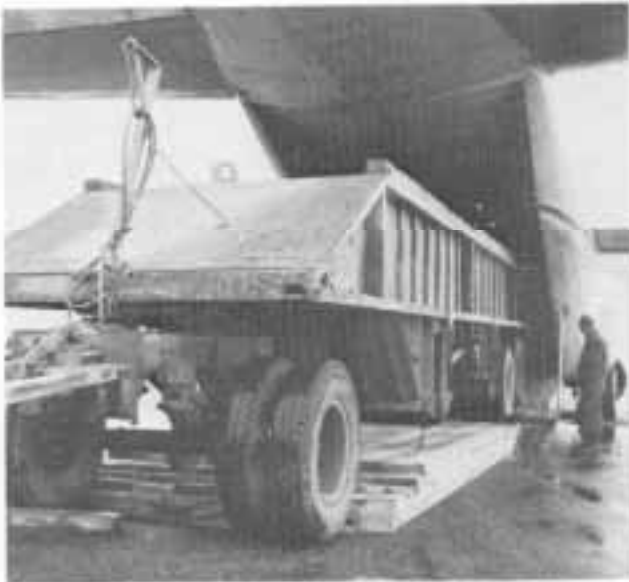
The Hercules cargo compartment can accommodate a variety of cargo.

Loads regularly flown by the Hercules include such weighty and bulky items as bulldozers, road graders, trucks, aircraft engines, and road tankers filled with fuel. Other cargo has included livestock, airplanes with wings stowed separately, helicopters with rotors removed, jeeps, tanks, a mobile dispensary and clinic, fuel drums, sacks of grain, water purification equipment, and cargo pallets.

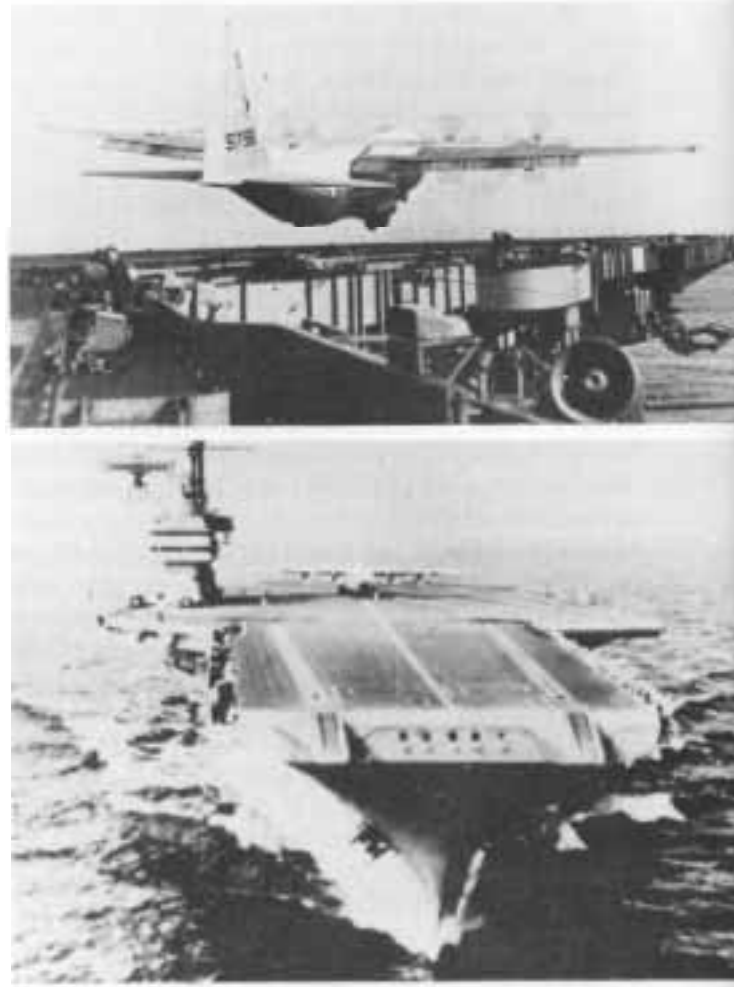
The Hercules in trial operations from the deck of the U.S.S. Forrestal.

Speaking of record books, perhaps this is the place to set down the Hercules' records to date. As mentioned earlier, the Hercules was the largest aircraft ever to land on, or take off from, an aircraft carrier. A USMC KC-130F set the record in 1963 making 29 touch-and-go landings and 21 unarrested, full stop landings and takeoffs on the U.S.S. *Forrestal*. The Hercules is also the largest operational ski-and-wheel equipped aircraft. As such, it holds all the skilift records for transports. For example, it is the largest plane ever to operate from the 10,000-foot high runway at the South Pole. The ski equipment has also allowed it to venture to places which were previously unreachable by air.

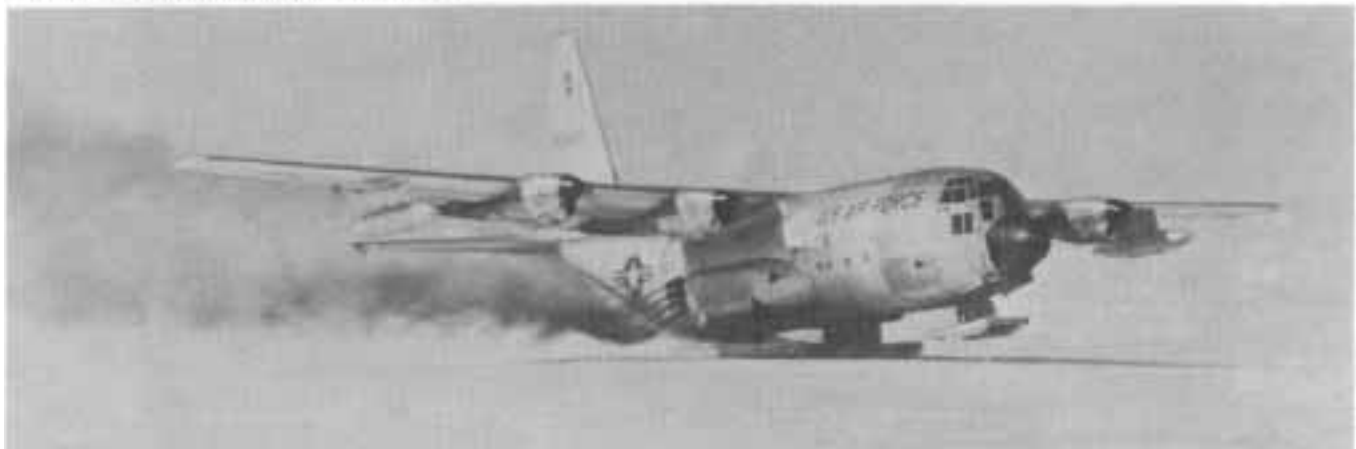
The skibird version of the Hercules taking off with JATO assistance.

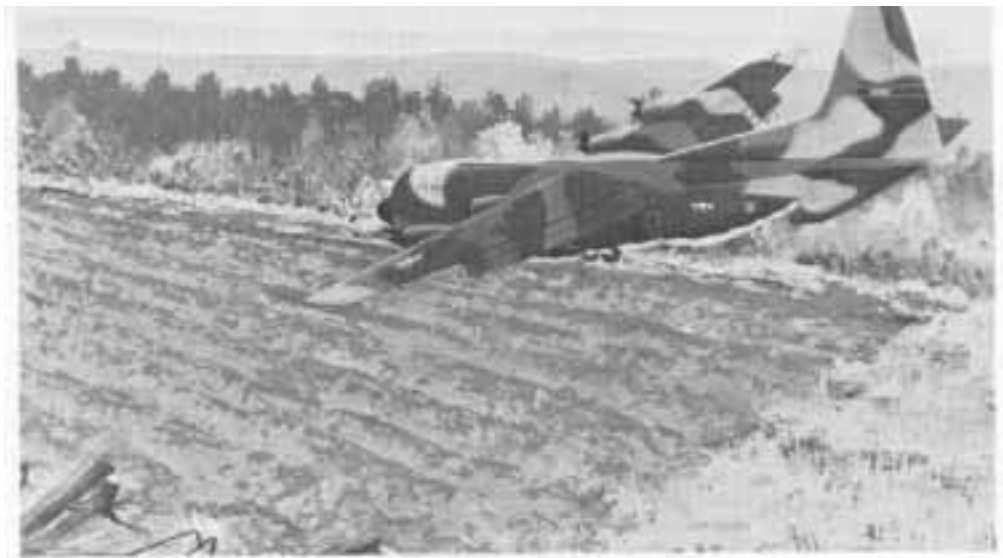
*A proposed Hercules version, the C-1 30SS (stretch/STOL).
Below: The L-400; a two-engine derivative of the Hercules.*

However, since they may still be in line for future development, some of the versions which have not yet taken concrete form should be discussed here. Several STOL (short takeoff and landing) versions have been proposed at different times. The latest one is the C-130SS, the stretch/STOL. The SS features an elongated fuselage (8.3 feet longer), greater payload, and modifications giving it true STOL capabilities. Research, design and wind tunnel evaluations have shown that the stretch/STOL Hercules would be the most cost-effective replacement for the C-130 now in service.
