Prepared by:
AECOM
Latham, NY

2014 Revised Restoration Work Plan

West Branch of Bloody Brook Bloody Brook Voluntary Cleanup Program Onondaga County, New York

August 2014

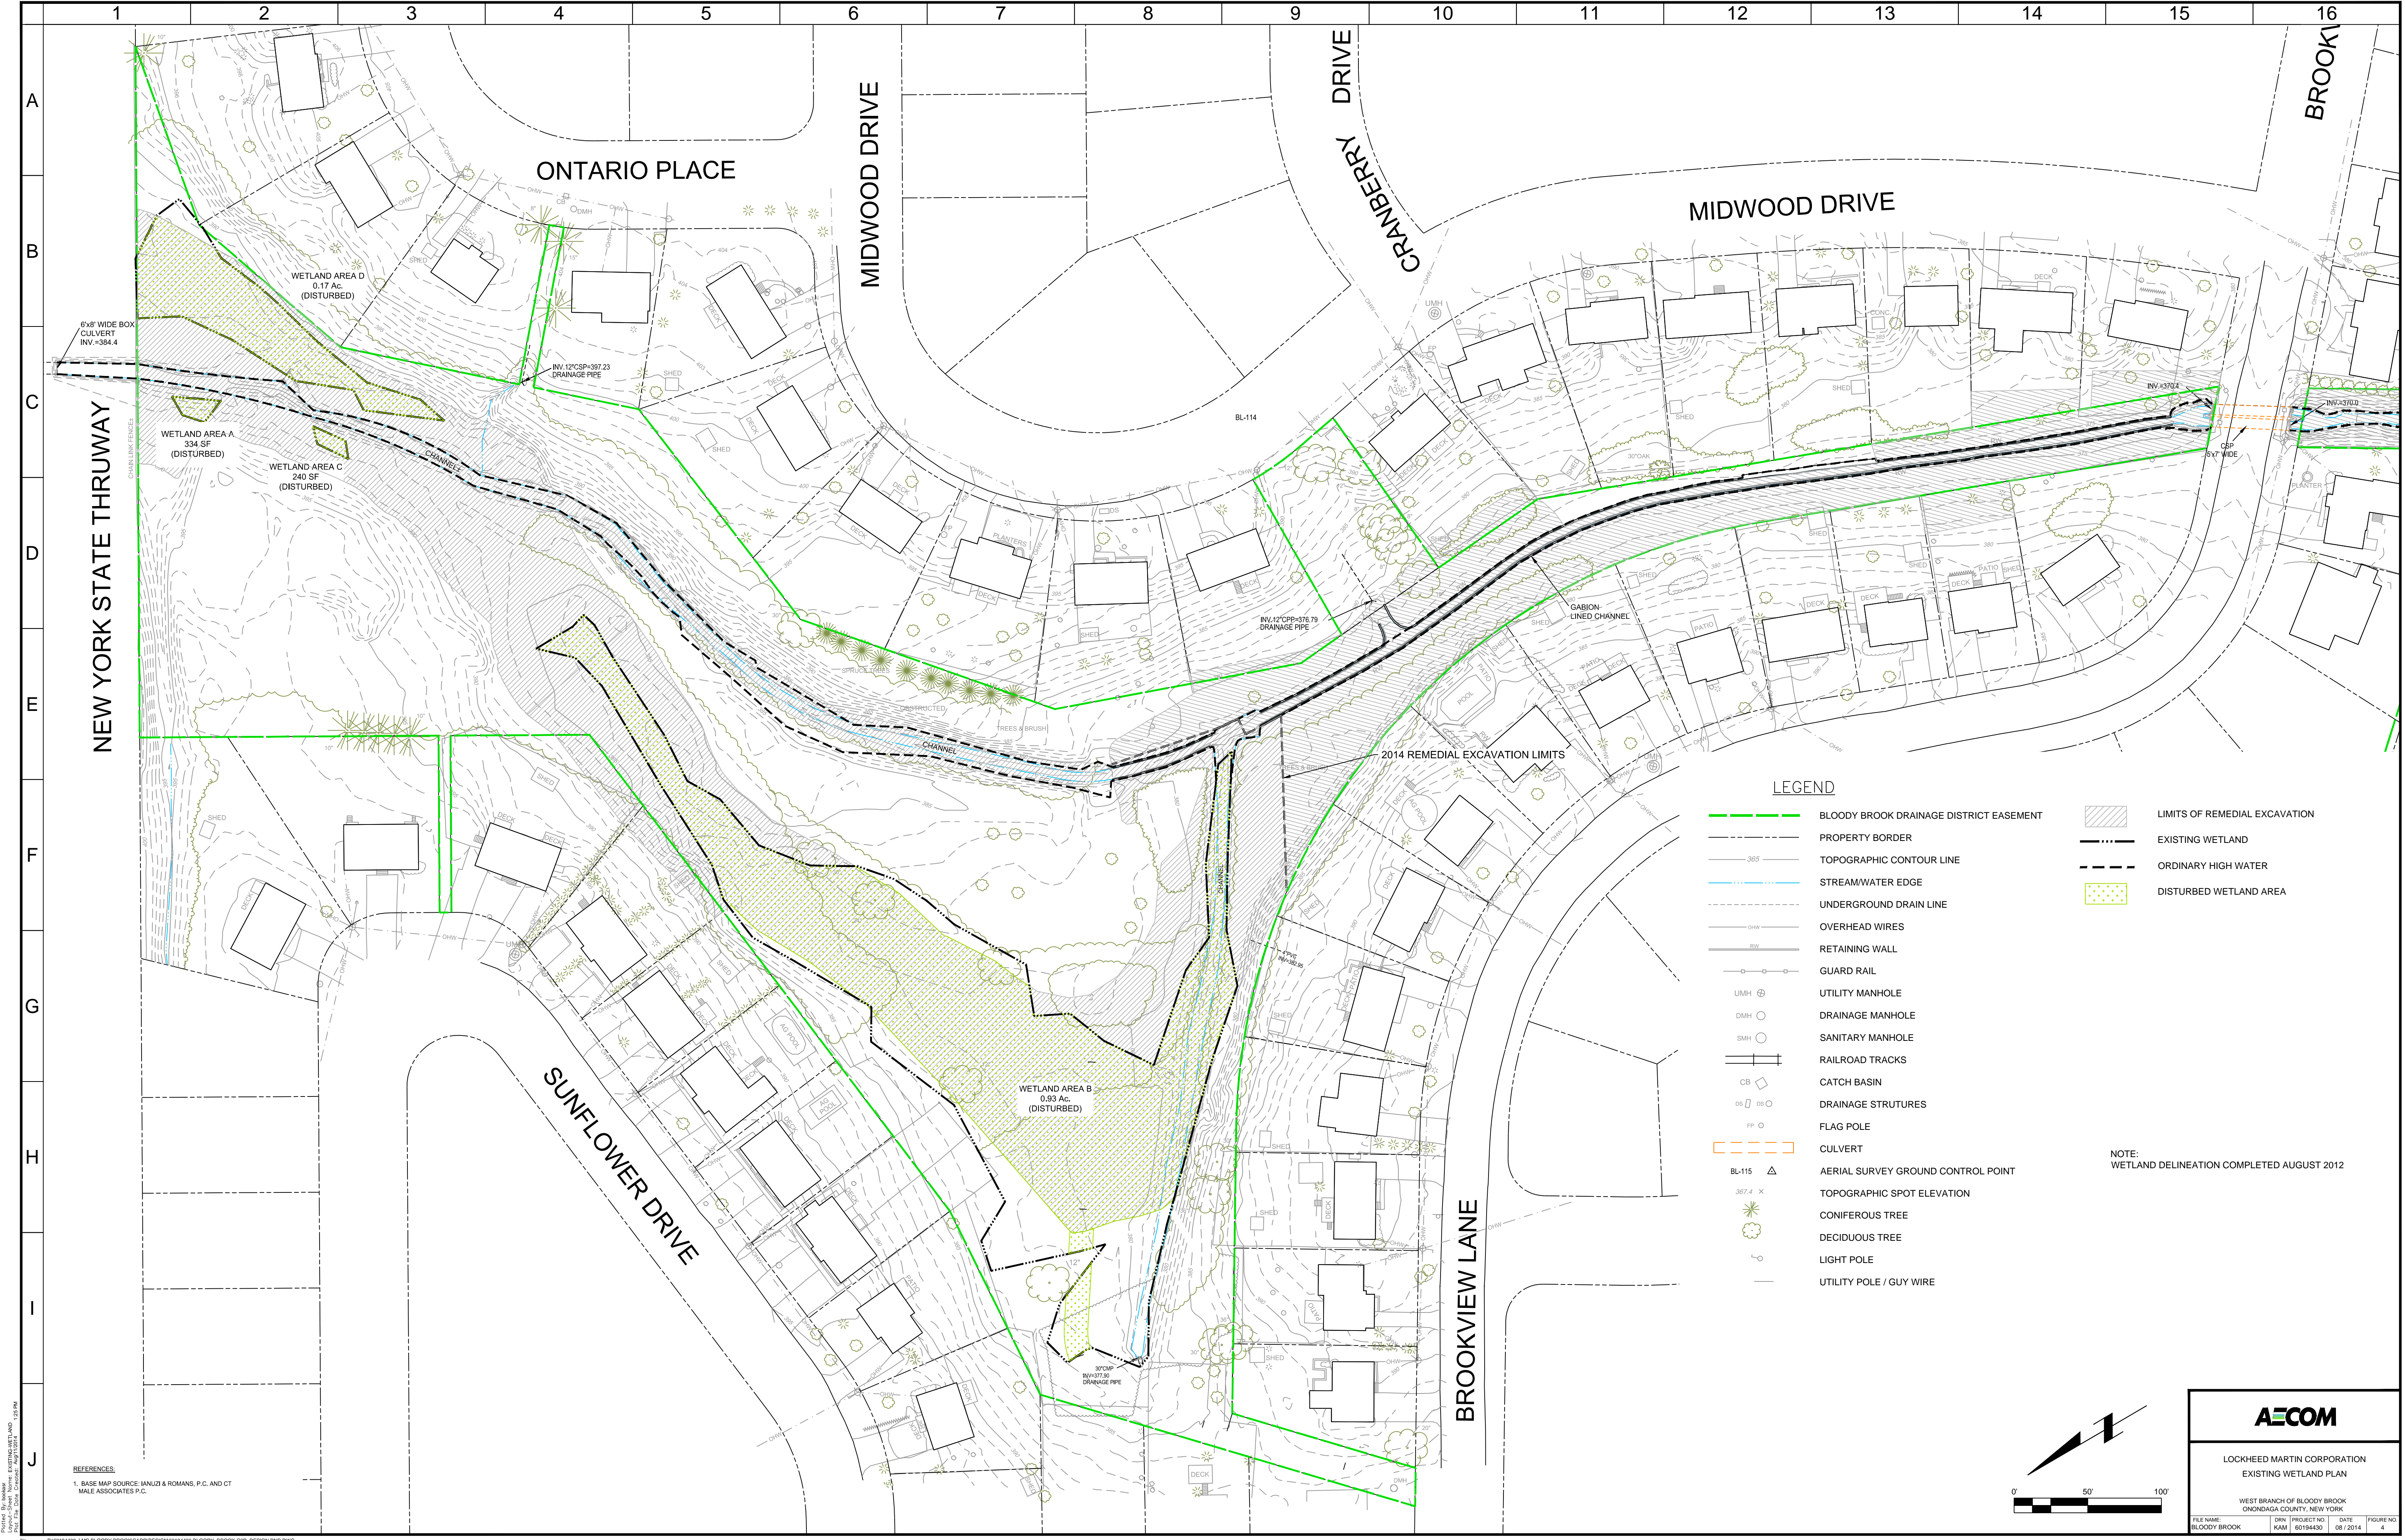
FILE NAME: BLOODY BROOK
PROJECT NO: 60164630
DATE: 08/2014
FIGURE NO: 3

The wooded area is the largest area to be disturbed (approximately 2.8 acres). The wooded area consists of several vegetation cover types presented below. These areas have been located and defined during the October 2013 ecological survey. A brief summary of each cover type is provided below and the locations of the cover types are shown on Figure 3.

LOCKHEED MARTIN CORPORATION
PROPOSED WETLAND PLAN WITH
EXISTING MAPPED HABITAT
WEST BRANCH OF BLOODY BROOK
ONONDAGA COUNTY, NEW YORK

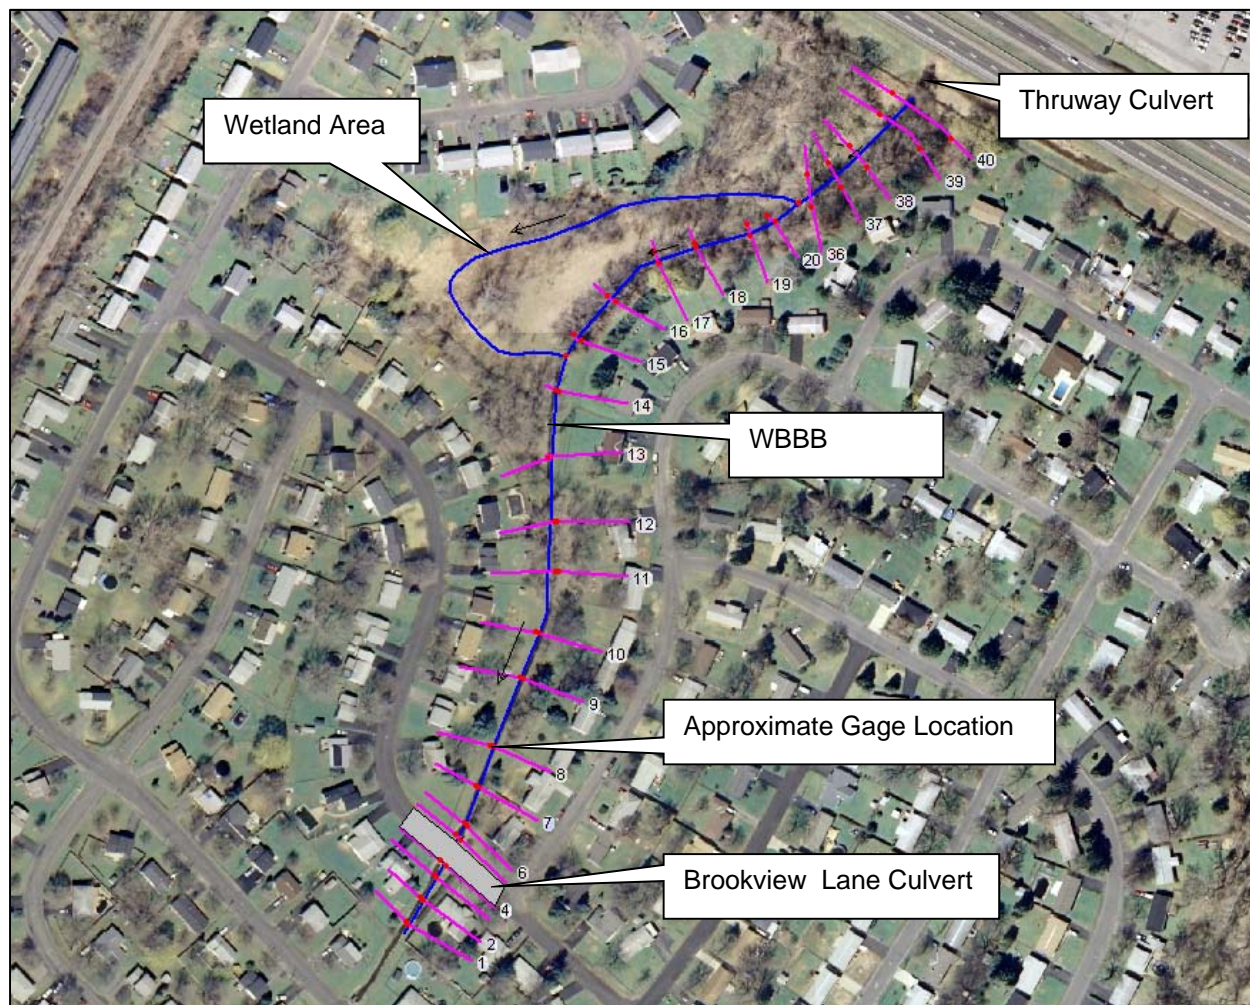
Figure 6
Existing Conditions HEC-RAS Model Extent
Hydraulic Analysis
West Branch of Bloody Brook
Bloody Brook Voluntary Cleanup Program
Onondaga County, New York

The existing conditions model was constructed using the HEC-GeoRAS toolkit for ArcGIS. HEC-GeoRAS is able to process geospatial data and create importable HEC-RAS geometry data. A three-dimensional surface generated from the existing conditions survey was imported into HEC-GeoRAS (AECOM, 2013). The center lines for the main channel and the wetland and cross-sectional cut lines were traced within ArcGIS. HEC-GeoRAS exports the cross-sectional elevation data and calculates the reach lengths to enable a clean import into the HEC-RAS model. Figure 6 shows the extent of the existing conditions model.

1. Red lines indicate location of cross sections used during analysis (see Appendices)
2. Wetland Area flow shown occurs during high storm events

The existing conditions model was calibrated to a single data point recorded during an August 2013 site visit. During the site visit, a water depth of 0.7 feet and a velocity of 0.40 feet per second were recorded at the gage location. Assuming a rectangular channel shape with a 5 foot width, the flow was calculated to be 1.4 cfs. The HEC-RAS model was given a flow of 1.4 cfs at the gage location and the channel roughness value was adjusted until the model predicted a flow depth of 0.7 feet at the gage location. A main channel Manning's roughness of 0.095 was needed to achieve the recorded depth of 0.7 feet at a flow of 1.4 cfs. While this roughness value is higher than typical values used for constructed channels, the gabion baskets and the jagged nature of the stones within them, along with debris present in the channel (see Figure 3), may be contributing to a higher than typical roughness value for the main channel.
