SERVICE NEWS

Vol. 8, No. 3, July -September 1981
CONTENTS

Aft Cargo Door Uplock Binding

by William B. Maddox, *Senior Aircraft Design Engineer*

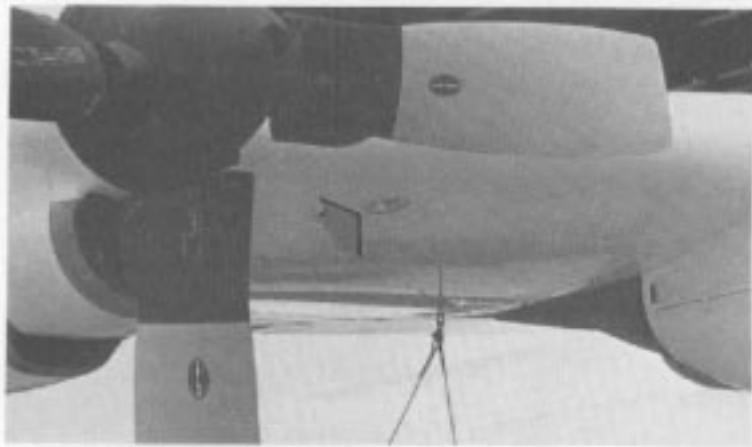
Hercules aircraft are equipped with two main landing lights, one located on the lower surface of each wing between the nacelles (Figure 1). They seldom require much attention beyond the occasional replacement of a burned-out lamp, but sometimes a landing light assembly is damaged, or found to be corroded or worn. In such cases, it may be necessary to remove the entire assembly for replacement or repair.

Figure 1 (left). Landing light location on E- and H-model Hercules aircraft. Figure 2 (right). Installed landing light in retracted position.

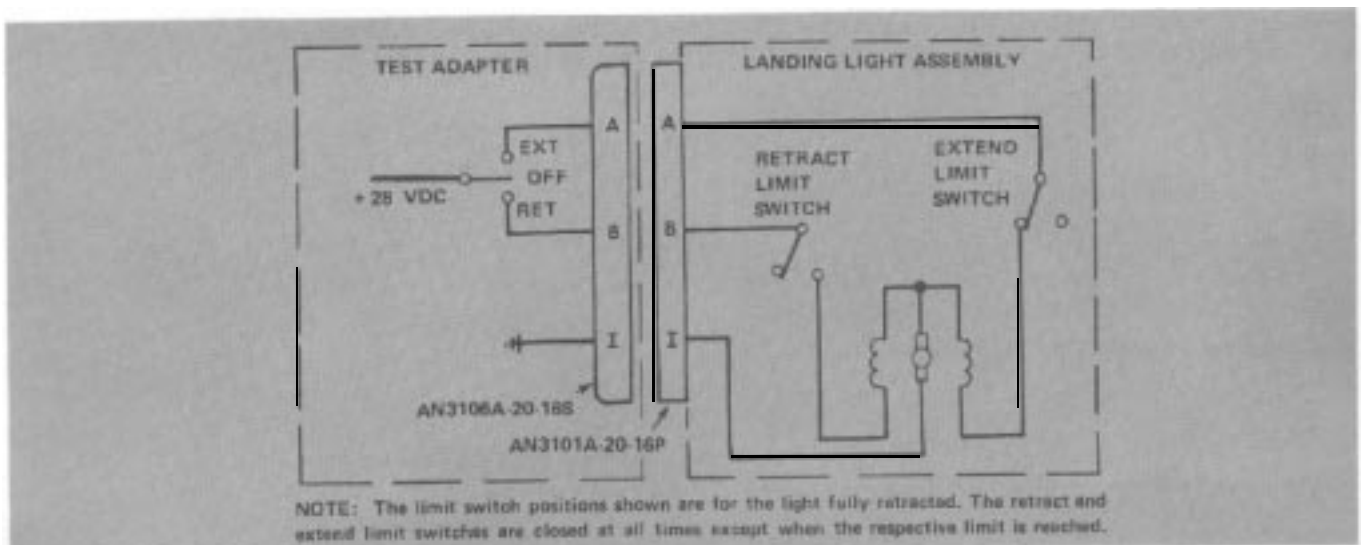
Figure 3. Schematic diagram of test adapter and landing light extend and retract circuits.

schematically in Figure 3. The actual construction details can be varied to suit the user, but the materials for the tester will include an AN3106A-20-16s connector or the equivalent, a three-position switch, and suitable wiring connections.

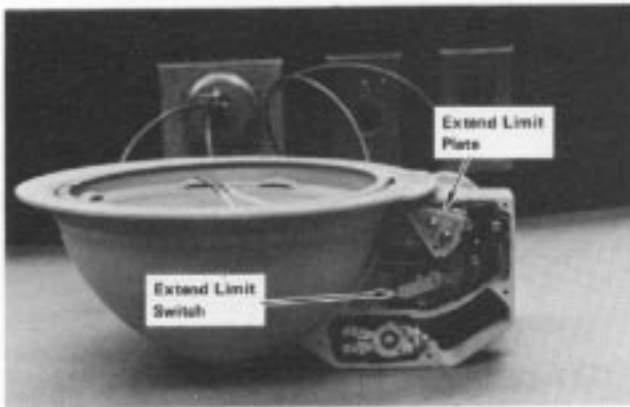
Figure 5. Unit with side cover removed

Remove the side cover to expose the extend limit plate and the extend limit switch (Figure 5). Supply 28 VDC power, using the test adapter described above.

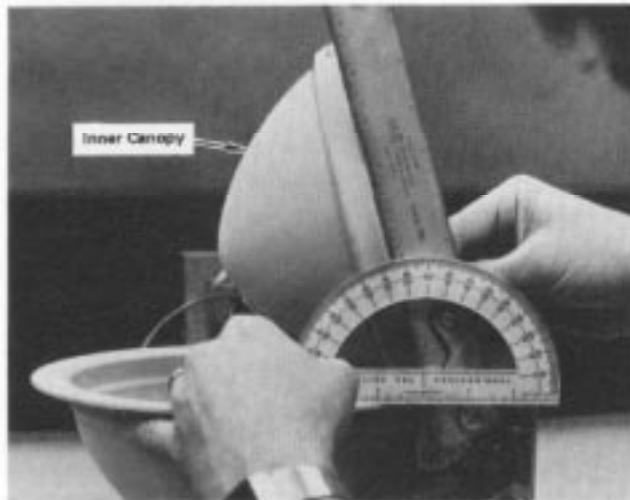
Figure 6. Inner canopy extended to preset angle of 74 (+1) degrees.

Move the switch of the test adapter to its extend position so that 28 VDC power is supplied through the extend limit switch to the motor. This will extend the inner canopy to the 74 (+/-1) degree extend angle which was preset by the vendor (Figure 6). Note that it will be easier to make the necessary angle measurements in the following steps if a lamp is installed in the light assembly (Figure 7). If a lamp is not installed, the retainer ring on the inner canopy must be held in the position it would normally occupy when the lamp is present. If the retainer ring is not in the correct position, an inaccurate measurement of the extend angle could result.

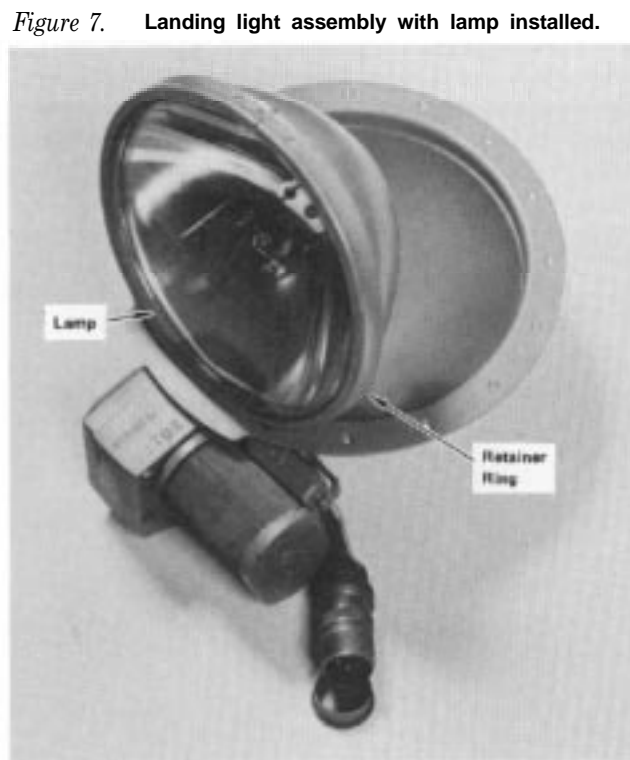
Figure 7. Landing light assembly with lamp installed.

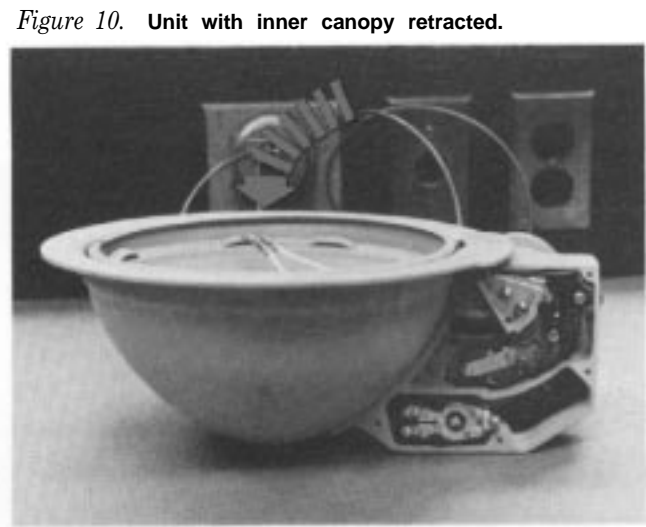
Figure 10. Unit with inner canopy retracted.

If the extend limit plate does not rotate far enough to allow the correct extend angle to be obtained (Figure 9), the extend limit switch itself will have to be adjusted. Before adjusting the extend limit switch, first rotate the extend limit plate clockwise to the approximate position that it had for the 74 degree extend angle. This is done more easily if the inner canopy is retracted before you try to rotate the extend limit plate (Figure 10).

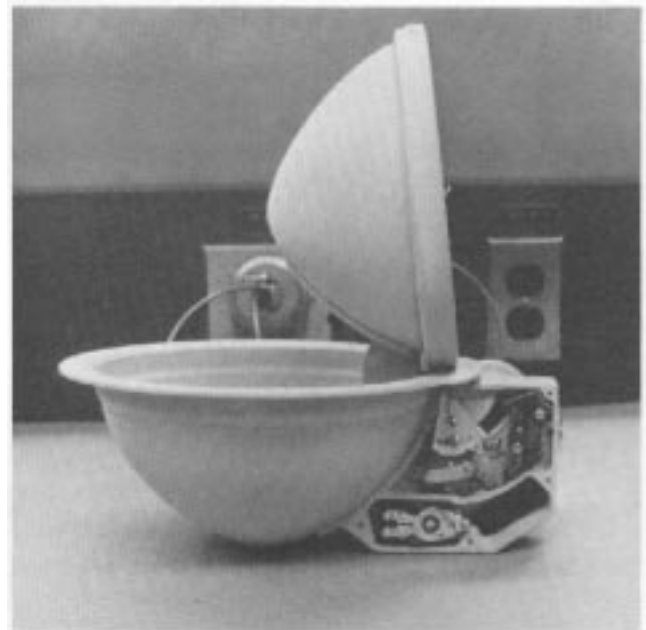
Figure 12. Inner canopy extended after limit switch adjustment.

After the extend limit plate has been repositioned to the 74 degree position, loosen the extend limit switch screw and slide the extend limit switch to the left (Figure 11). Now retighten the extend limit switch screw and extend the canopy (Figure 12). Again attempt to adjust the extend angle to 88 (+/-1) degrees by rotating the extend limit plate counterclockwise, as previously described. If an extend angle of 88 (+/-1) degrees still cannot be obtained, the extend limit switch will have to be moved farther to the left.

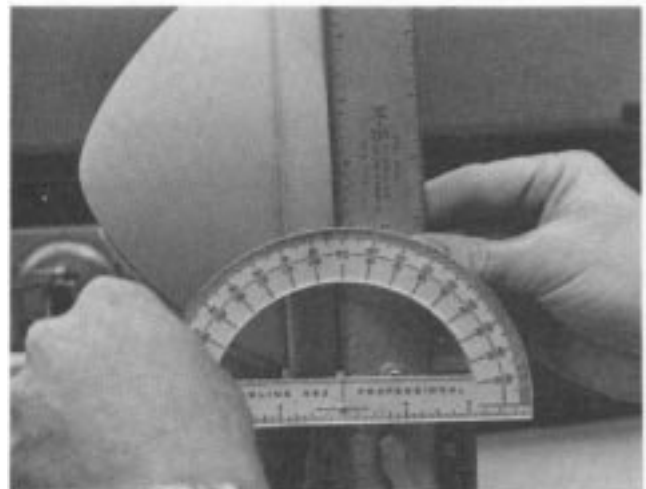
Figure 13. Landing light properly adjusted for A-model aircraft (see text for other models).

When an extend angle of 88 (+/-1) degrees has been reached (Figure 13), ensure that both screws loosened during this procedure have been retightened, and then reinstall the side cover. Now retract the canopy and remove the test adapter. The landing light assembly is now properly adjusted and ready for installation in the aircraft.
