A SERVICE PUBLICATION OF LOCKHEED AERONAUTICAL SYSTEMS COMPANY-GEORGIA

NESA WINDOWS

Vol. 15, No. 1, January-March 1988

NESA WINDOWS: All About Electrically Heated Glass

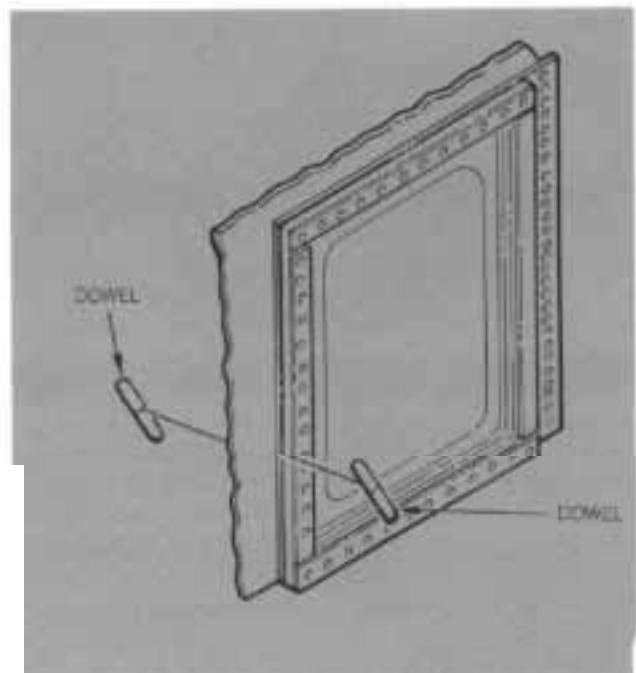
Figure 11. Window removal tool (locally manufactured).

Several maintenance organizations have reported good results from the use of a simple special tool during window removal. The tool consists of two 4-inch pieces of wooden dowel about the thickness of a broom handle, and a two-foot length of 0.032 safety wire (Figure 11).

To use it, first make a small opening in the sealant between the window and the frame with a putty knife and wedges, and then thread one end of the safety wire through. Secure both ends of the wire to the dowels; one inside the aircraft and one outside. Using a sawing motion, two technicians can then draw the wire all the way around the windshield frame, cutting the old sealant in the process. After the sealant has been cut, a little pressure on the glass will usually remove even the most stubborn panel.

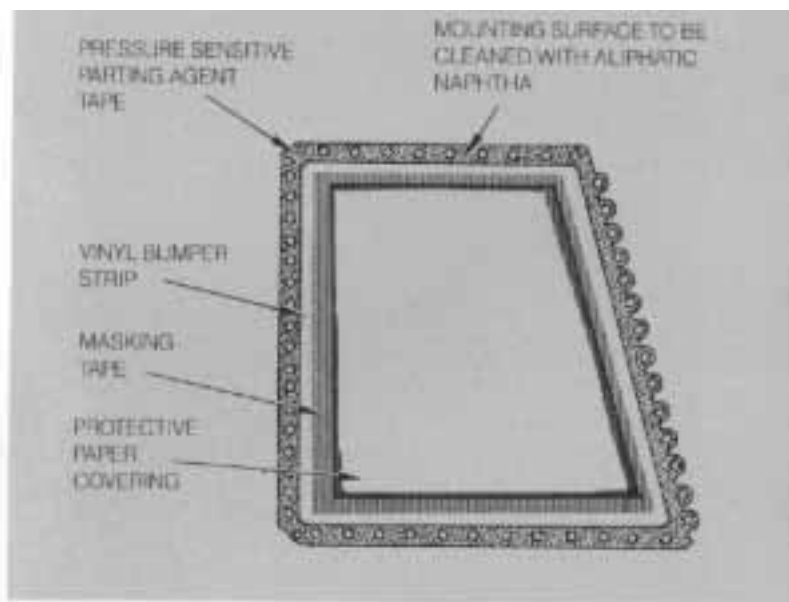
figure 12 Preparing a windshield panel for installation.

Apply 1-inch wide pressure-sensitive parting agent tape to the cleaned mounting surface of the windshield that will come into contact with the windshield frame. It is acceptable to overlap the parting agent tape at the corners, but do not apply tape to the vinyl bumper strip (Figure 12). Trim the parting agent tape to conform to the shape of the windshield.

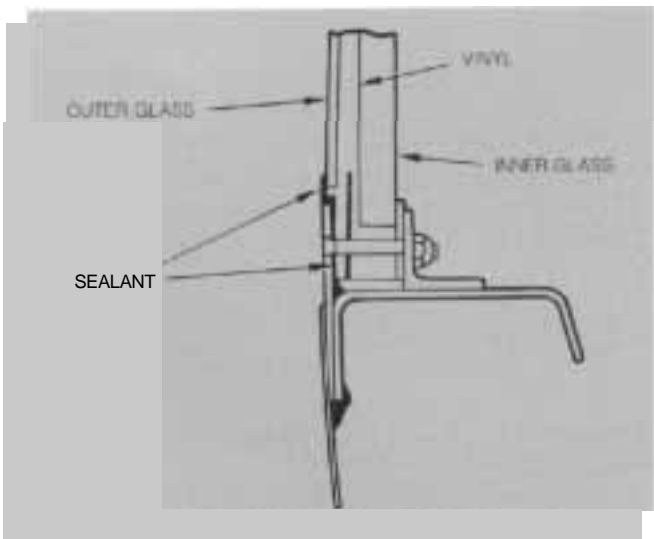
Figure 73. Exterior sealant trim.

Fill all depressions and voids between the airframe and windshield with specification MIL-S-8784, Class B, low-adhesion sealant. Carefully examine the outer surface of the window along the edges of the frame where the vinyl and the outer glass layer meet. Apply sealant as necessary to ensure a smooth, continuous seal between the window frame and the glass insert (Figure 13). Remove any excess.

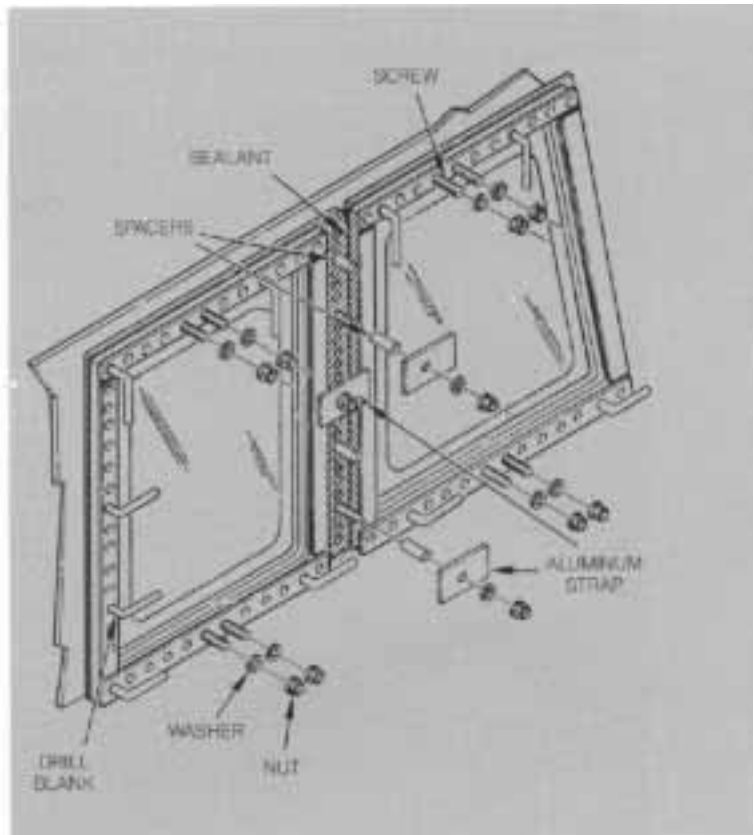
Figure 74. Installation for sealant curing.

Attach an aluminum strap across the joining windshield panel edges on two or more of the temporary screws and torque to 20 inch-pounds (Figure 14). The strap may be fabricated from 0.090-to 0.125inch stock about 1% inches by 2% inches. Now remove the masking tape from the outside skin opening and allow the sealant to cure for a minimum of 24 hours.

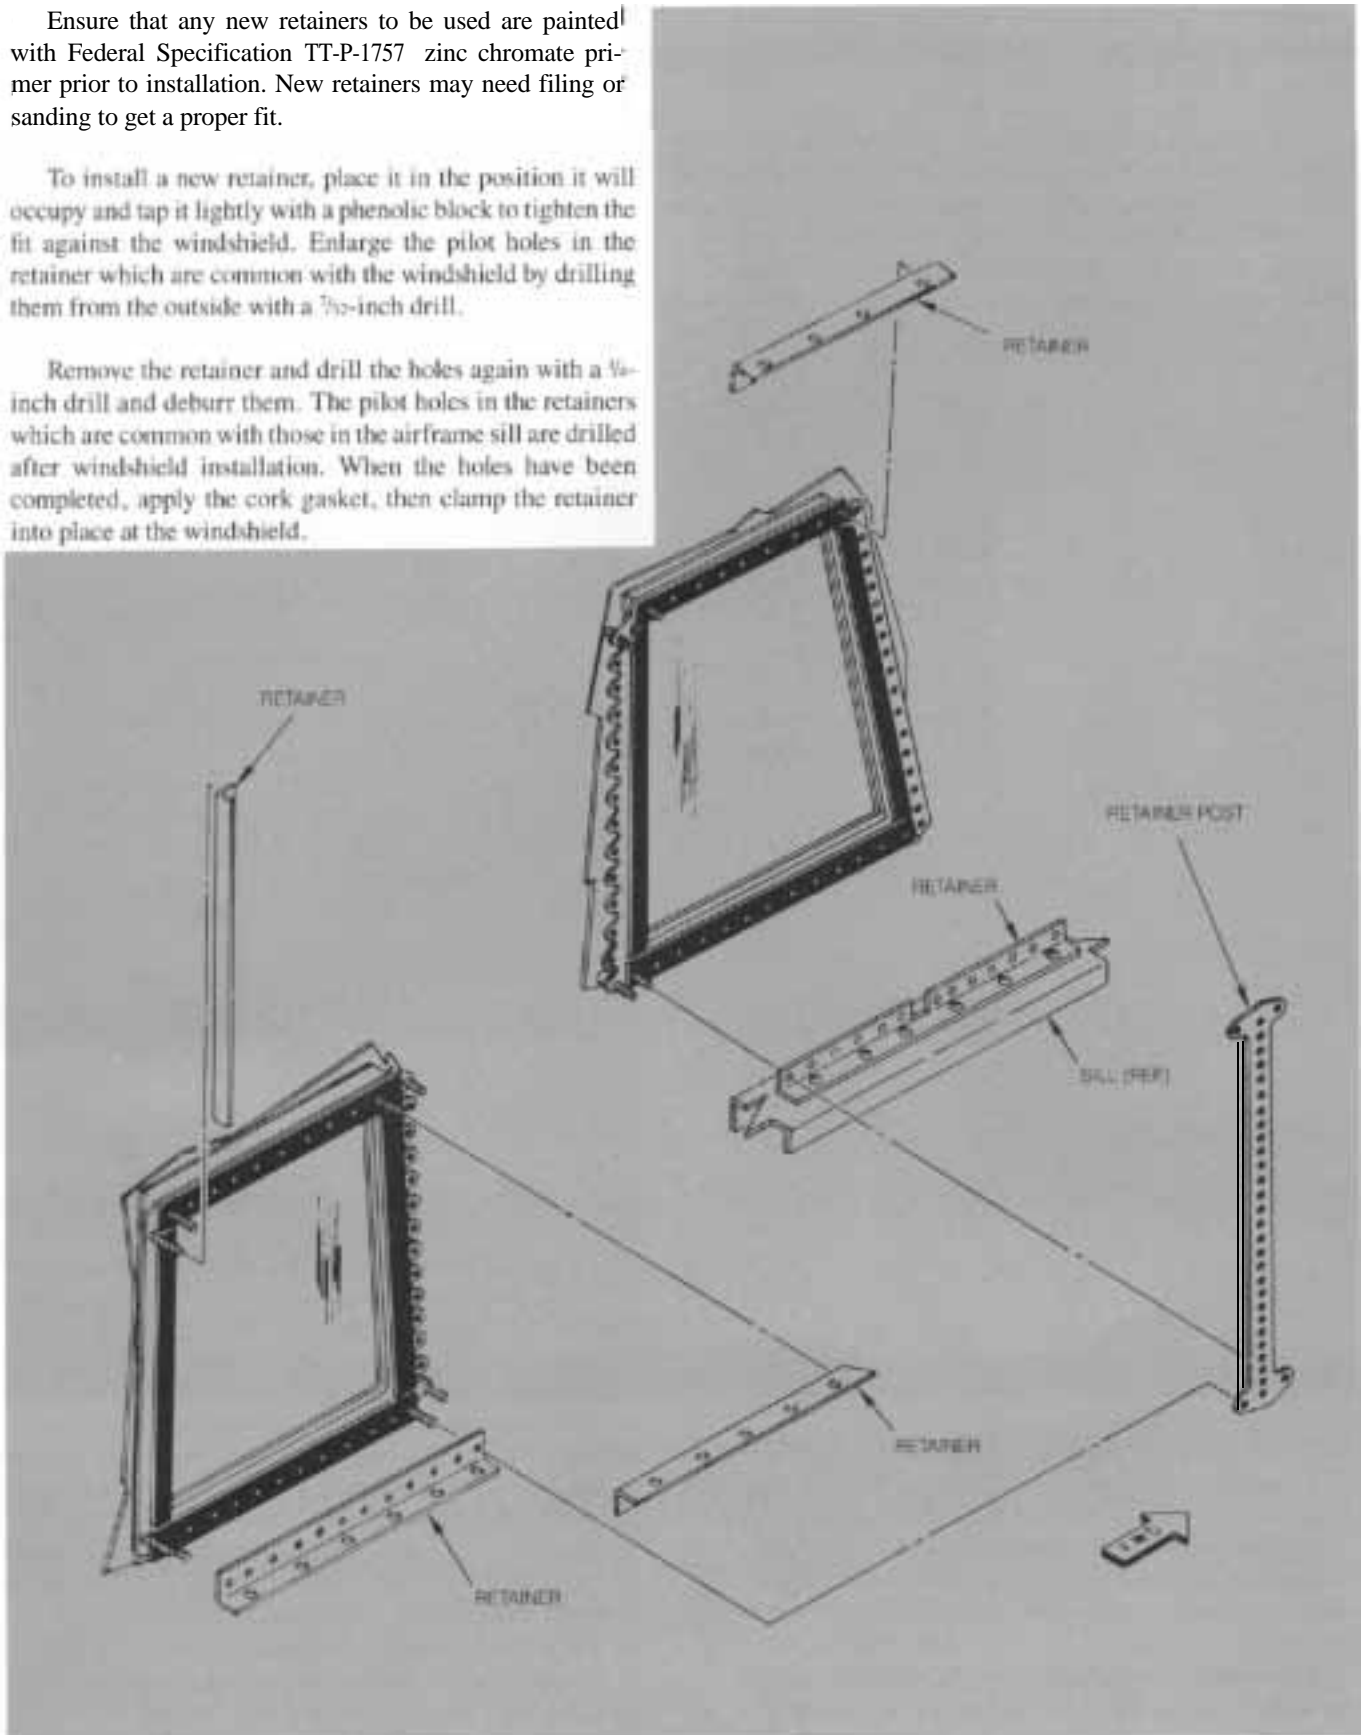
Figure 75. Installing windshield retainers.

To install a new retainer, place it in the position it will occupy and tap it lightly with a phenolic block to tighten the fit against the windshield. Enlarge the pilot holes in the retainer which are common with the windshield by drilling them from the outside with a $\frac{3}{32}$ -inch drill.

Remove the retainer and drill the holes again with a $\frac{1}{8}$ -inch drill and deburr them. The pilot holes in the retainers which are common with those in the airframe sill are drilled after windshield installation. When the holes have been completed, apply the cork gasket, then clamp the retainer into place at the windshield.
