2018 Restoration Maintenance Work Plan

Bloody Brook Onondaga County, New York

October 2018

2018 RESTORATION MAINTENACE WORK PLAN BLOODY BROOK ONONDAGA COUNTY, NEW YORK

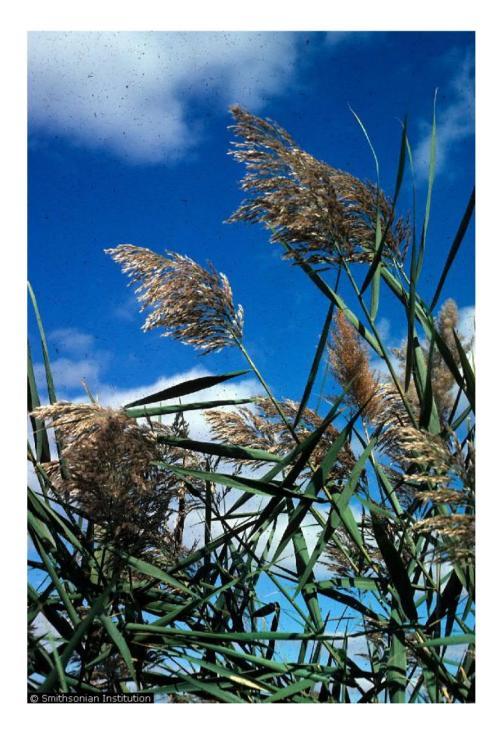
Phragmites

There were two primary invasive species of plants noted, *Phragmites* and purple loosestrife. Manual removal was successful at reducing the population of these species and will continue to be implemented at the site with monthly invasive species inspections and removal activities completed during the growing season. The presence of purple loosestrife leaf beetles has been observed, but due to the persistence of the purple loosestrife at the site, manual removal will continue to be implemented. The Bloody Brook Invasive Species Control Procedure for *Phragmites* and purple loosestrife is included in this work plan as Attachment D.

- 1. If there is a seed head on the plant, this should be cut off and placed in a garbage bag for disposal, taking care not to drop seeds onto the ground.
- 2. The entire plant should then be dug up by:
 - a. Loosening up the ground with a spading fork,
 - b. Grasping the base of plant by hand and pulling the plant out by the roots, or use Uprooter to remove the stem and roots. *Phragmites* produces long horizontal root systems, and purple loosestrife produces a large taproot. If possible, try to gently but firmly pull at the roots to remove as long a piece of root as possible. This will minimize the number of small pieces of root left in the ground (each of which can produce a new plant next year).
- 3. All of the plant is then placed in a garbage bag for disposal.
- 4. Take care not to step on, dig up, or otherwise damage desirable plants, especially any shrubs or trees.
