SERVICE NEWS

A Service Publication of Lockheed Aeronautical Systems Company

Vol. 20, No. 3, July-September 1993

Plugs and Covers for Your Hercules

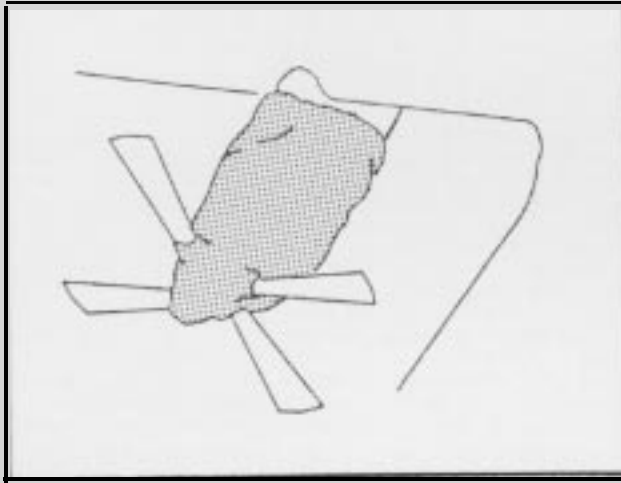
Propeller Spinner and Engine Nacelle Cover

The PN 404100-1 Spinner and Nacelle Cover (shown above) is a protective device designed for use in particularly harsh environments. It is made of weather and sunlight-resistant vinyl fabric.

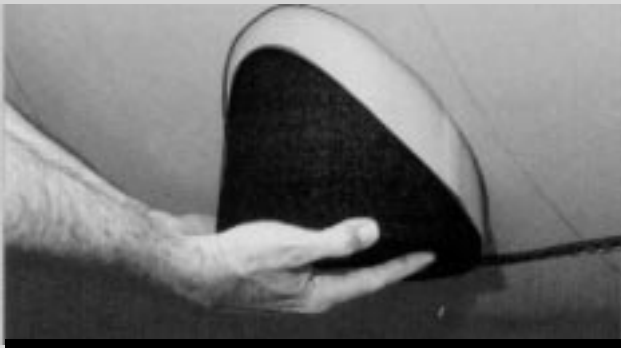
To avoid such damage, it is very important to insert this plug in a vertical position which matches the duct angle as shown above. The sides of the plug are slightly tapered, and very little force is needed to seat it correctly. When properly seated, the bottom flat surface is almost parallel to the ground.

Extra caution should be used when inserting the round exhaust plug into the cargo compartment exhaust duct. This is a round duct that extends downward from the wheel well, but it is cut at the end to a shape that approximately conforms to the exterior shape of the wheel well panels. Because the duct is not squared off at the end, there is a tendency for the plug to be inserted at an angle, with the bottom tilted outward.

Then, since the plug does not seem to insert easily, extra force is used to push the plug into the duct. This can result in a large tear in the plug surface, caused by the sharp, specially contoured edge of the metal duct.

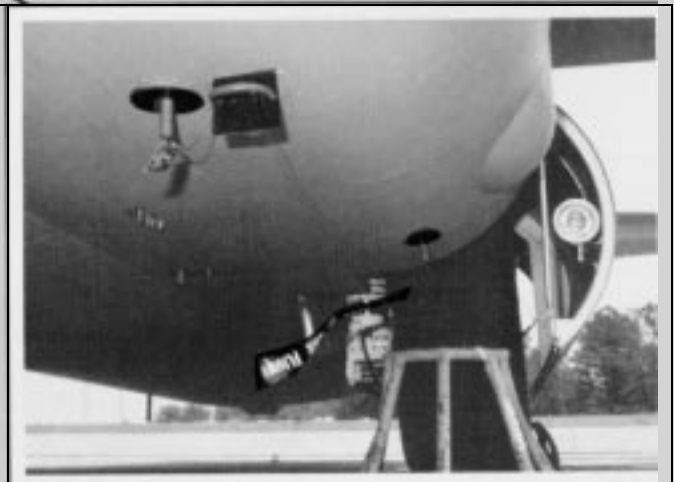
Figure 2. APU cooling air port assembly.

These APU cooling air plugs are formed from red thermoplastic sheeting, and have numerous slots which provide flexibility during insertion.

Three small air scoops and outlets are located on the underside of the aircraft below the APU. These ducts can be plugged with the PN 3402904-1 APU Cooling Air Port Plug Assembly (Figure 2). This assembly is not included as part of the standard plug set provided with new aircraft. If your Hercules is equipped with skis, the PN 3402409-3 assembly must be used.
