# Stormwater Drain Pipe North Segment Debris Removal Report

Akron, Ohio

Prepared for:
Lockheed Martin Corporation

Prepared by: ARCADIS 600 Waterfront Drive Pittsburgh Pennsylvania 15222 Tel 412.231.6624 Fax 412.231.6147

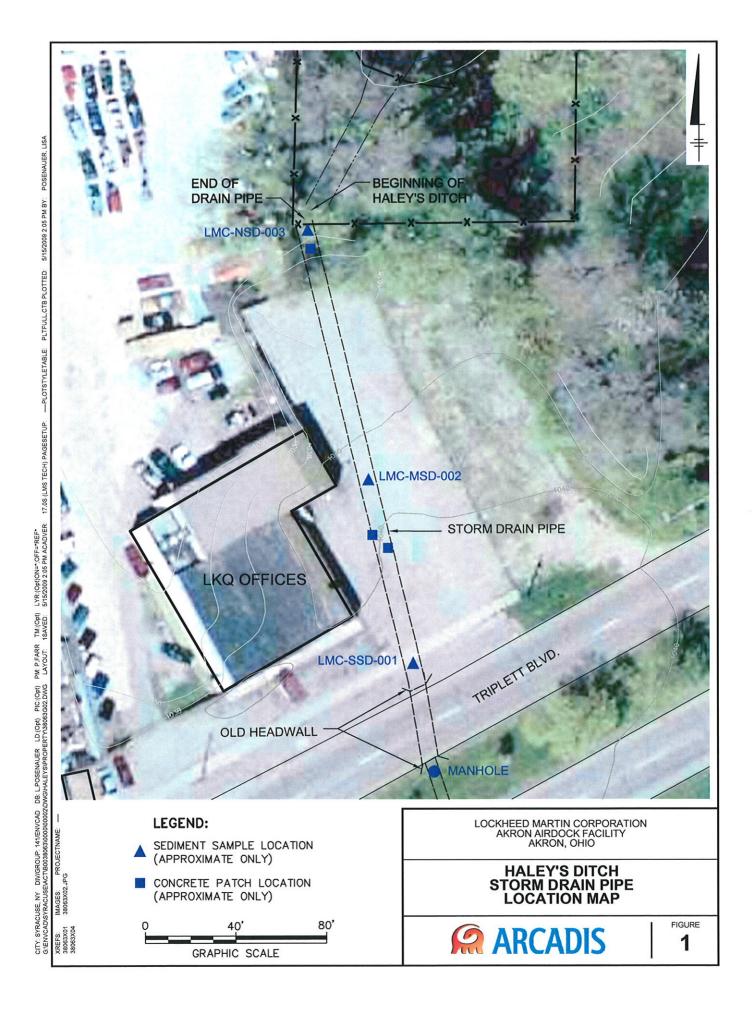
- The steel storm drain pipe was degraded in three areas, such that openings were observed to the fill
  material surrounding the pipe. These locations are shown on Figure 1. Each of these openings was
  sealed with concrete.
