VOL. 2, NO. 4, OCTOBER - DECEMBER 1975

SERVICE NEWS

A SERVICE PUBLICATION OF LOCKHEED-GEORGIA COMPANY, A DIVISION OF LOCKHEED AIRCRAFT CORPORATION

WASHING THE HERCULES

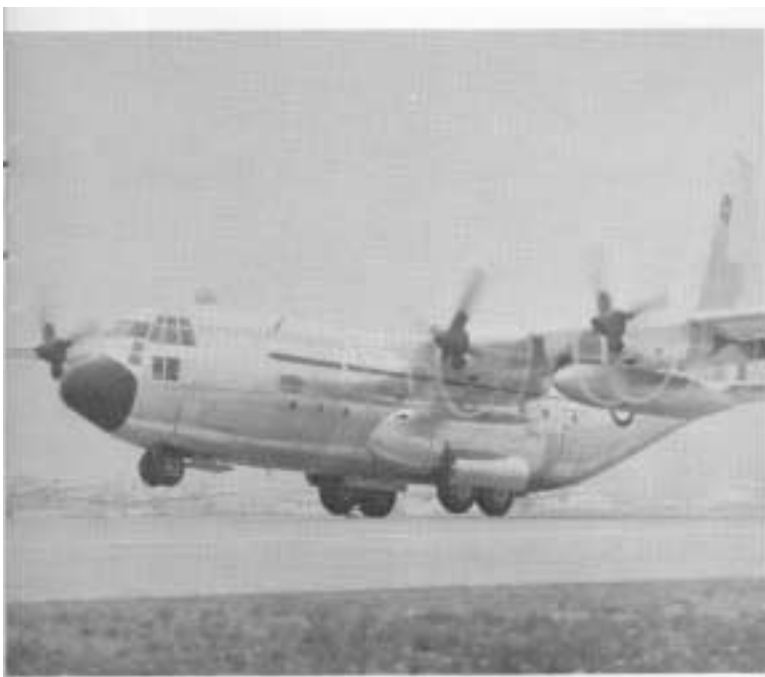
Corrosion from entrapped contaminants in wing fairing.

Corrosion - any corrosion - shortens the life of metal structure. Corrosion is being found on some Hercules airplanes in critical areas such as the center wing section, flap wells, and beneath the cargo floor. Exhaust deposits from the engines swirled into the flap wells by propeller blast are corroding the flap wells; exhaust deposits and salts in solution in the atmosphere attack the center wing section; hauling cargo such as cattle, gasoline, fertilizer, and other such items can leave corrosive deposits beneath the cargo floor to attack the fuselage skin. Low level flights over water, ground operation of engines with flaps extended, low and slow flights, all add their part to the corrosion problem.

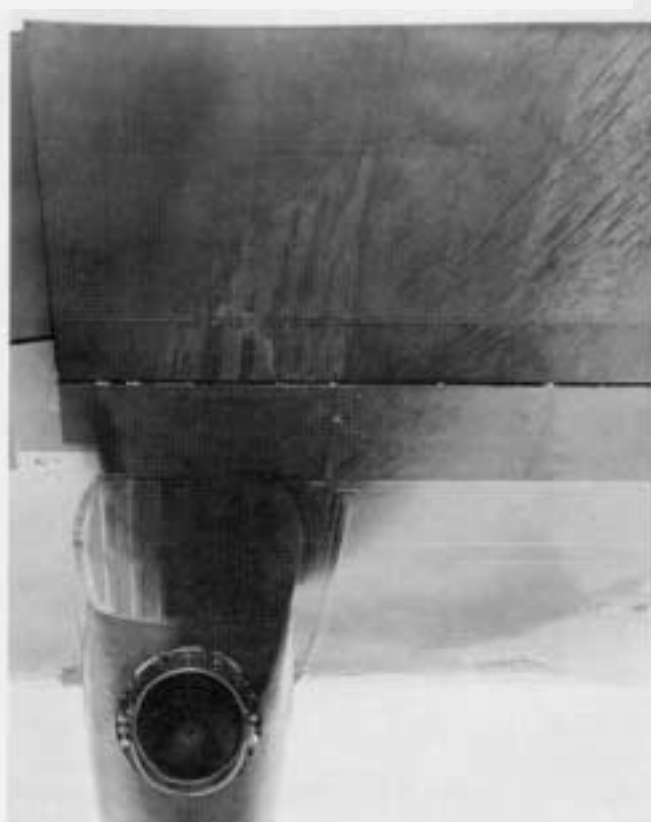
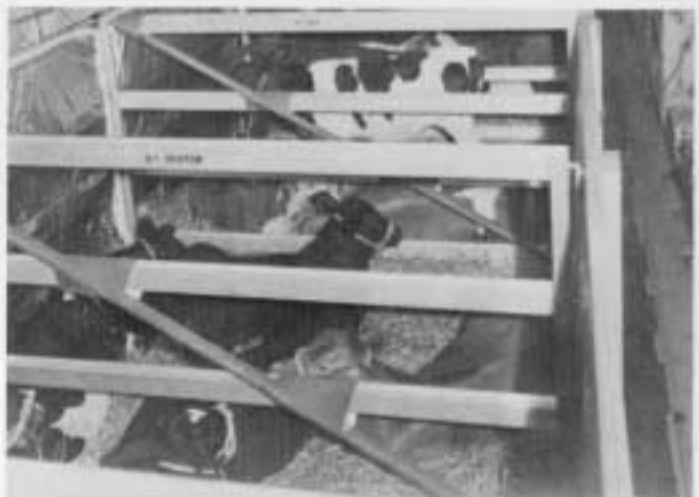
Lower Left: A more frequent cleaning of the engine exhaust trails is necessary in any environment. Upper Right: Drain holes in cargo door skin. Lower Right: A cargo that leaves corrosive deposits.

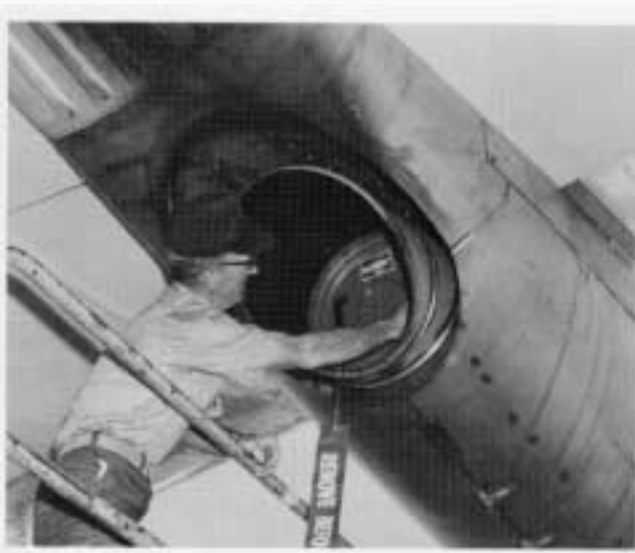
Above: Engine tailpipe plug being installed to prevent entrance of contaminants. Below: Waterproof adhesive tape and sheet material are used to prevent damage by cleaning solutions during washing. Openings are closed, plastic areas are covered and the landing gear is shielded with these materials.

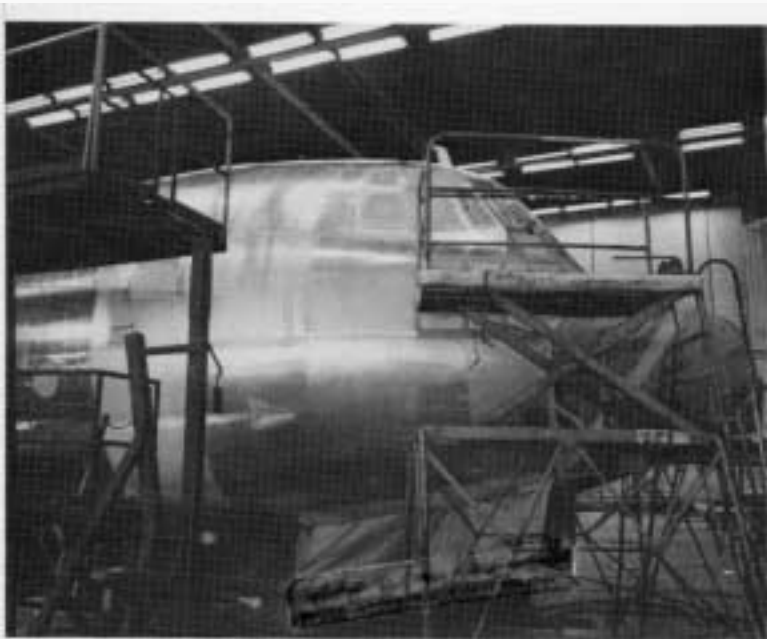
WASHING SEQUENCE

STEP 1. The washing usually starts with the forward fuselage:

The best sequence for washing the Hercules is shown in the step-by-step illustrations accompanying this article. Starting at the bottom and working up prevents streaking that occurs if you start at the top and let cleaner run down on the unwashed areas. Keeping the rinse water going helps prevent streaking. In fact, a good wetting before starting to wash will not only remove some surface dirt, but through capillary action can help build up a clean water barrier in small crevices, and will tend to keep strong solutions from getting into the crevices. Being difficult to remove, the solution can lead to corrosion in these areas.

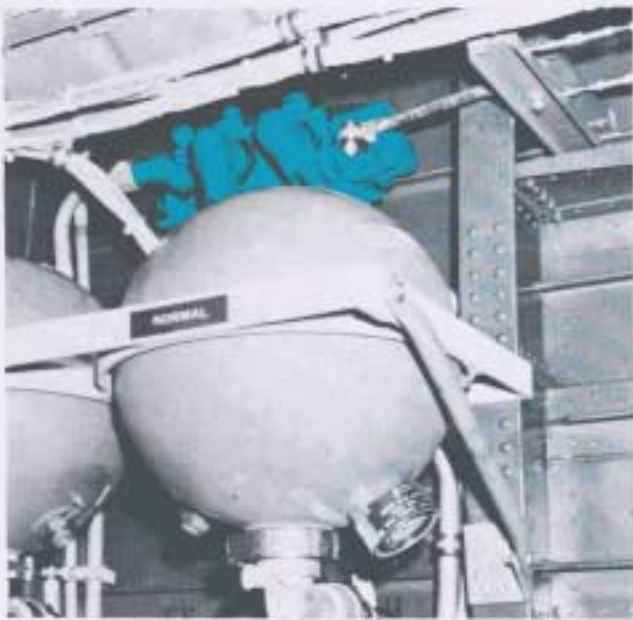
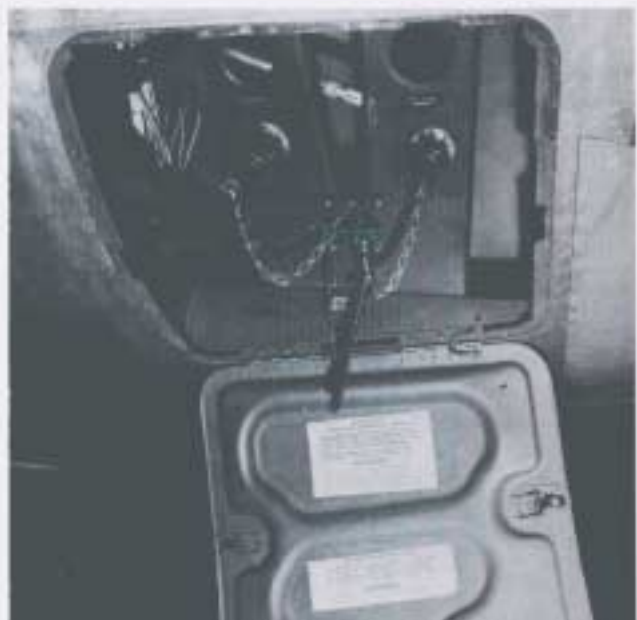
PHOTOGRAPH OF ENCLOSED AREA ABOVE LEFT MAIN WHEEL WELL. HIGHLIGHT SHOWS LOCATION OF THE GROUND TEST INTERCONNECT VALVE ON PRODUCTION HERCULES SINCE A CHANGE IN 1965. VALVE IS ACTUATED MANUALLY BY CABLES FROM A HANDLE LOCATED IN THE LEFT WHEEL WELL FAIRING. EARLY HERCULES HAD TWO INTERCONNECT VALVES DIRECTLY BEHIND THE HANDLE.
