# *SERVICE NEWS*

A SERVICE PUBLICATION OF LOCKHEED-GEORGIA COMPANY, A DIVISION OF LOCKHEED CORPORATION

**Vol. 8, No. 1, January-March 1981**

# MARK II Anti-Skid

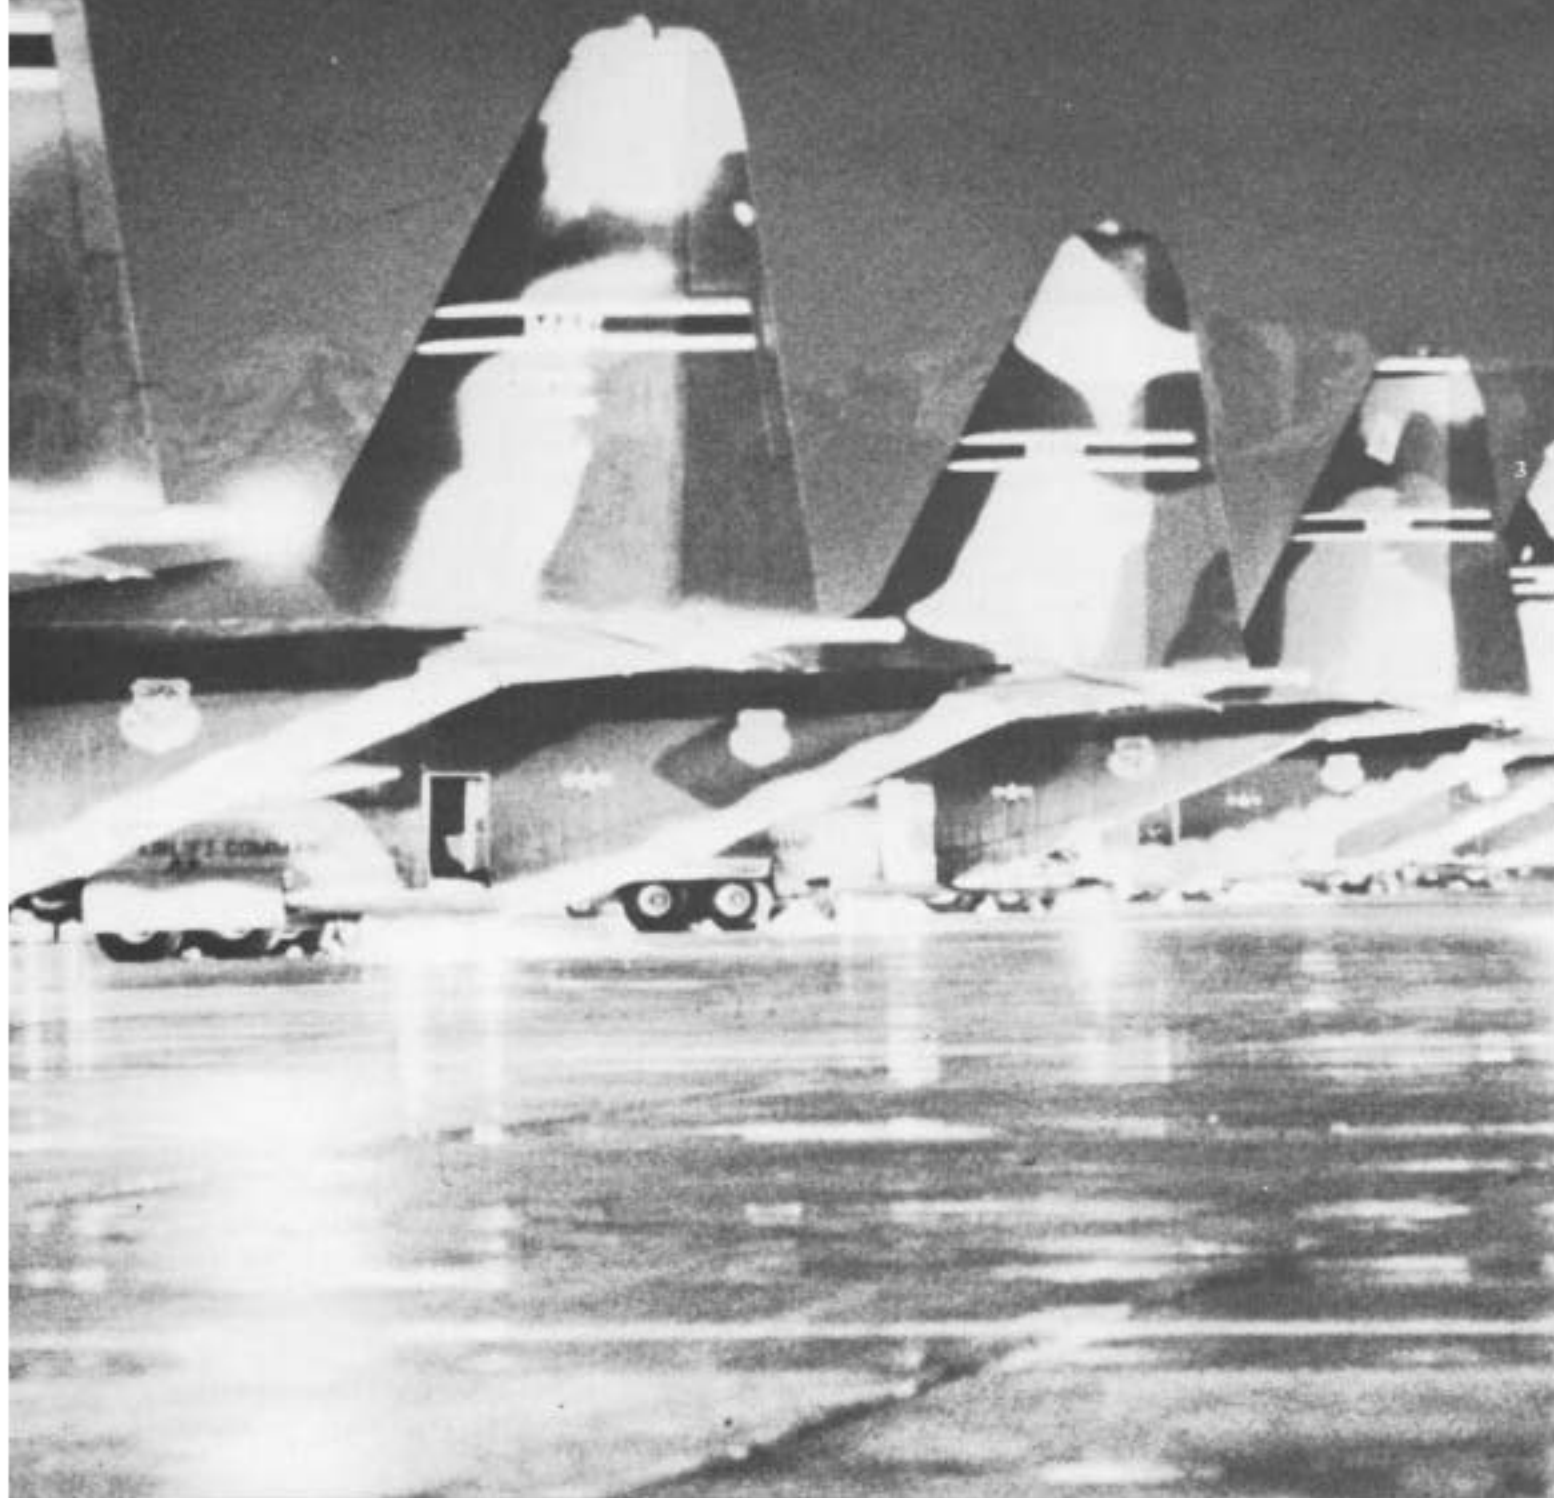
MARK II ANTI-SKID COMPONENTS LOCATION

The Mark II system detects an approaching skid by measuring wheel deceleration. If a wheel slows down more than it should, and before it can begin to skid, the Mark II reduces brake pressure proportionally so that the skid is prevented. The Mark II prevents skidding by sensing the exact amount of brake pressure needed for safe braking under all runway conditions and without tire damage.

The Mark II monitors itself continually with a fail-safe system that detects power loss or open valves and displays these findings visually in the Hercules aircraft flight station.

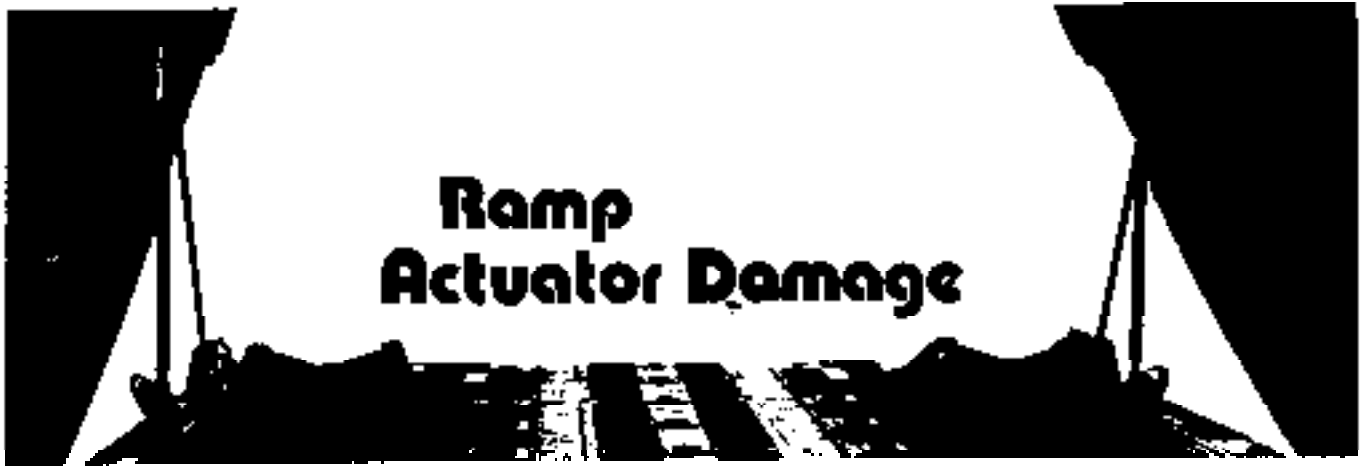
Figure 2. Modified fitting installation.

Some Hercules aircraft operators have experienced ramp actuator piston rod damage due to insufficient clearance between the ramp actuator rod and a bolt and nut used to attach a fitting to the sloping longeron (P/N 342986-3L or -3R) at fuselage station 847, butt line 61.625.

The clearance problem occurs during in-flight operation of the ramp. The actuator rod position shifts due to component wear and forces acting on the ramp during in-flight operation.

- ◆ Reference Figure 2 - Reinstall the bolt (A) in the opposite direction (head outboard). Make certain that the washer (B) is under the bolt head and washer (C) is placed under the nut (D). Retorque the bolt to the torque value specified in the applicable maintenance manual.
