SERVICE NEWS

*Checking Engine
Performance*

Vol. 19, No. 1, January-March 1992

Checking T56 Engine Performance

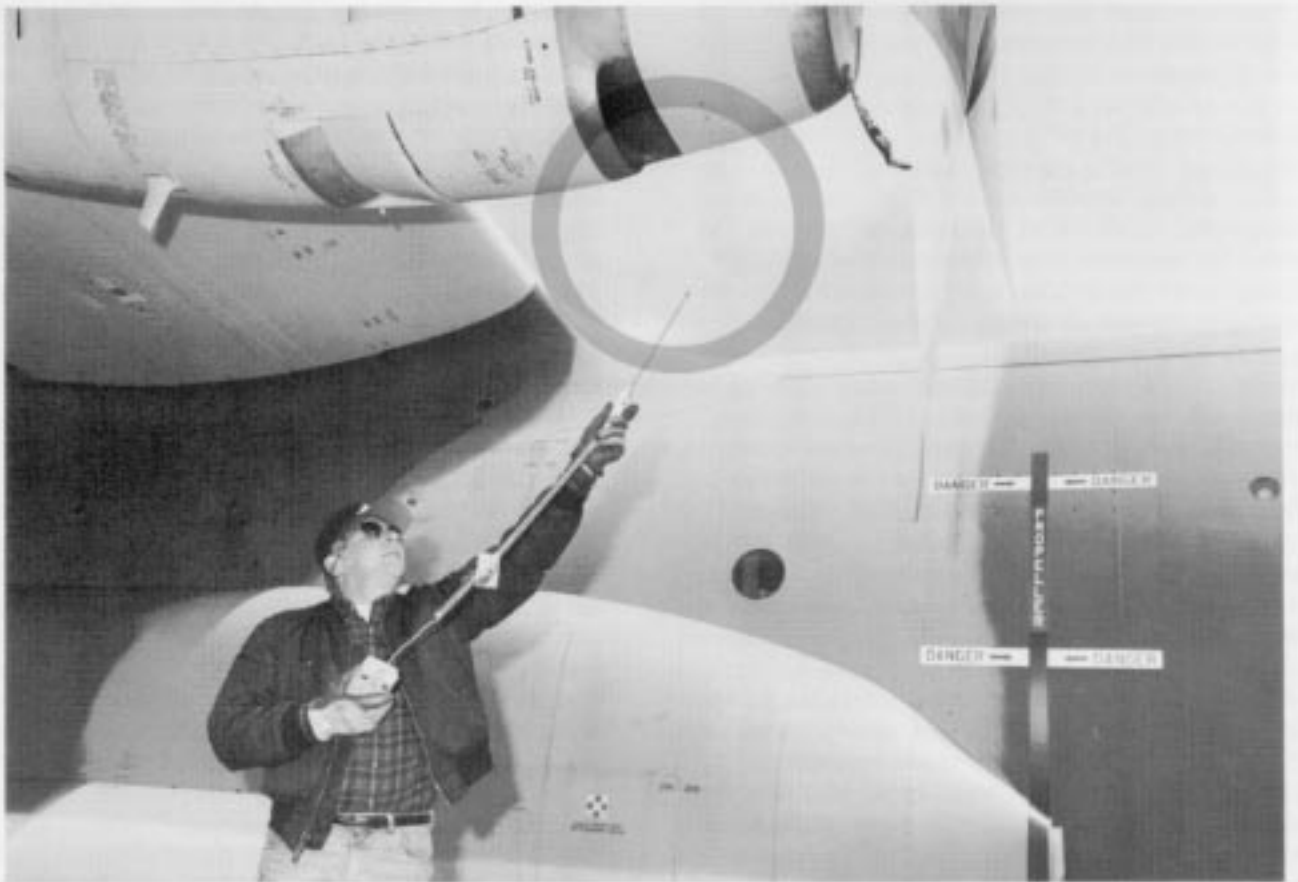
Figure 3. The ambient air temperature must be measured as accurately as possible for valid engine performance results. Be sure to take temperature readings in a shaded area.

2. Be sure to calibrate the tachometer, torque meter, and turbine inlet temperature indicator of the affected engine before doing a performance check.
3. The ambient temperature should be measured as accurately as possible, in a shaded area under the wing. A precision mercury thermometer, or a digital electronic thermometer, are the instruments of choice. Let the thermometer stabilize fully before use. A 2.8°C error (5°F) results in a 2% error in the engine performance calculation.

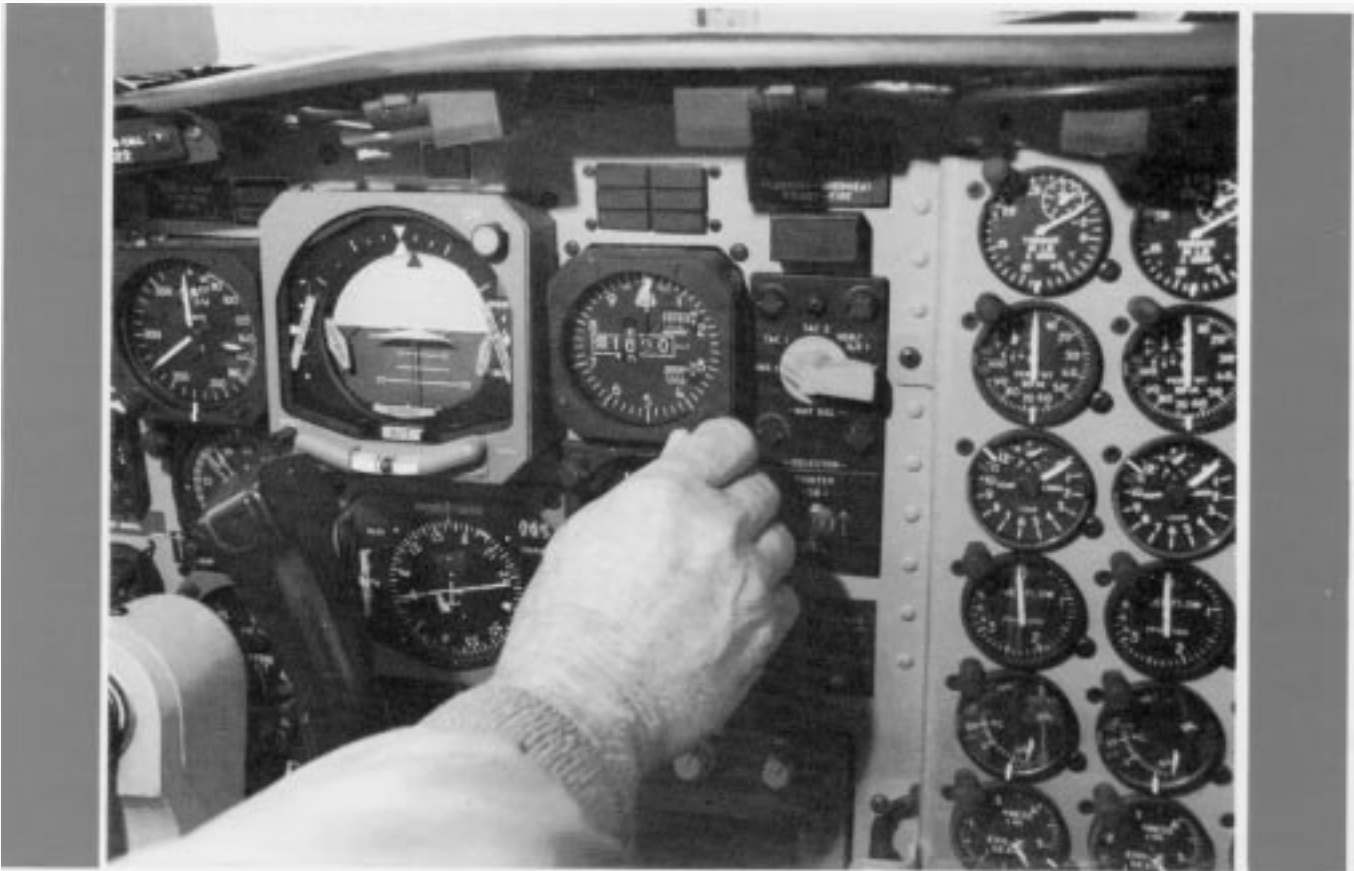
Figure 4. Pressure altitude is also a critical parameter. Averaging the readings obtained from two flight station altimeters reduces the chances of error.

4. Obtain and record the pressure altitude. This should be the aircraft altimeter reading when 29.92 inches of mercury is set in the "Kollsman window" of the altimeter. Average the readings of two altimeters on the flight deck. A 300-foot *error* in the altitude reading will result in a 1% error in calculated performance.

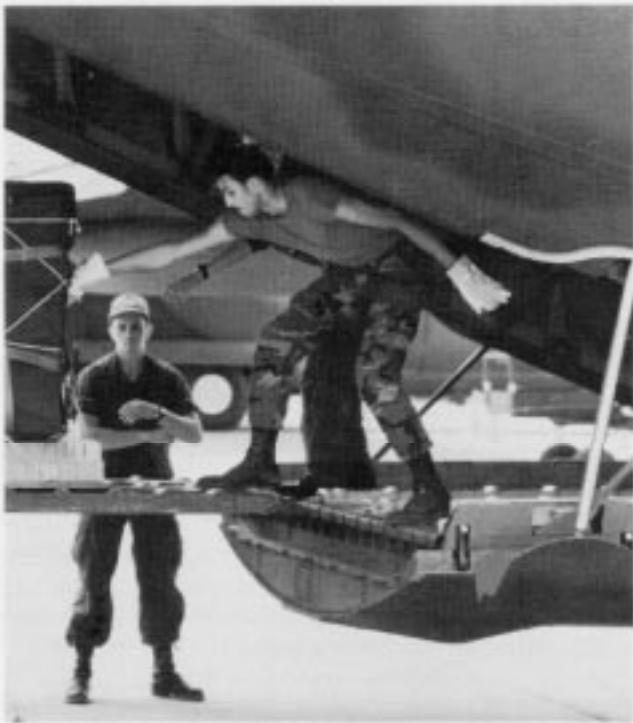
The hook at ramp station 10 may fail to engage if the ramp is heavily loaded and the aircraft is parked in a turn.

The failure of a hook at ramp station 10 to engage its hook retainer is a problem which shows up most frequently when the ramp is loaded with cargo and the aircraft is parked after completing a turn.

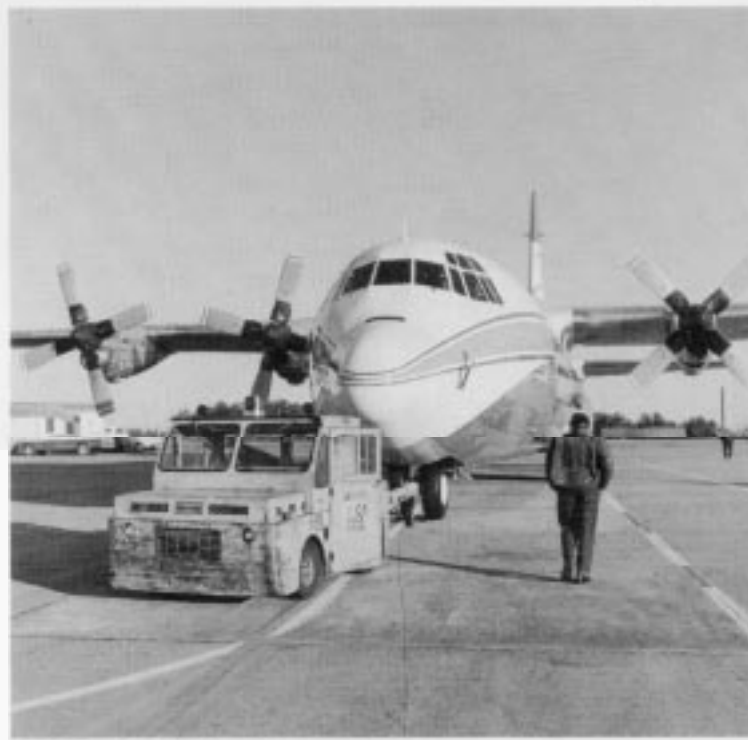
Moving the aircraft in a straight line for two revolutions of the main tires may permit all hooks to engage properly.

When the Hercules aircraft is towed-or taxied in a turn, the main landing gear tires are deflected laterally. Before stopping the aircraft, it is always best to proceed forward in a straight path for several more feet to avoid leaving the tires deflected and under stress while the aircraft is parked.

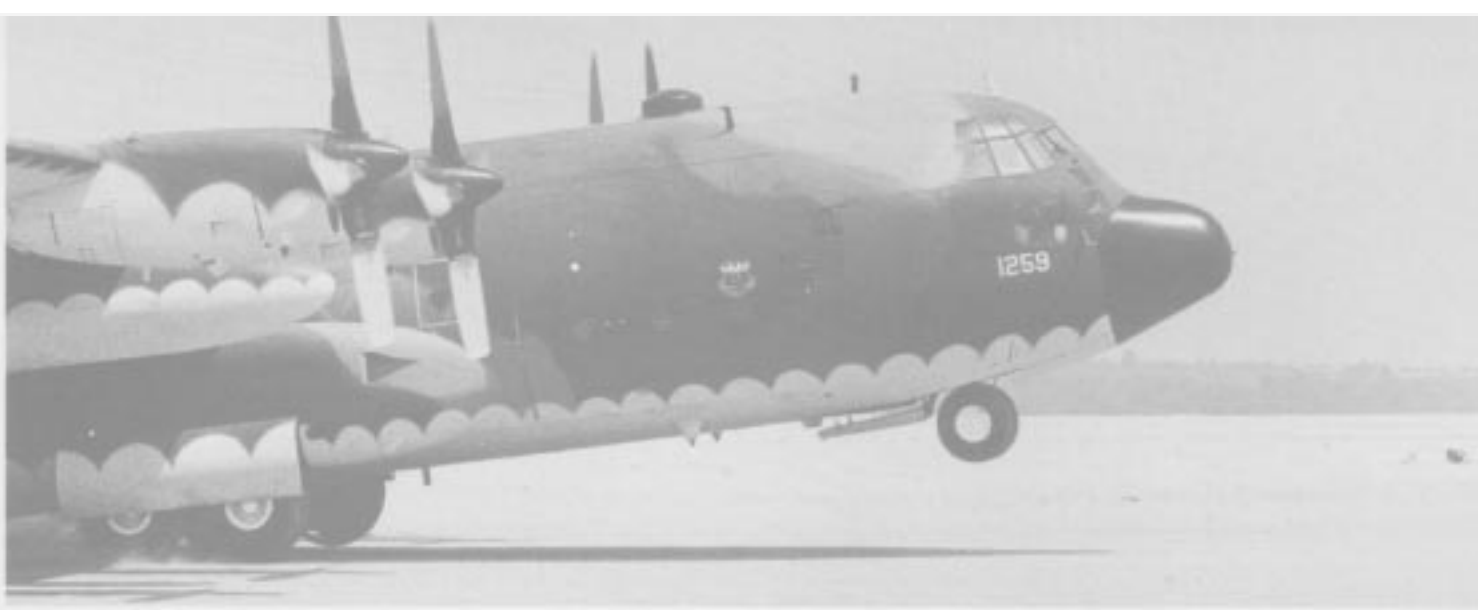
If you are unsure whether your Hercules has hard struts or soft struts, there are several ways to find out. One way is to examine the data plate on the strut to see the part number or servicing pressure. This information can then be compared with information in the appropriate illustrated parts breakdown or maintenance manual to provide an answer. Unfortunately, you cannot depend on the color of the data plate itself as a designation for hard **or soft** struts. All struts manufactured in the last decade or so, hard or soft, have data plates that are red in color.
